APPENDIX C
Petrographic Analysis Reports

Appendix D: Petrographic Analysis

Introduction for Airports I – III

Airport I

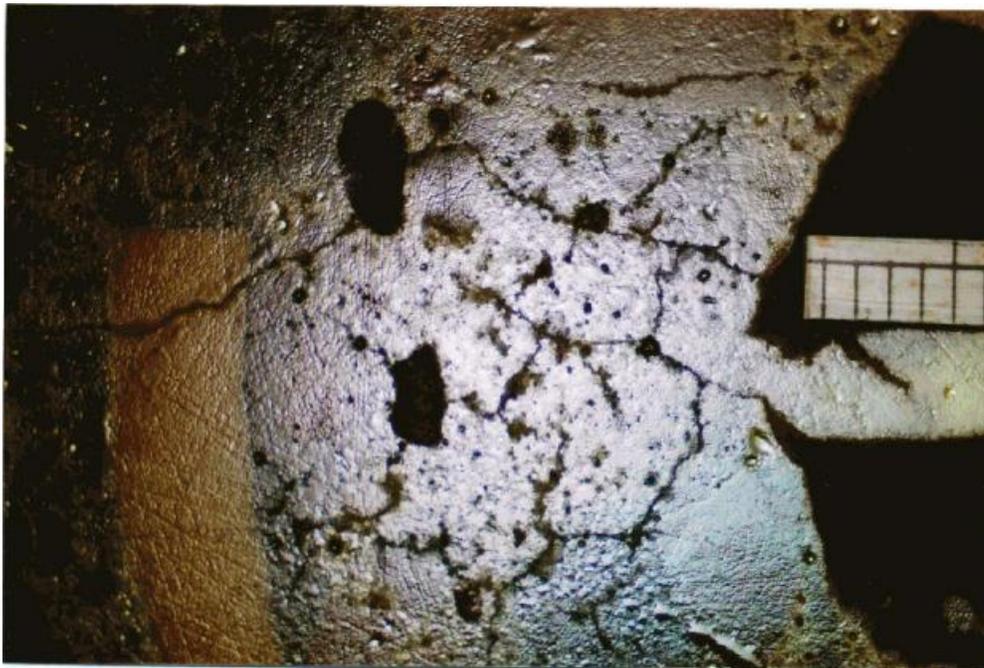
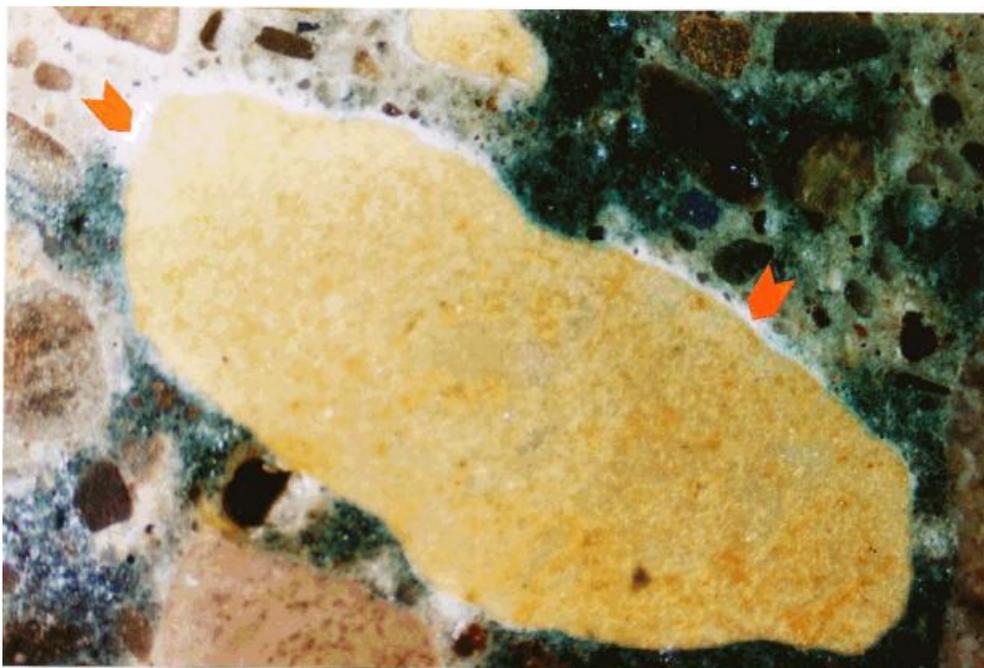
Figure 1: (Upper) Typical ACR macrocracking and microcracking in Victor – 2 Core at a depth of 90 mm in an epoxy-impregnated surface (without lapped removal of the excess epoxy) under the stereomicroscope in oblique, reflected, diffuse light. Similar cracking was observed throughout the entire length of the core. Millimeter scale divisions. (Lower) Tan dolomitic coarse aggregate limestone under the stereomicroscope in Victor – 2 Core at a depth of approximately 140 mm, partially surrounded by a thin discontinuous band of white carbonated paste (mows), the carbonation believed to result from an alkali carbonate reaction. LP = 16 mm.

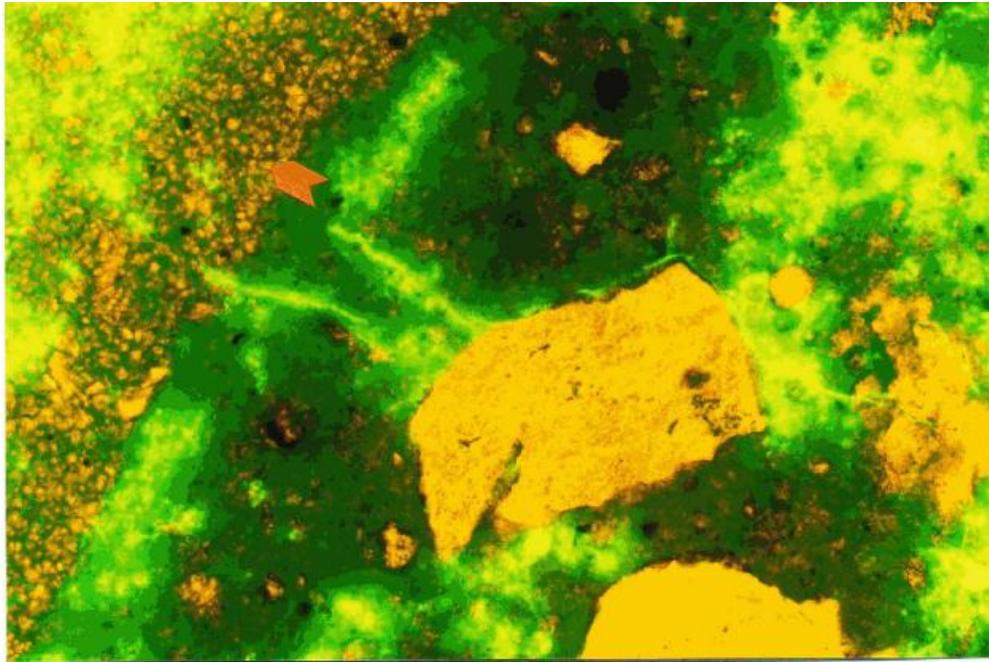
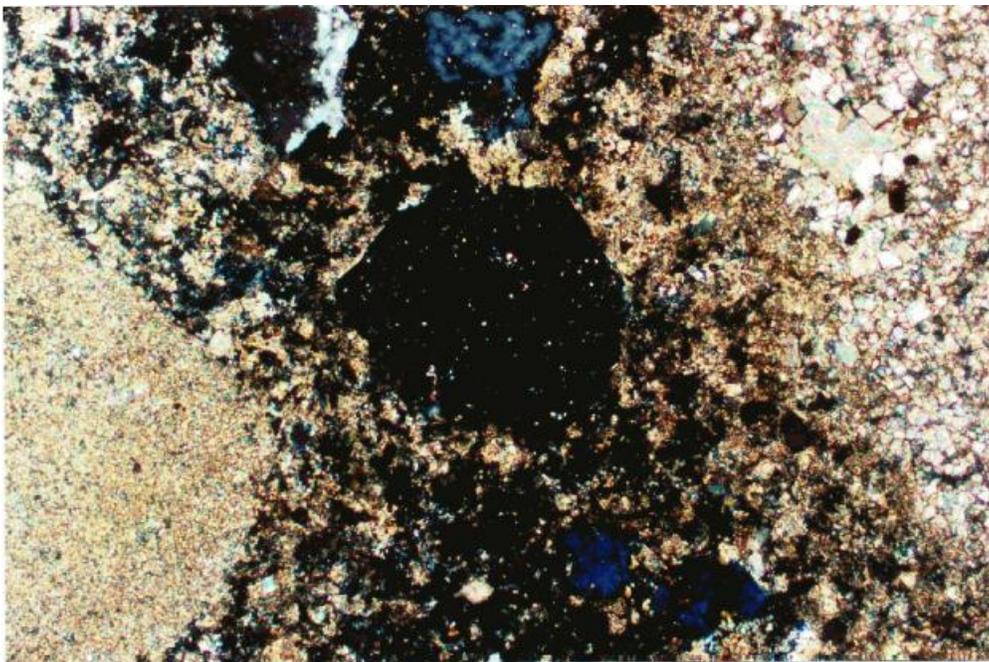
Figure 2: (Upper) Thin-section view at 100X of Victor – 2 Core at a depth of 90 mm in transmitted polarized light with simultaneous reflected UV light. Left side of photo illustrates relatively low permeability reaction rim on dolomitic limestone aggregate (arrow) through which a microcrack passes into the adjacent paste. LP = 1.0 mm. (Lower) Thin-section of Victor – 2 Core at a level of 135 mm in cross-polarized transmitted light at 100X. Dolomitic limestone aggregates on left and right sides of photo with intervening carbonated paste (from ACR) and rounded quartz grain (black). The carbonated paste is white to off-white in the lapped section viewed under the stereomicroscope. LP = 1.0 mm.

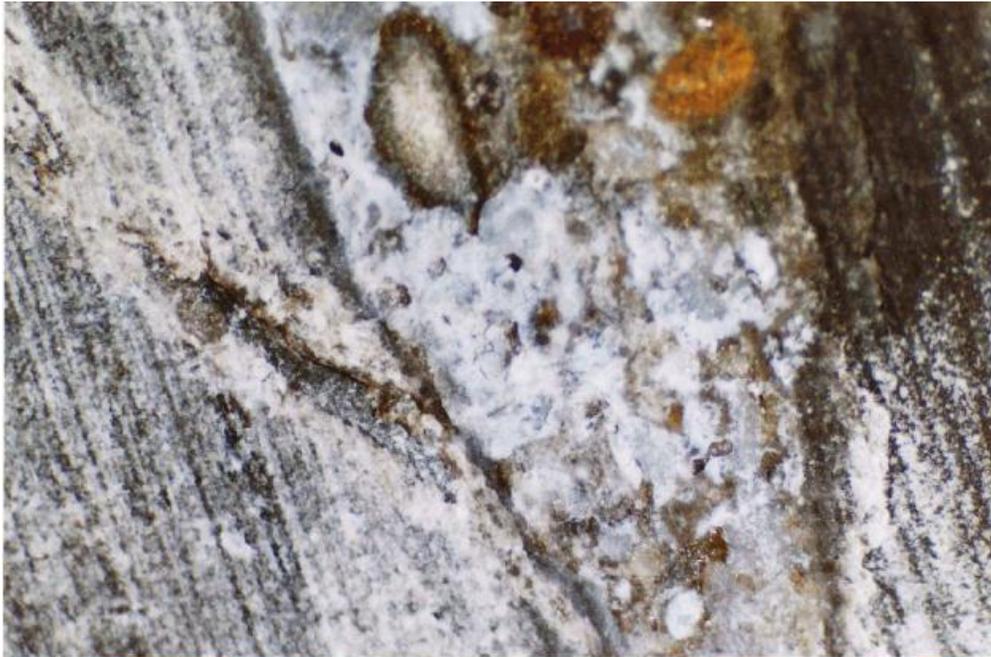
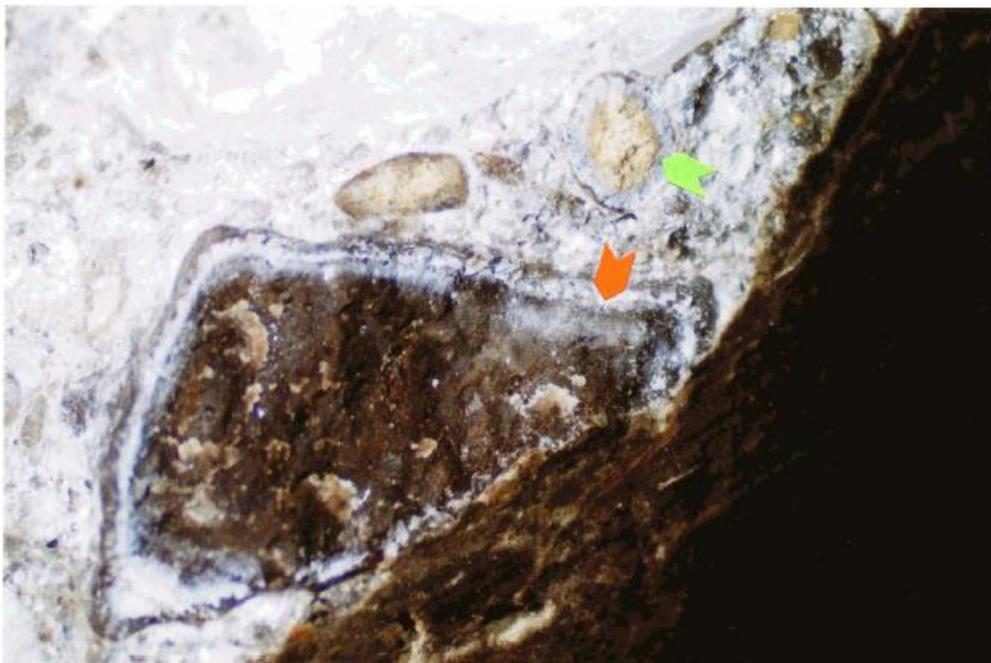
Figure 3: (Upper) Exterior side of Echo – 2 Core, as received, under the stereomicroscope, illustrating white ASR gel that accumulated at a depth of 110 millimeters after core drilling, and suggesting mobilization of gel by the drilling LP = 10 mm, (Lower) Fracture surface at depth of 65 mm in Echo – 2 Core under the stereomicroscope, exposing a reaction-rim crack, coated with white ASR gel in a dark coarse-aggregate limestone (orange arrow) and yellowish tan siltstone of the fine aggregate (green arrow). Dark area in lower right is shadow of core, LP = 20 mm.

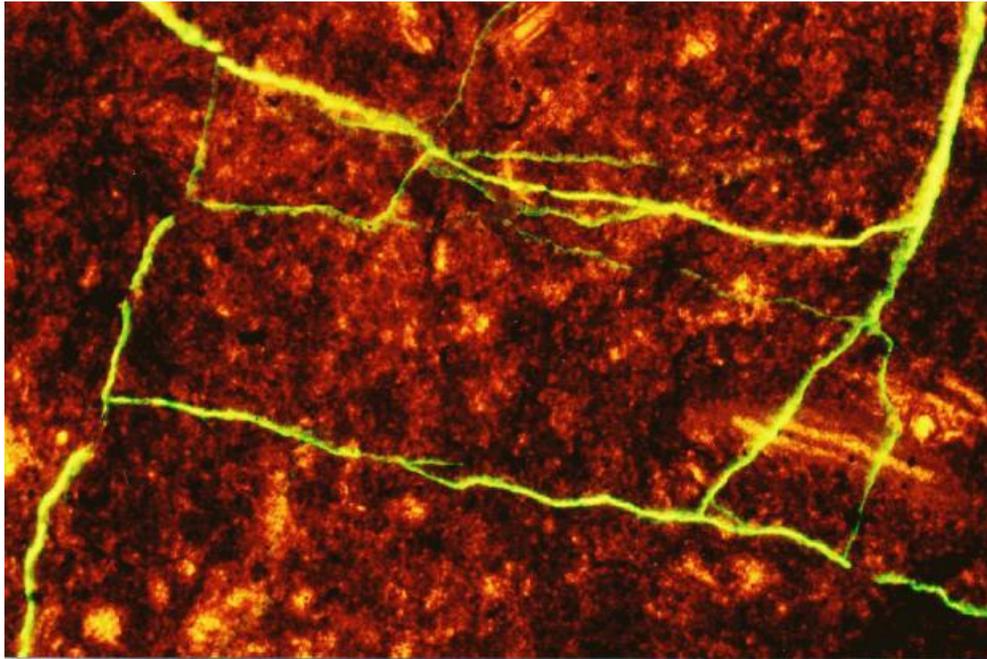
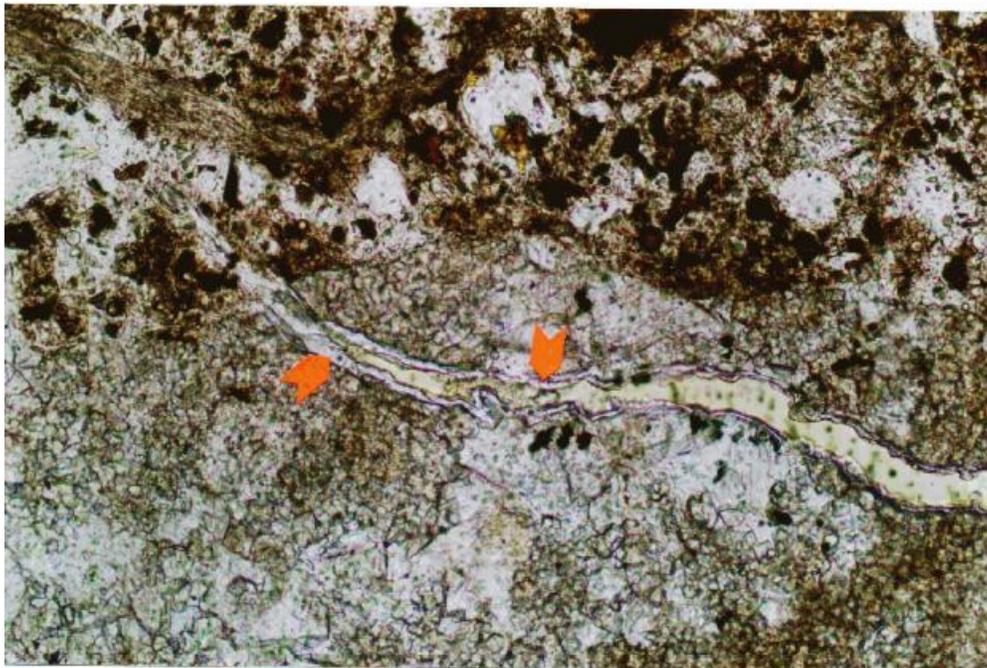
Figure 4: (Upper) Vertically oriented thin section of "box" crack in limestone aggregate in Echo – 2 Core in transmitted plane-polarized light and simultaneous reflected UV light at a magnification of 40X and depth of approximately 195 mm. One of many intricate crack patterns abundant in these limestone aggregates. LP = 2.6 mm, (Lower) Dark limestone in thin section at 200X, showing peripheral microcrack partially lined with ASR gel (orange mows). Crack enters paste and terminates nearby. LP = 0.5mm.

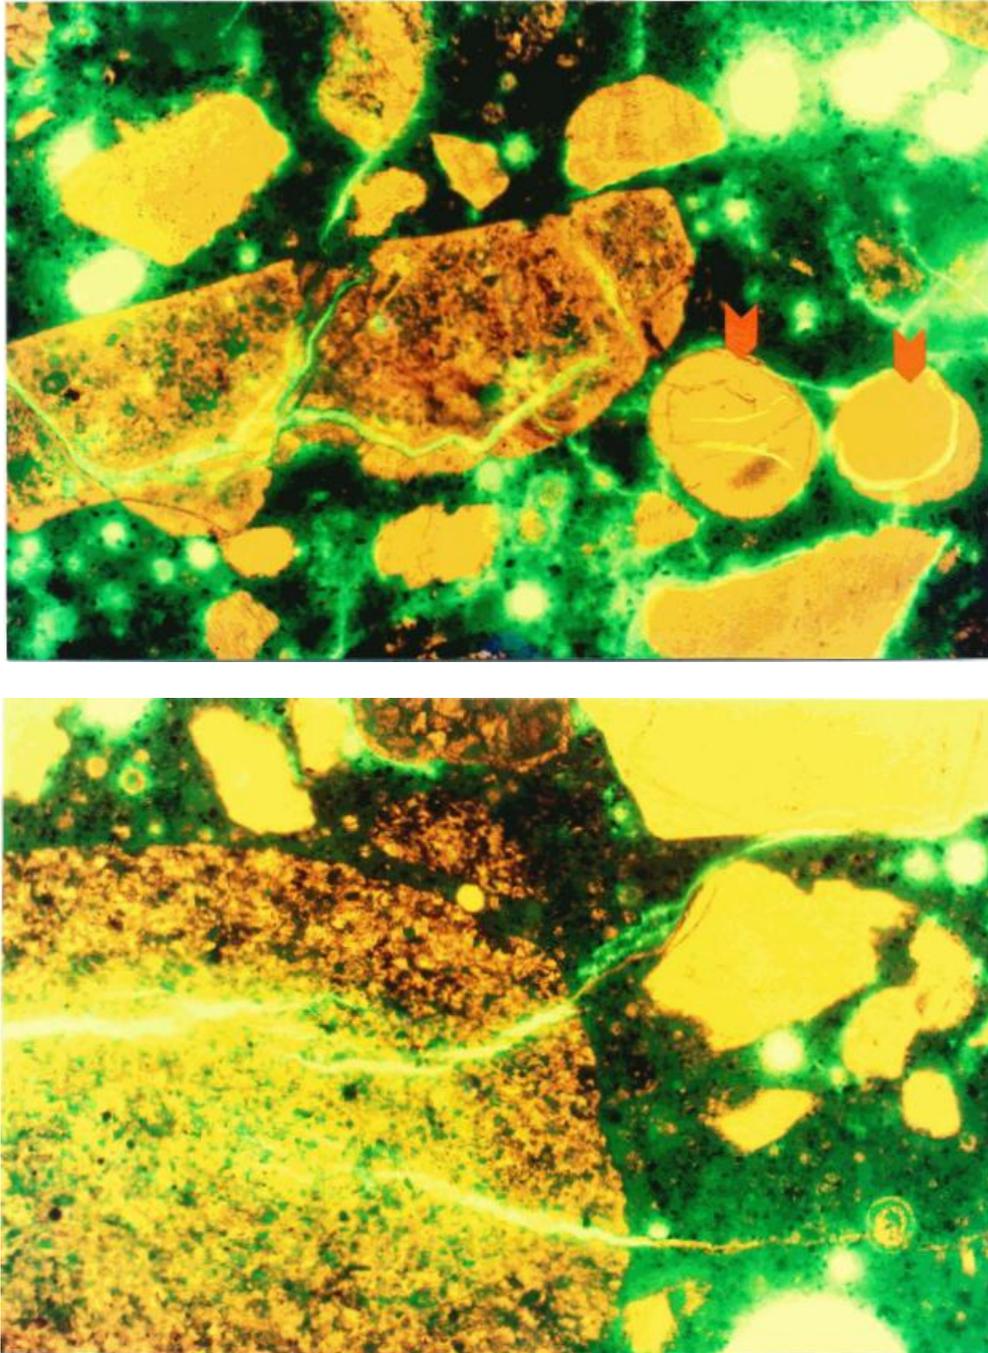
Figure 5: (Upper) Thin section of Echo – 2 Core at 40X, illustrating a fine-aggregate chert particle with microcracking and adjacent ASR gel in voids (arrows). LP = 26 mm (Lower) Typical ASR microcracking in a chert-cemented siltstone in the fine aggregate at 40X. Transmitted polarized light and simultaneous reflected UV light LP = 2.6 mm.

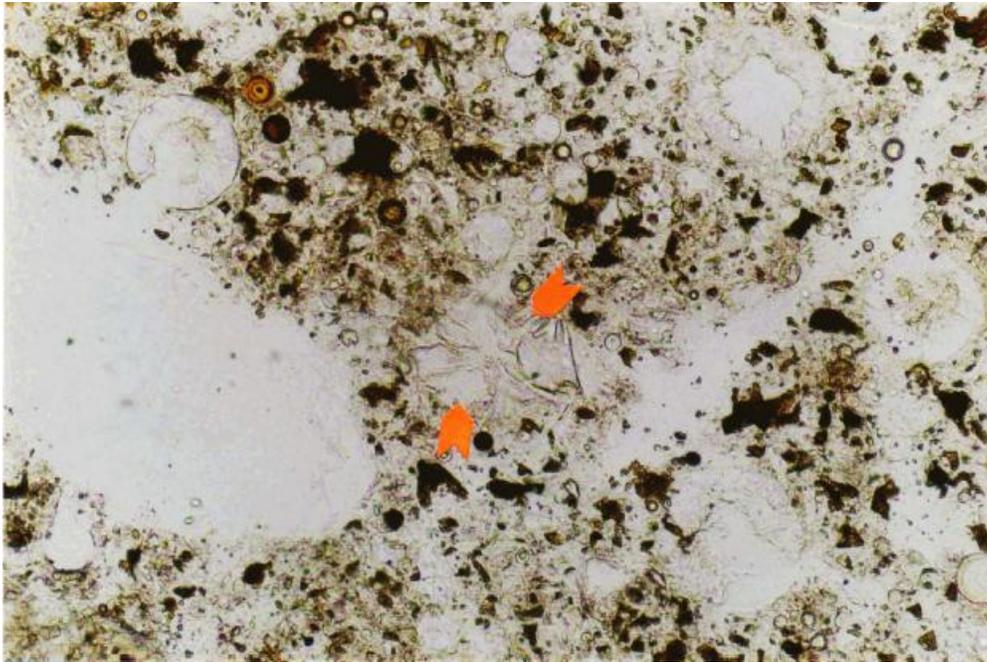
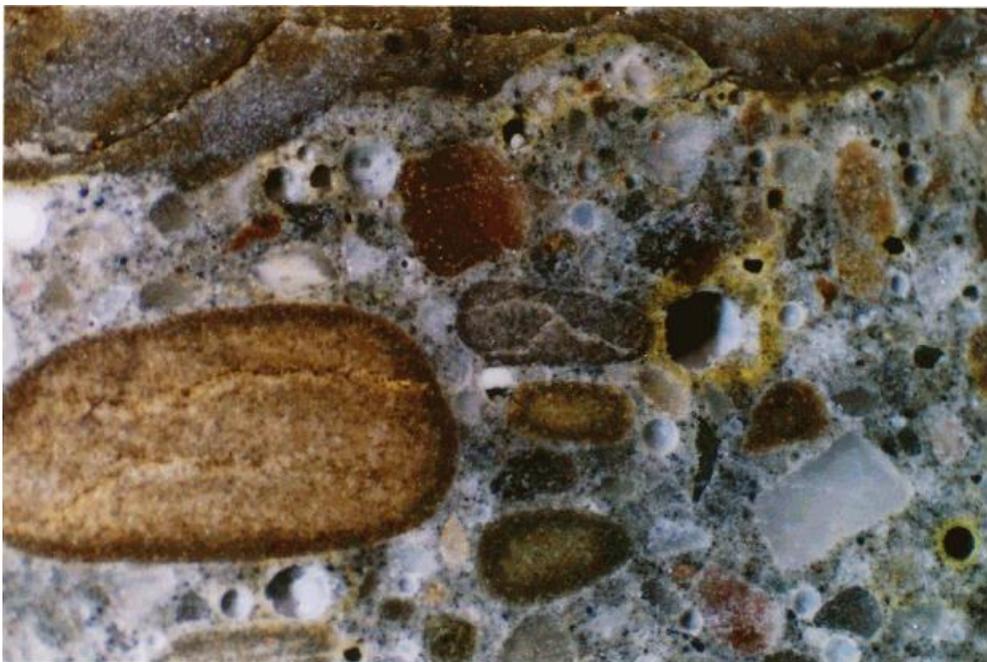
Figure 6: (Upper) Thin section of Echo – 2 Core at 200X in transmitted plane-polarized light. Arrows point to a cluster of radiating crystals of calcium hydroxide (epezite) formed from free lime (not shown in the photo), an unusual occurrence in concrete. No associated damage was found. Round air voids contain fillings and linings of ettringite. LP = 0.5 mm. (Lower) Lapped section of Echo – 6 Core under the stereomicroscope. Limestone at top of photo. Central area shows well-rounded siltstone particles with horizontal microcracks, reaction rims or weathering rims (or combination), and white ASR gel in void (arrow). Depth in core = 140 mm. LP = 13 mm.

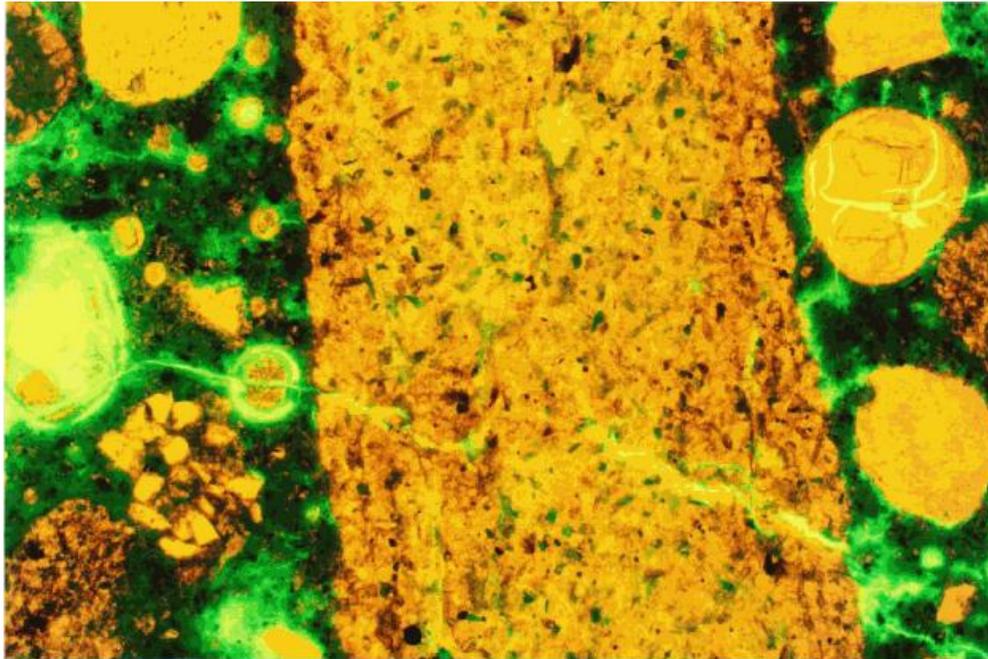
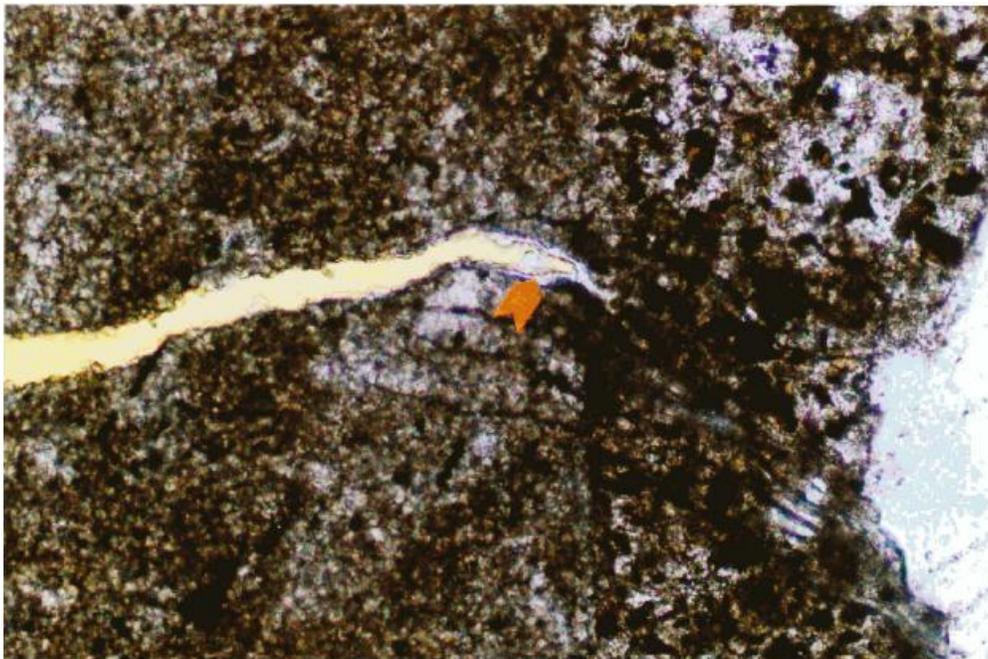
Figure 7: (Upper) Vertically oriented thin section of ASR-microcracked siltstone, abundant in the coarse fraction of the fine aggregate in Echo – 6 Core. Depth is approximately 150 mm. Adjacent voids contain ASR gel. Simultaneous reflected UV light and transmitted plane-polarized light at 40X. LP = 2.6 mm. (Lower) Thin-section view of limestone in Echo – 6 Core at a depth of 140 mm, showing a crack containing a partial lining of ASR gel (arrow) at and across the aggregate-paste interface, one of several similar observations. LP = 0.5 mm.

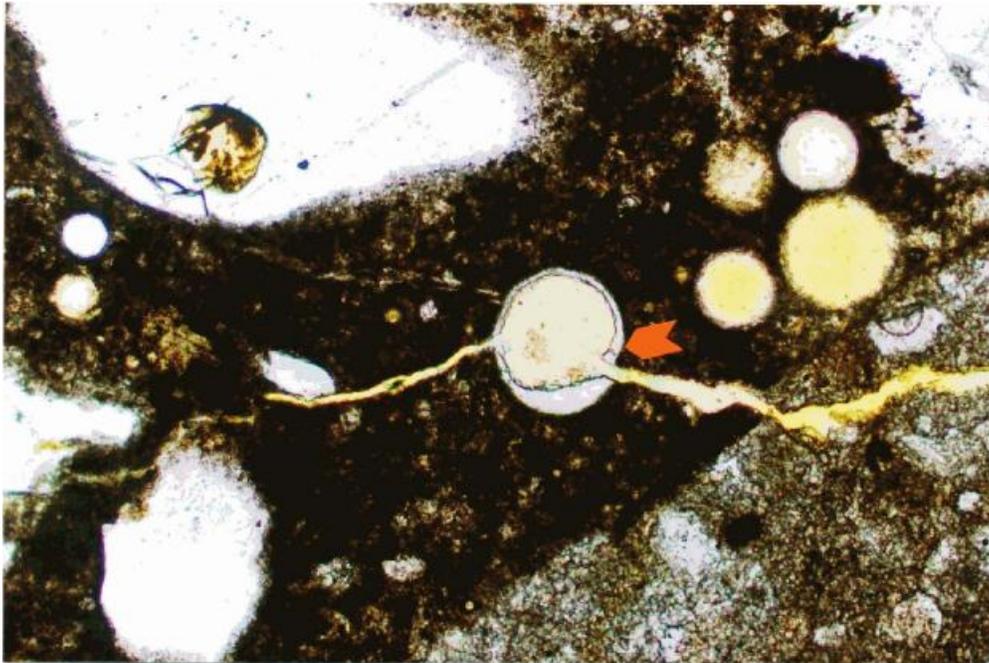
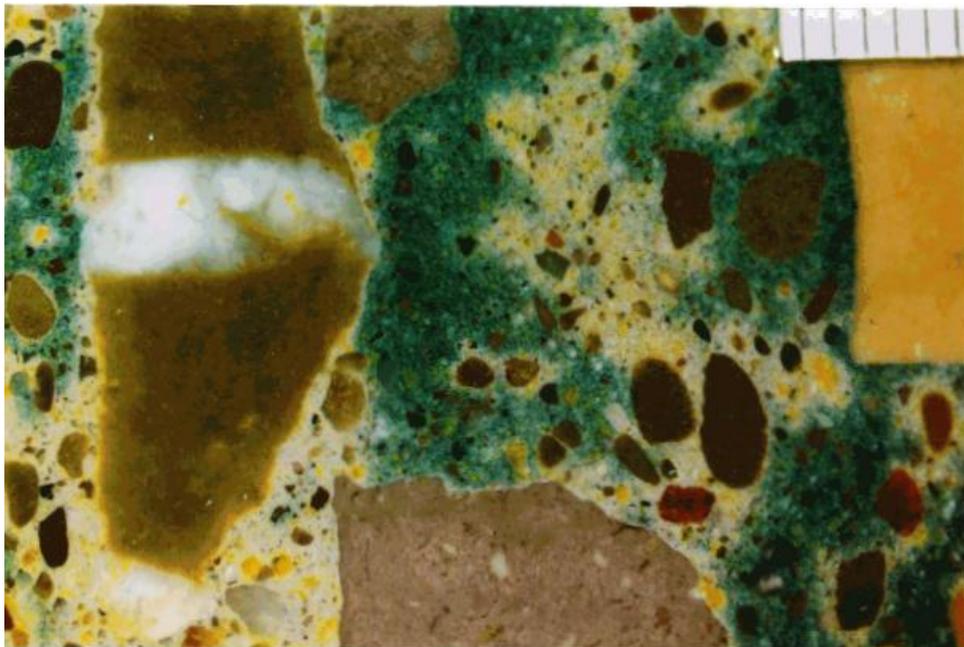
Figure 8: (Upper) Relatively thick thin section of Echo – 6 Core at 100X, showing microcrack passing out of a limestone and offsetting ASR gel (arrow) in a partially filled void, indicating the gel deposit is older than the crack. LP = 1.0 mm. (Lower) Lapped section of Victor – 2 Core at a depth of 90mm below the core top under the stereomicroscope, showing typical, irregular, green coloration of the paste, indicating use of glassy blast-furnace slag (confirmed in thin section). Millimeter scale divisions.

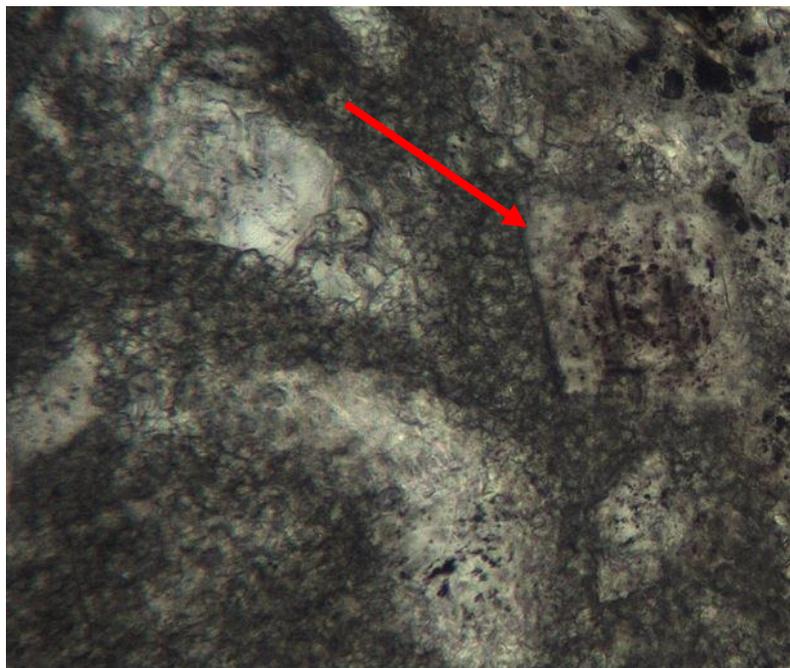
Figure 6. Thin section photomicrograph of Core 1 illustrating dolomite rhomb with an argillaceous inner core and non-argillaceous outer rim and ragged upper crystal face (red arrow). 120X magnification. Vertical field of view is 0.7 mm. Plane-polarized light.

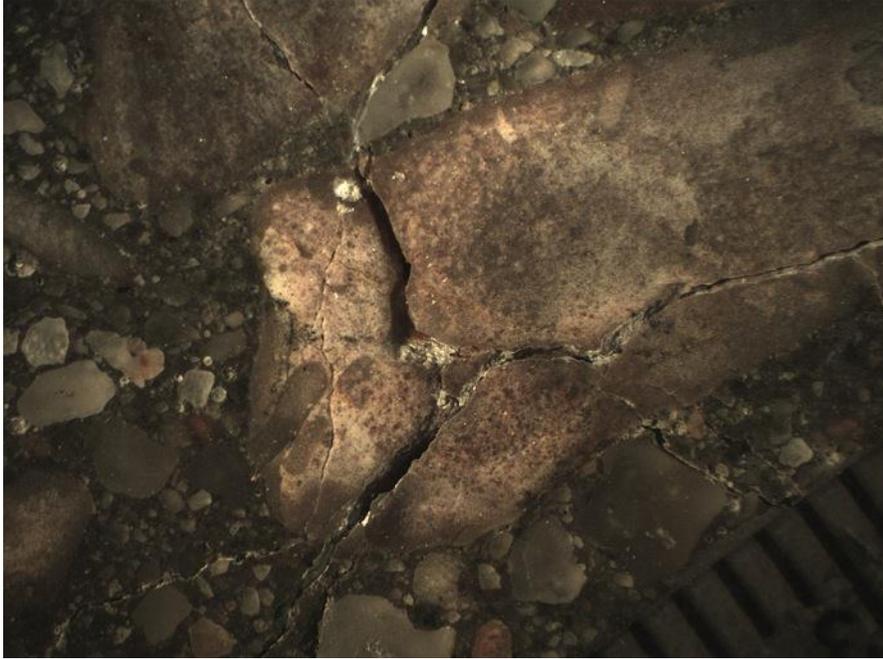
Figure 7. Magnified lapped slice of Echo 5 – Core 4 showing cracks radiating out from a rimmed, dolomite coarse aggregate particle. White, brucite (and other related) deposits line the cracks. This is typical of damage due to alkali-carbonate reaction. Scale is in millimeters.

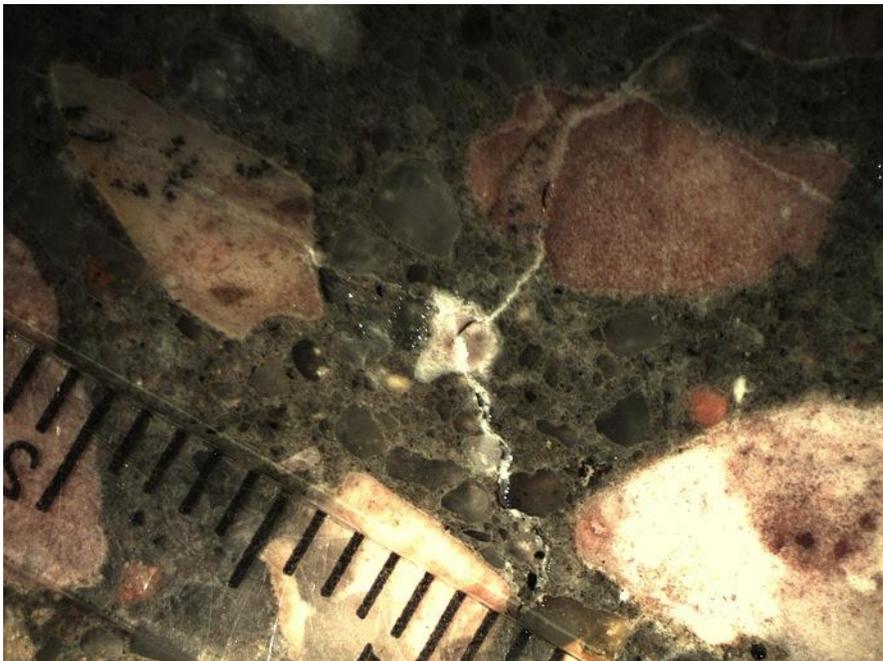
Figure 8. Photomicrograph of the magnified lapped slice of Echo 5 – Core 4 showing cracks radiating out from a small, dolomite coarse aggregate particle. White, brucite (and other related) deposits line the cracks. This is typical of damage due to alkali-carbonate reaction. Scale is in millimeters.

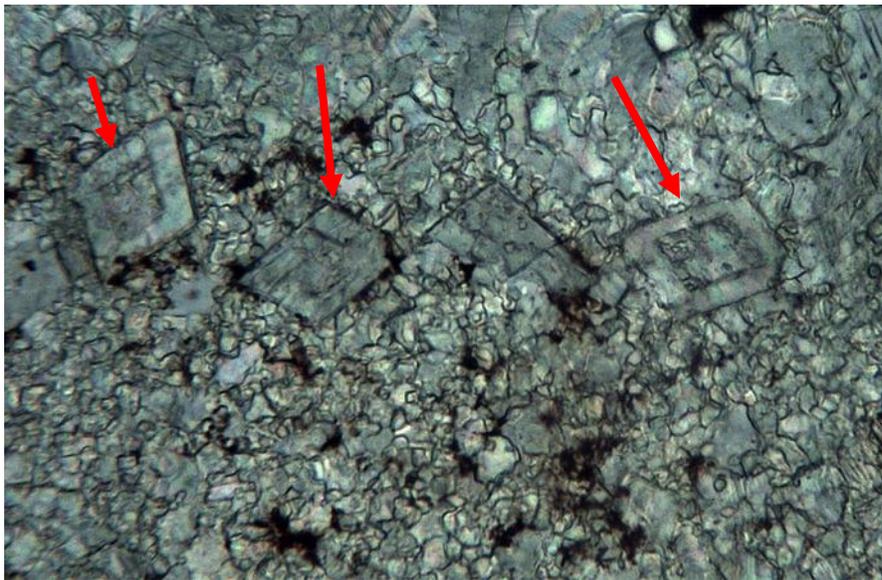
Figure 10. Thin section photomicrograph of Echo 5 – Core 4 illustrating dolomite rhombs with inner dolomitic cores and outer rims transitioning to calcite (red arrows) in a coarse aggregate particle. Brown clay is dispersed within the matrix. Vertical field of view is 0.6 mm. Plane-polarized light.

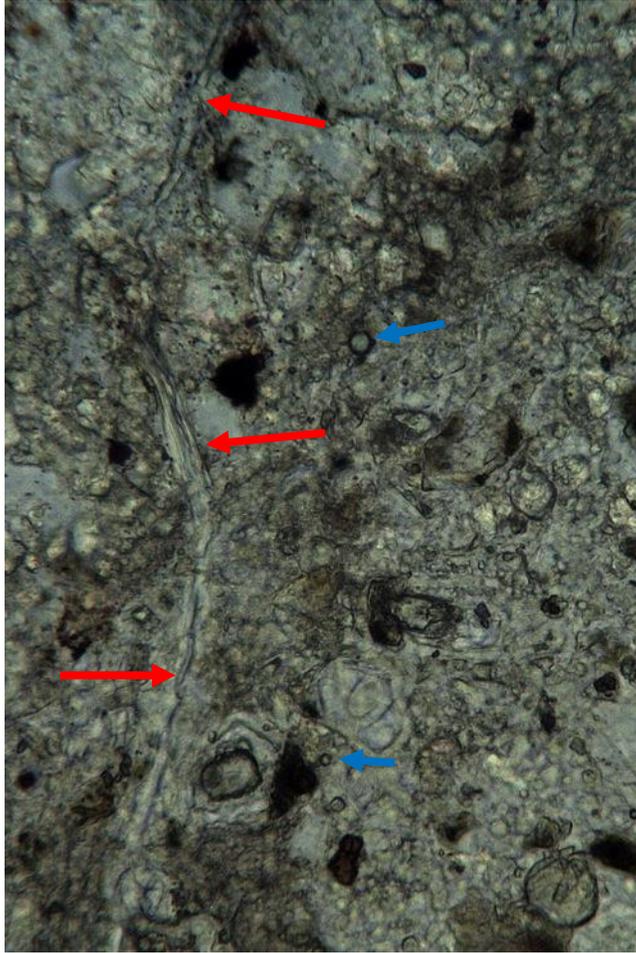
Figure 11. Thin section photomicrograph of Echo 5 – Core 4 illustrating a crack radiating out from a dolomite coarse aggregate particle (at top left) into the cementitious materials paste (red arrows). The crack is lined with brucite. Note the presence of residual fly ash particles (blue arrows). Vertical field of view is 0.25 mm. Plane-polarized light.

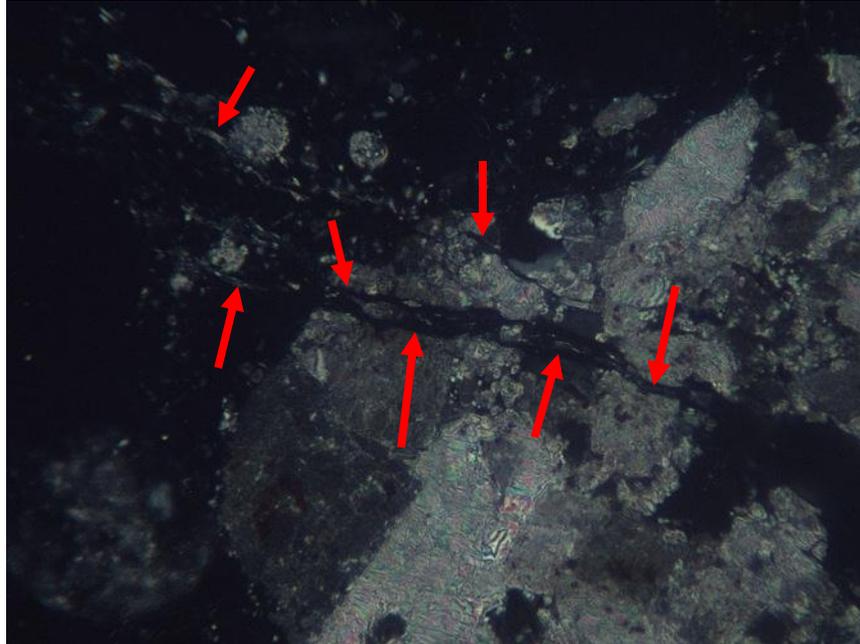
Figure 14. Thin section photomicrograph of Echo 5 – Core 4 illustrating a crack radiating out from a dolomite coarse aggregate particle (gold colored) into the cementitious materials paste (red arrows). The crack is lined with (gray appearing) brucite. Vertical field of view is 0.60 mm. Cross-polarized light.

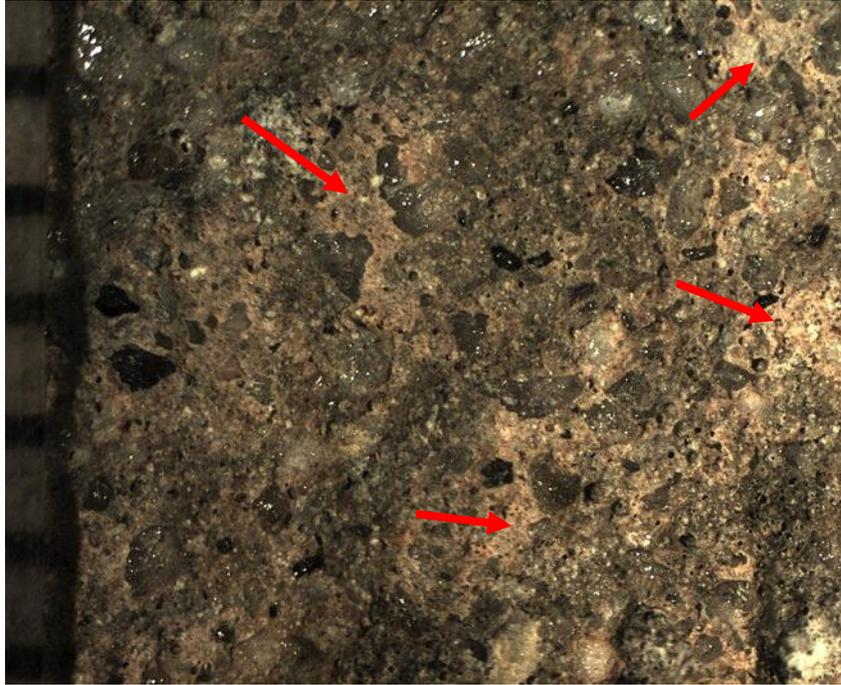
Figure 18. Close-up of the wearing surface of Core C1C7. Red arrows point to areas of minor surface pitting and fresh (pinkish) carbonation. Scale is in millimeters.

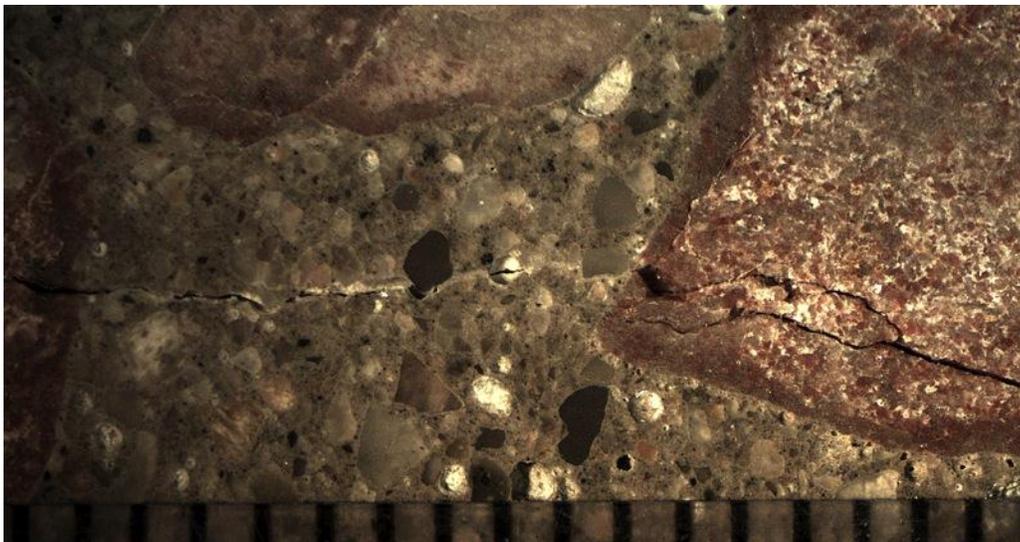
Figure 19. Magnified lapped slice of Core C1C7 showing cracks radiating out from a rimmed, dolomite coarse aggregate particle. White, brucite (and other related) deposits line the cracks and voids. This is typical of damage due to alkali-carbonate reaction. Scale is in millimeters.

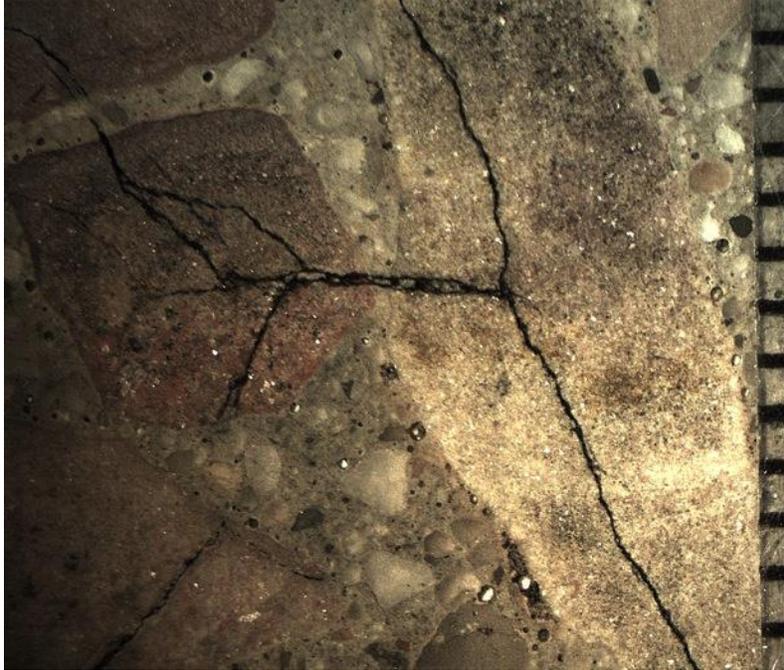
Figure 20. Magnified lapped slice of Core C1C7 showing cracks radiating out from reacting dolomite coarse aggregate particles. White, brucite (and other related) deposits line the cracks and voids. This is typical of damage due to alkali-carbonate reaction. Scale is in millimeters.

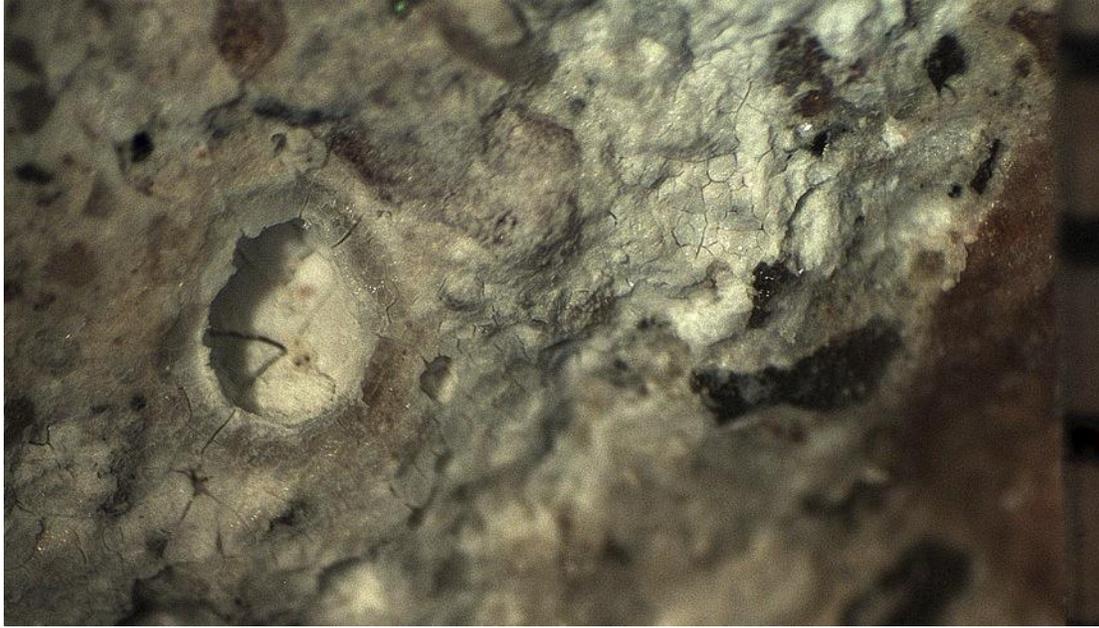
Figure 22. Crack surface in Core C1C7 lined with various, secondary deposits, including white, pearly brucite; translucent magnesite; amorphous, desiccated (and pattern cracked) alkali gel (and other related) deposits. Scale is in millimeters.

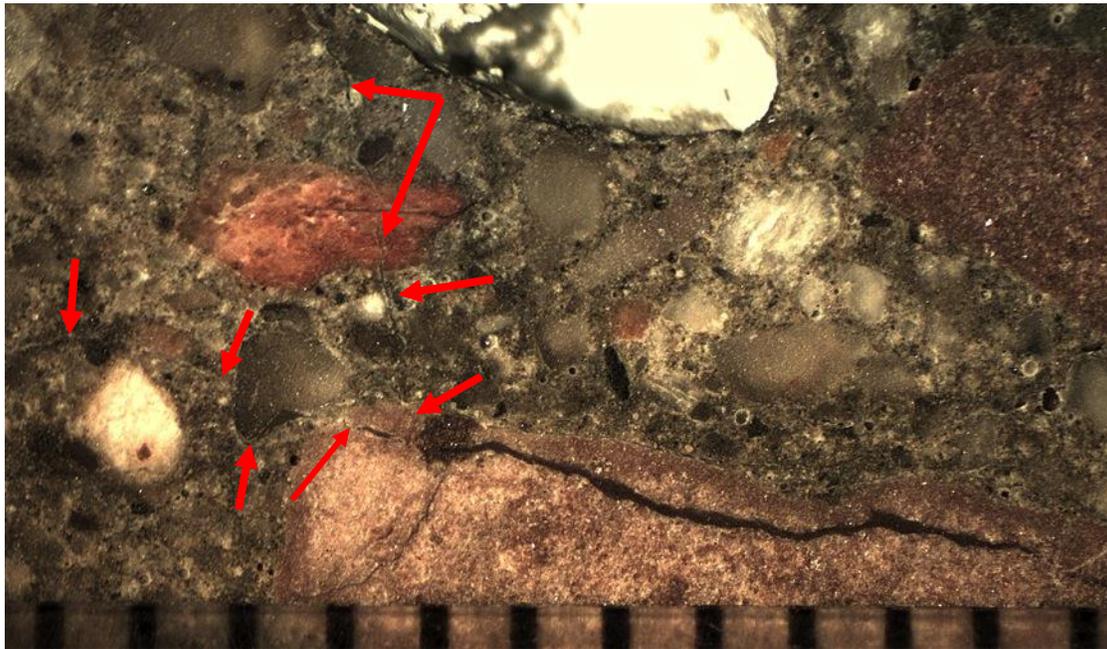
Figure 23. Magnified lapped slice of Core G1 showing cracks radiating out from a rimmed, dolomite coarse aggregate particle (red arrows). White, brucite (and other related) deposits line the cracks and voids. This is typical of damage due to alkali-carbonate reaction. Scale is in millimeters.

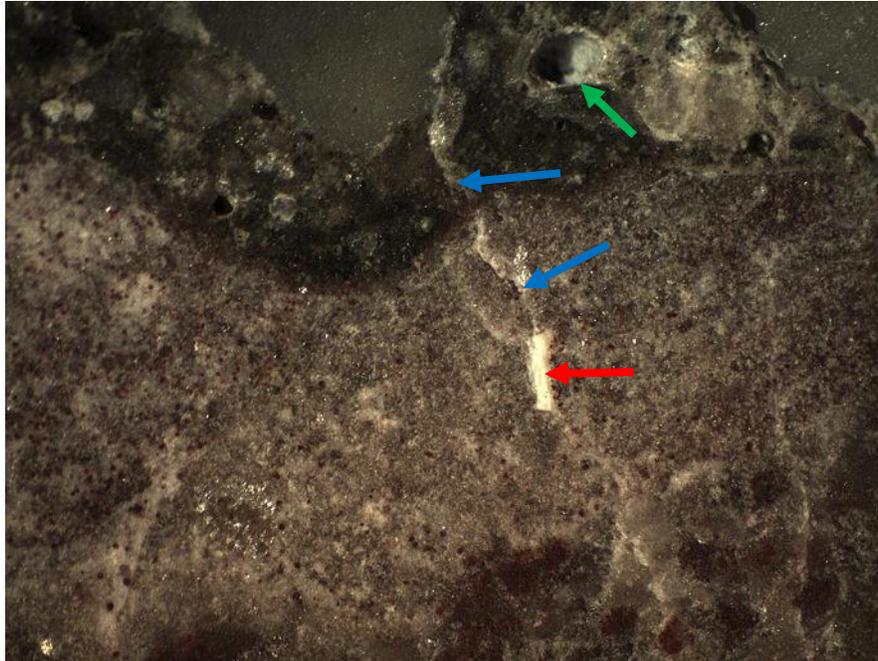
Figure 24. Magnified lapped slice of Core G1 showing a crack radiating out from a rimmed, dolomite coarse aggregate particle (blue arrows). The crack appears to originate in a coarse, fibrous, white brucite (red arrow) particle. Fine brucite lines a nearby void (green arrow).

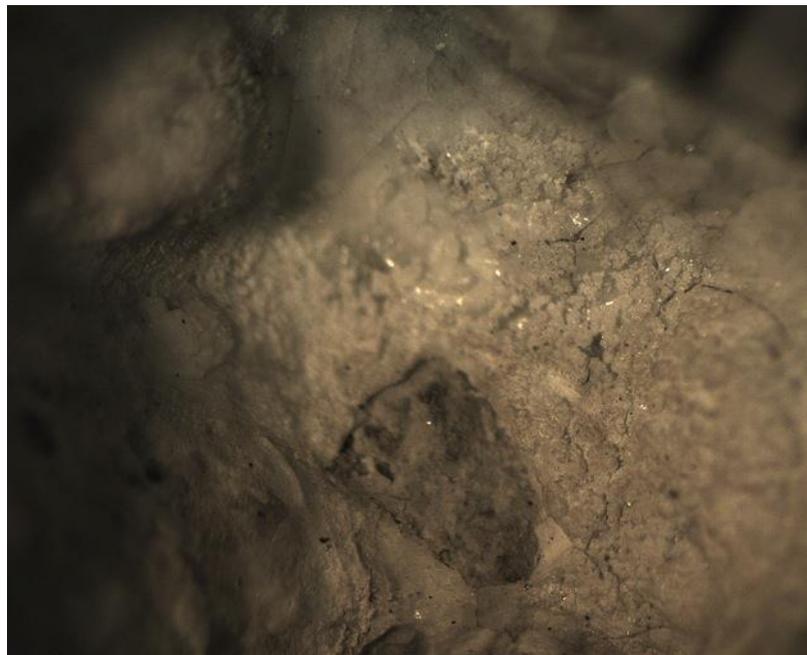
Figure 25. Void lining in Core G1 containing various, secondary deposits, including white, pearly brucite; translucent magnesite; dull, white, botryoidal clusters of nesquehonite; amorphous, desiccated (and pattern cracked) alkali gel (and other related) deposits. Scale is in millimeters.

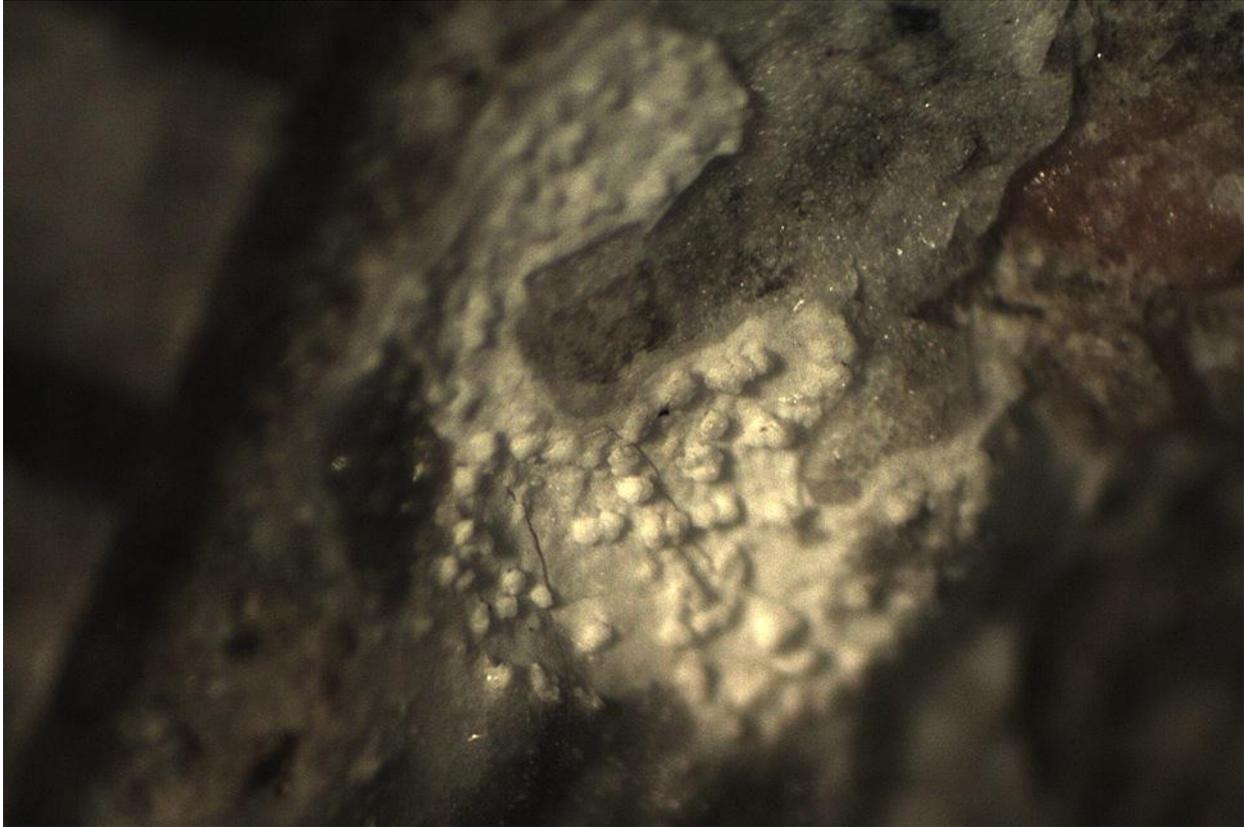
Figure 26. Crack surface in Core G1 lined with various, secondary deposits, including white, pearly brucite; translucent magnesite; and dull, white, botryoidal clusters of nesquehonite. Scale is in millimeters.

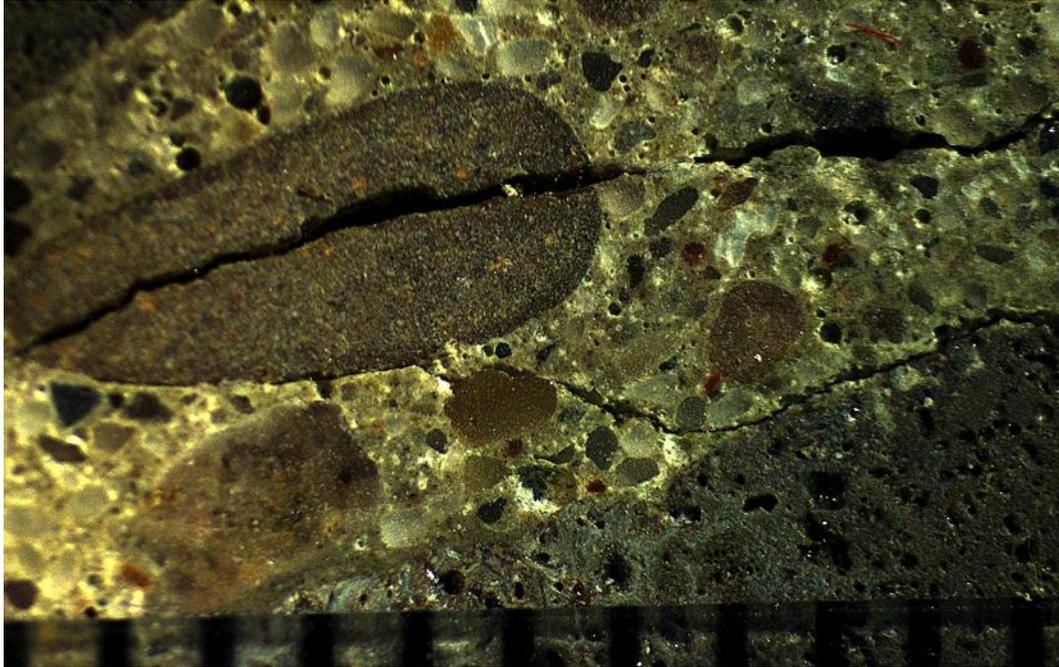
Figure 5. Lapped surface of Core 4 showing horizontal oriented cracking and microcracking. Scale is in millimeters.

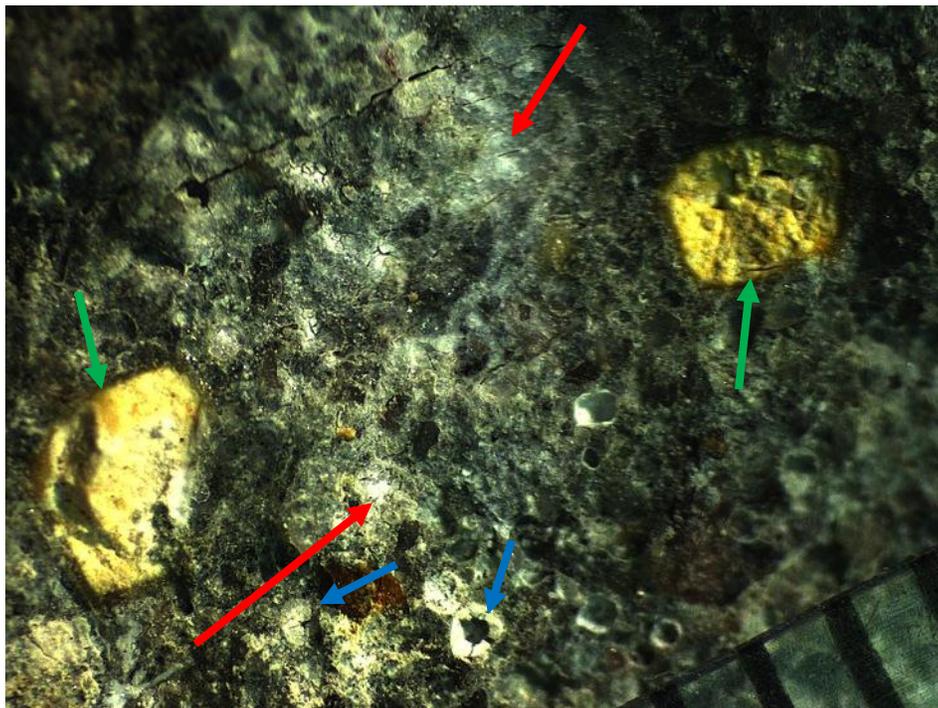
Figure 6. Magnified cracked surface in Core 4 where white alkali-silica gel lines the crack (red arrows) and voids adjacent to the crack (blue arrows). Two beige-yellow, cracked, rimmed and reacting chert particles are present along the crack (green arrows). Scale is in millimeters.
