APPENDIX C
Petrographic Analysis Reports

Appendix D: Petrographic Analysis

Introduction for Airports I – III

Airport I

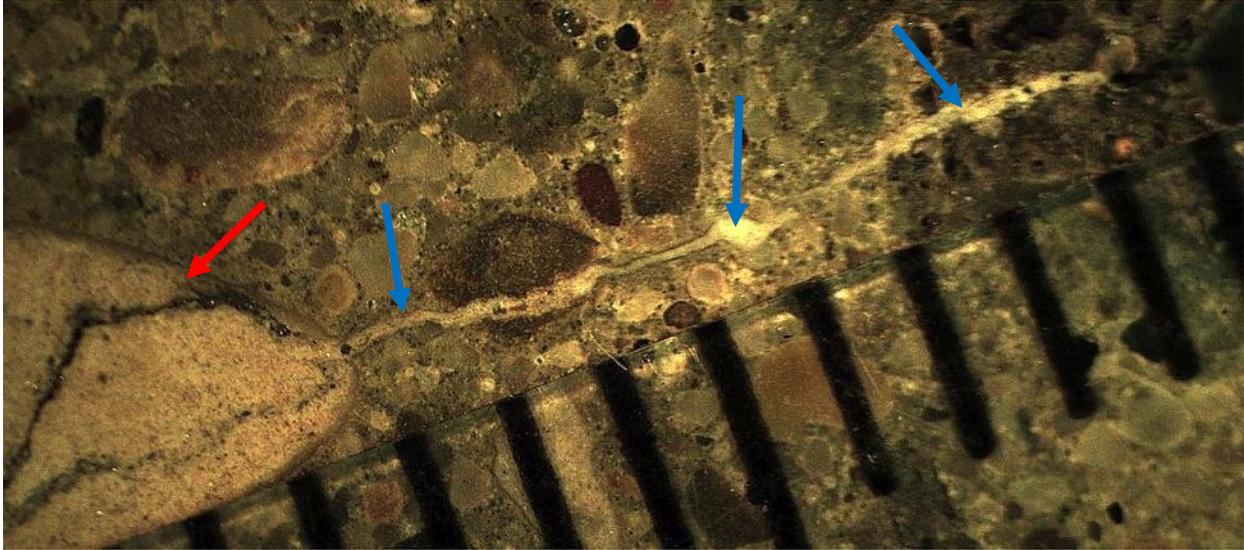
Figure 7. Lapped surface of Core 4 illustrating a crack radiating from a rimmed, beige chert particle (red arrow) into adjacent paste. The crack is filled with white alkali-silica gel (blue arrows). Scale is in millimeters.

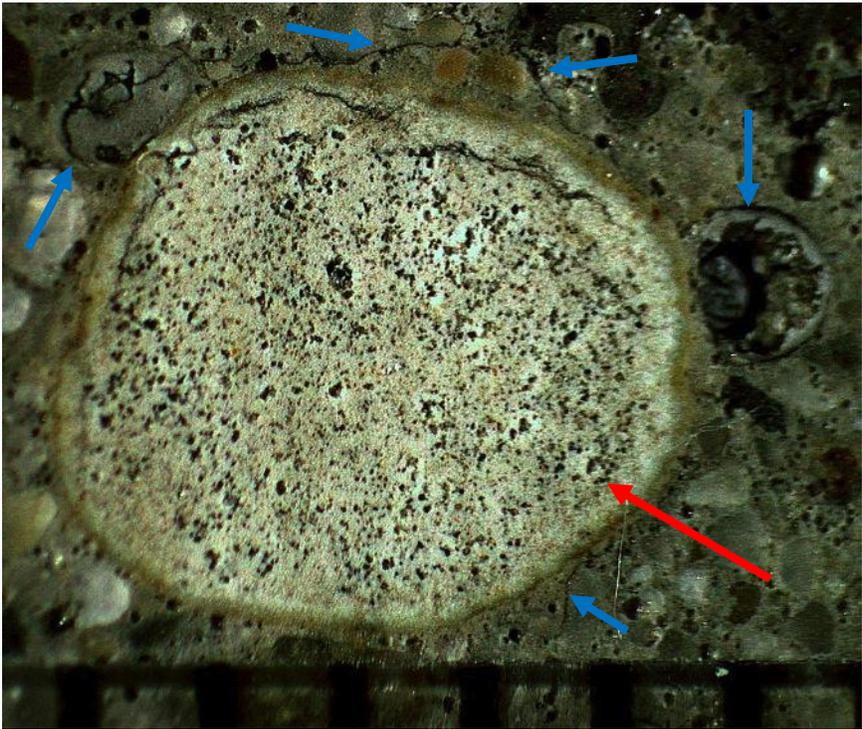
Figure 8. Photomicrograph of the magnified lapped slice of Core 7 showing cracks radiating from a rimmed, beige chert particle (red arrow) into adjacent paste. The crack and adjacent voids are filled with white alkali-silica gel (blue arrows). Scale is in millimeters.

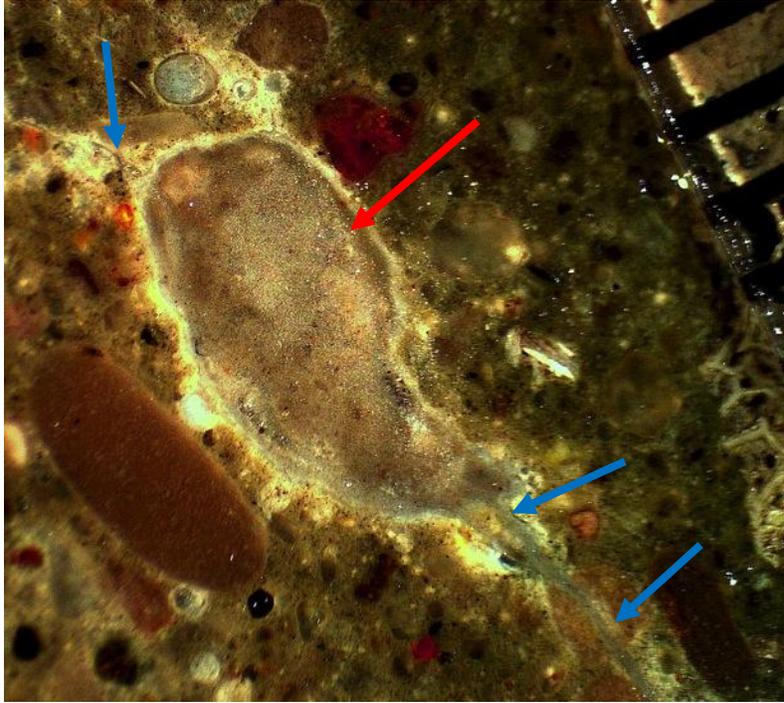
Figure 9. Photomicrograph of Core 9 illustrating a crack radiating from a rimmed chert particle (red arrow) into adjacent paste. The crack is filled with white alkali-silica gel (blue arrows). Scale is in millimeters.

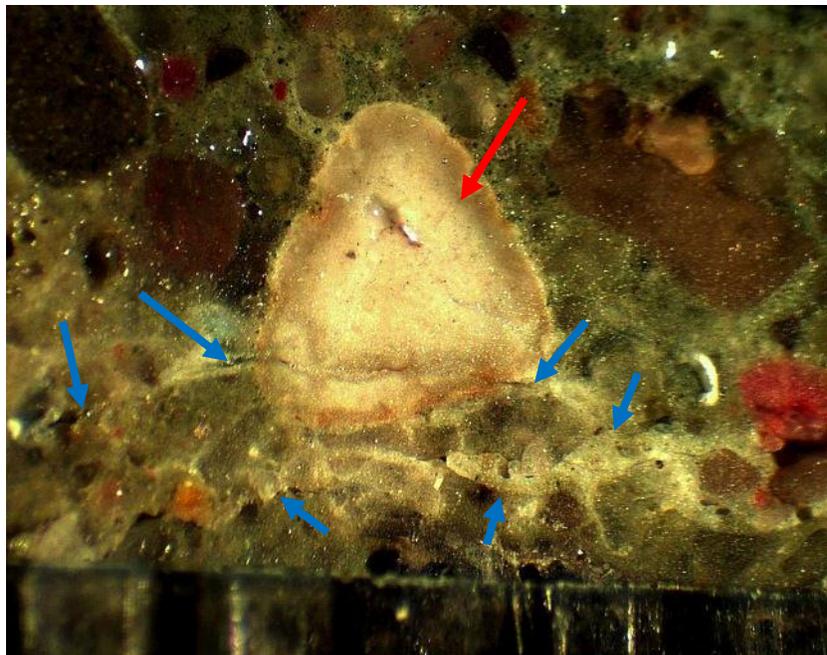
Figure 10. Photomicrograph of Core 12 showing cracks radiating from a rimmed chert particle (red arrow) into adjacent paste. The crack is filled with white alkali-silica gel (blue arrows). Scale is in millimeters.

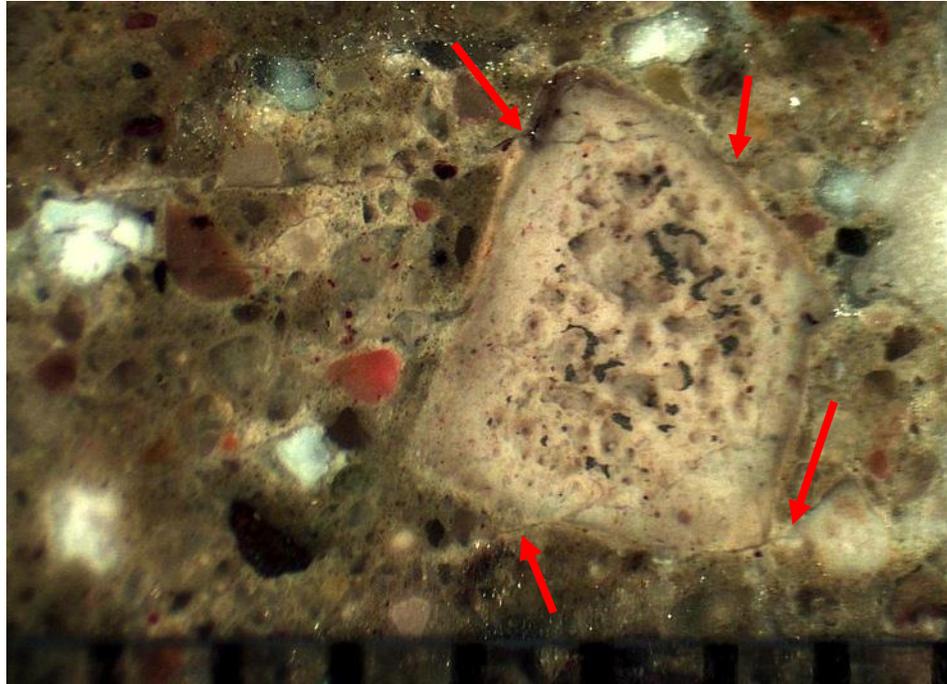
Figure 11. Photomicrograph of Core 12 illustrating cracks radiating out from a rimmed chert aggregate particle into the paste (red arrows). The cracks are lined with alkali-silica gel. Scale is in millimeters.

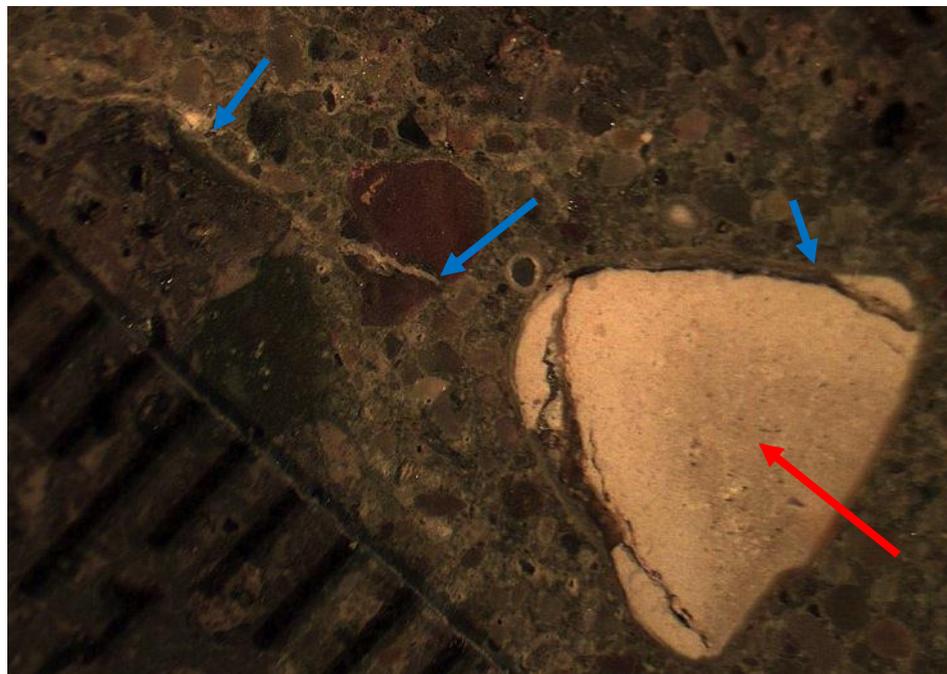
Figure 12. Photomicrograph of Core 12 showing cracks radiating from a rimmed chert particle (red arrow) into adjacent paste. The cracks are filled with white alkali-silica gel (blue arrows). Scale is in millimeters.

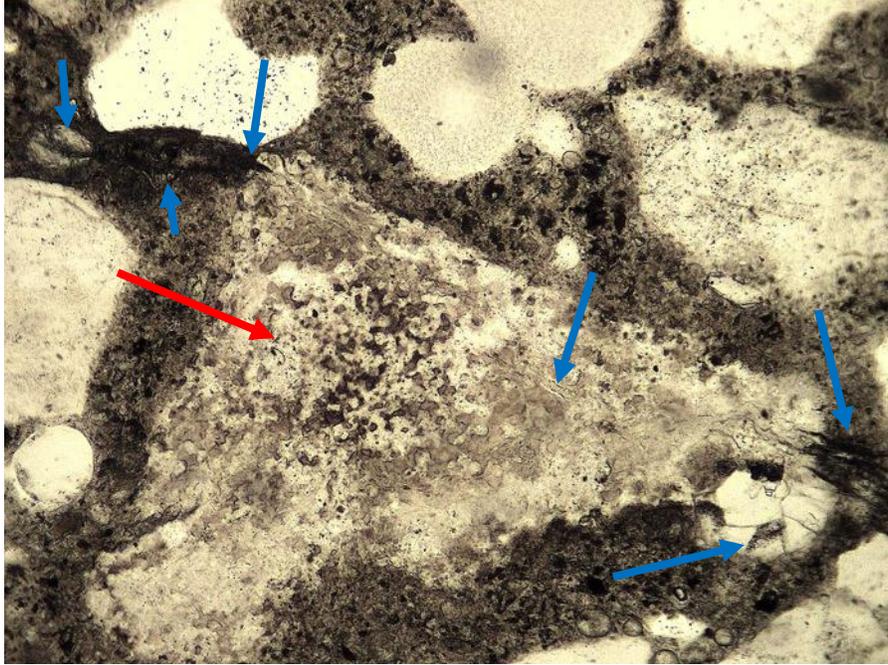
Figure 13. Thin section photomicrograph of Core 12 illustrating a crack radiating out from a chert aggregate particle (red arrow) into the cement paste. The crack and an adjacent void are lined with alkali-silica gel (blue arrows). Vertical field of view is 0.60 mm. Plane-polarized light.

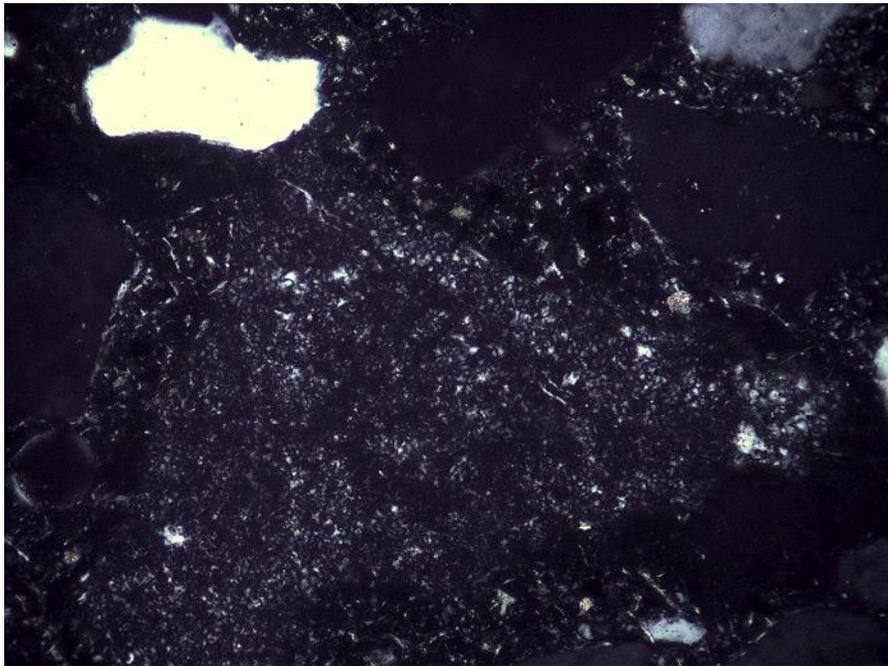
Figure 14. Thin section photomicrograph of Core 12 showing the same view as Figure 13, only in crossed polarized light. Vertical field of view is 0.60 mm.

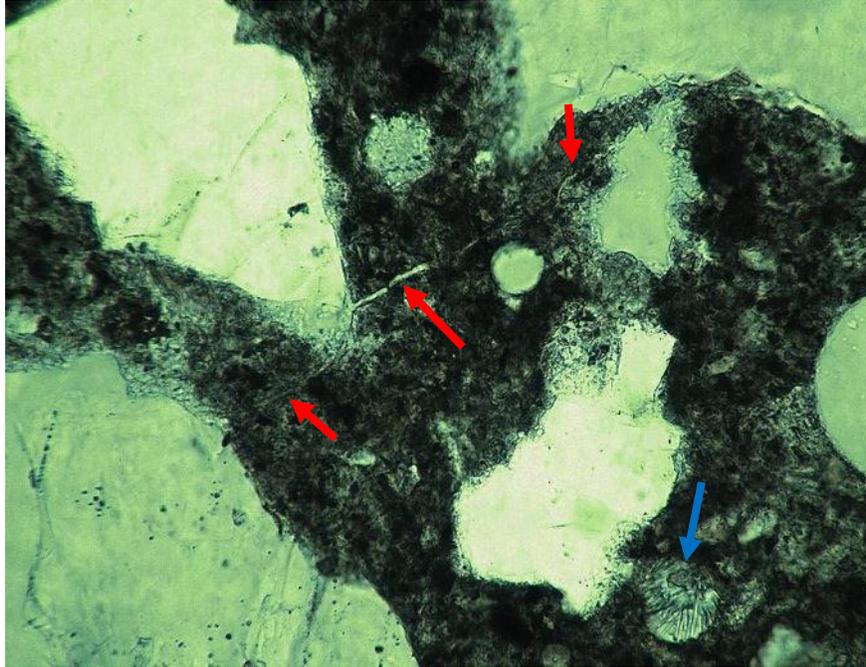
Figure 7. Thin section photomicrograph of a portion Core B-1 where alkali-silica gel lines a crack (red arrows) and a void is filled with ettringite (blue arrows). Vertical field of view is 0.60 mm. Plane-polarized light.

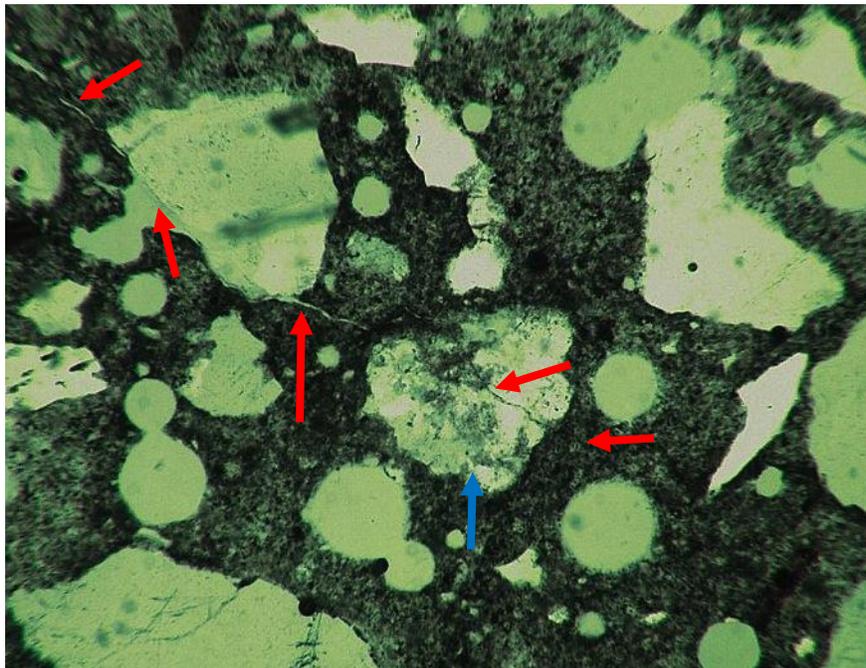
Figure 8. Thin section photomicrograph of a portion Core B-1 where alkali-silica gel lines a crack (red arrows) and the crack radiates out from a reacting particle (blue arrow). Vertical field of view is 1.1 mm. Plane-polarized light.

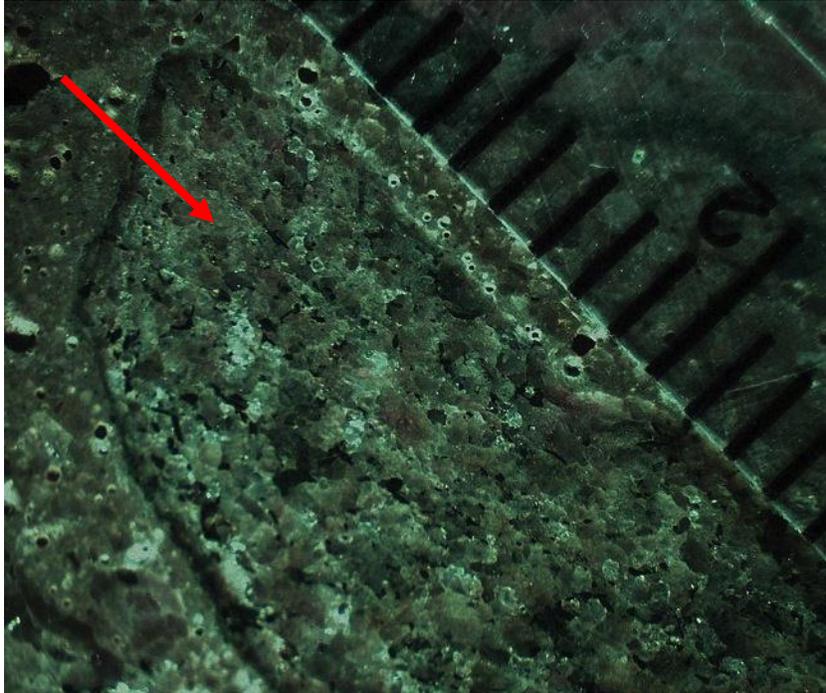
Figure 9. Photomicrograph of Core B-1 illustrating a rimmed gneiss particle (red arrow). Scale is in millimeters.

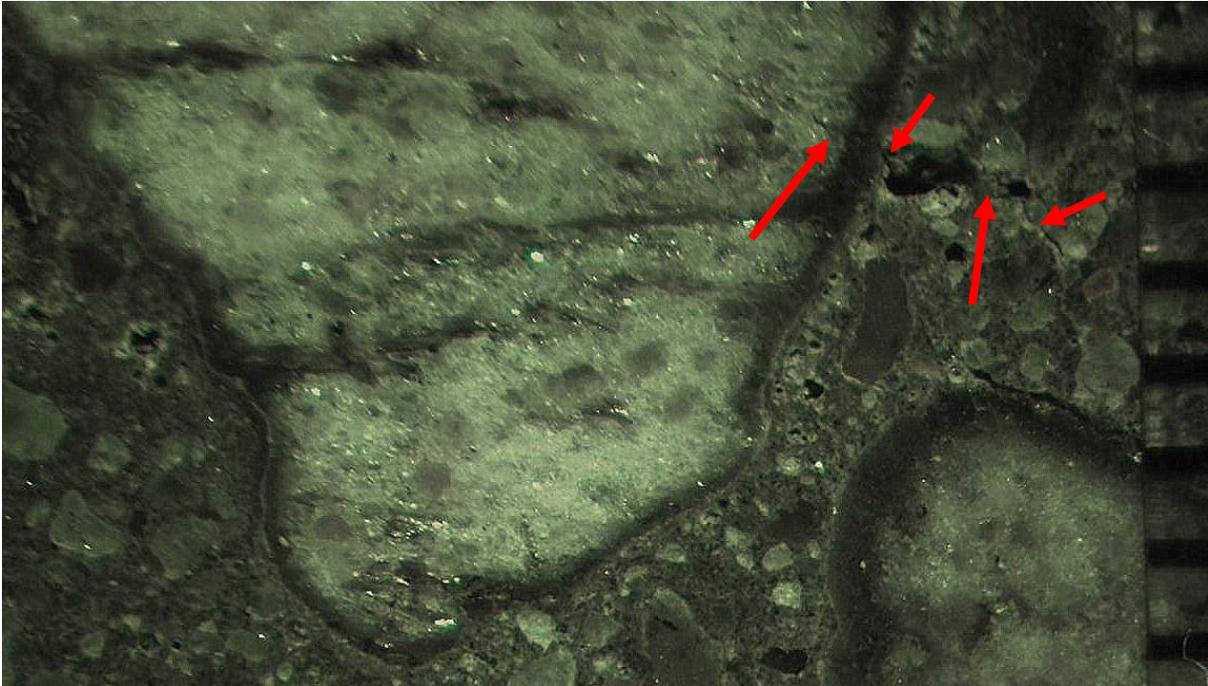
Figure 15. Photomicrograph of Core F-2 showing a cracked and rimmed gneiss particle with the crack radiating into adjacent paste (red arrows). Scale is in millimeters.

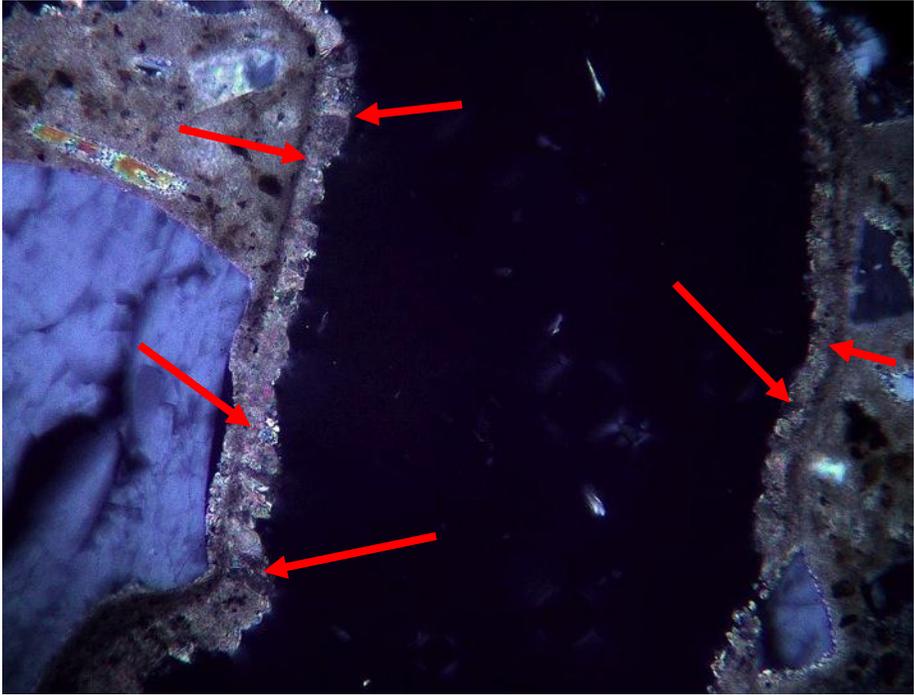
Figure 18. Thin section photomicrograph of Core K-1 along a crack extending down from the pavement wearing surface. The crack is lined with calcite (red arrows). Vertical field of view is 0.60 mm. Cross-polarized light.

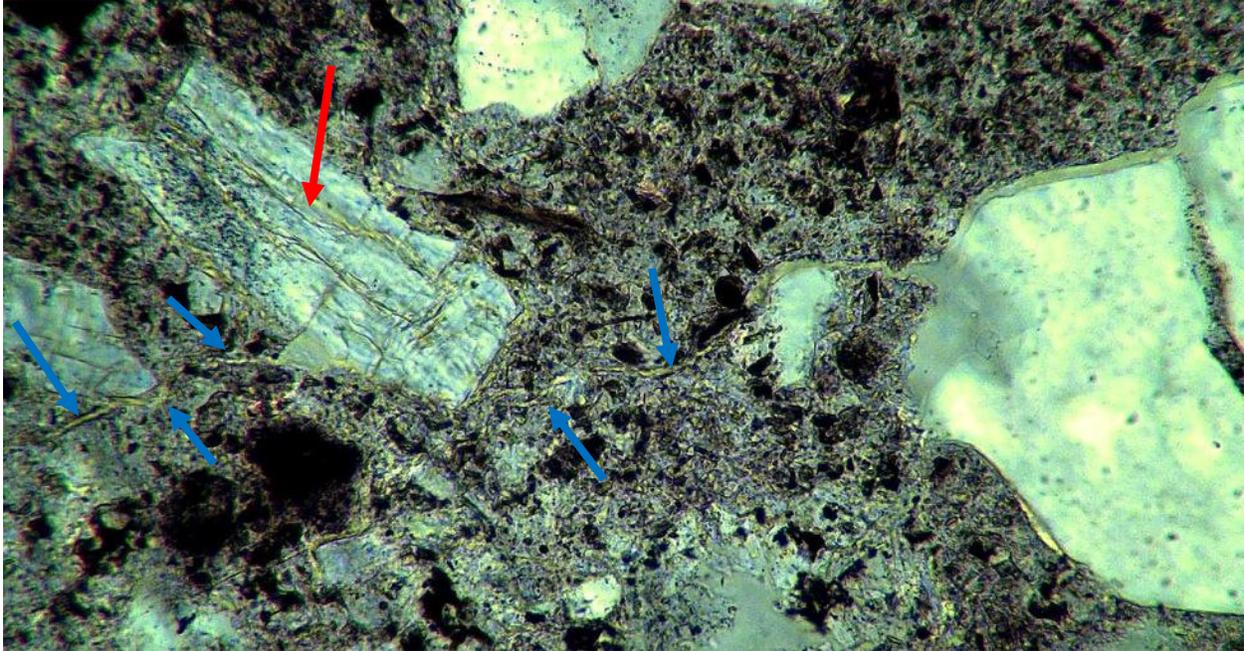
Figure 21. Thin section photomicrograph of Core R-5 illustrating a cracked and reacting aggregate particle (red arrow) with crack radiating out into adjacent paste and filled alkali-silica gel (blue arrows). Vertical field of view is 0.60 mm. Plane-polarized light.

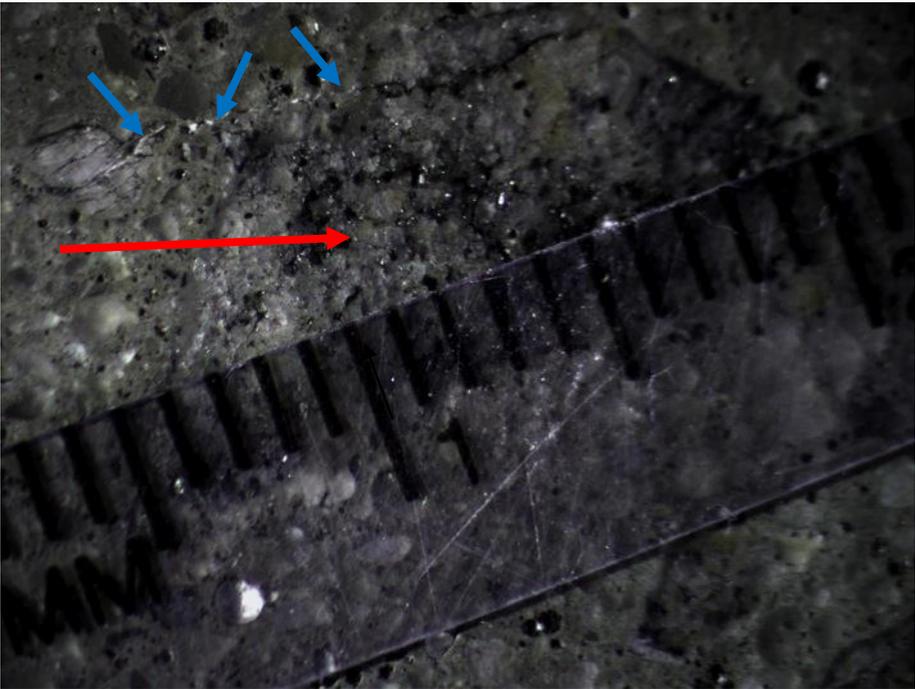
Figure 22. Photomicrograph of Core R-5 showing a cracked and rimmed gneiss particle (red arrow) with an alkali-silica gel filled crack radiating into adjacent paste (blue arrows). Scale is in millimeters.

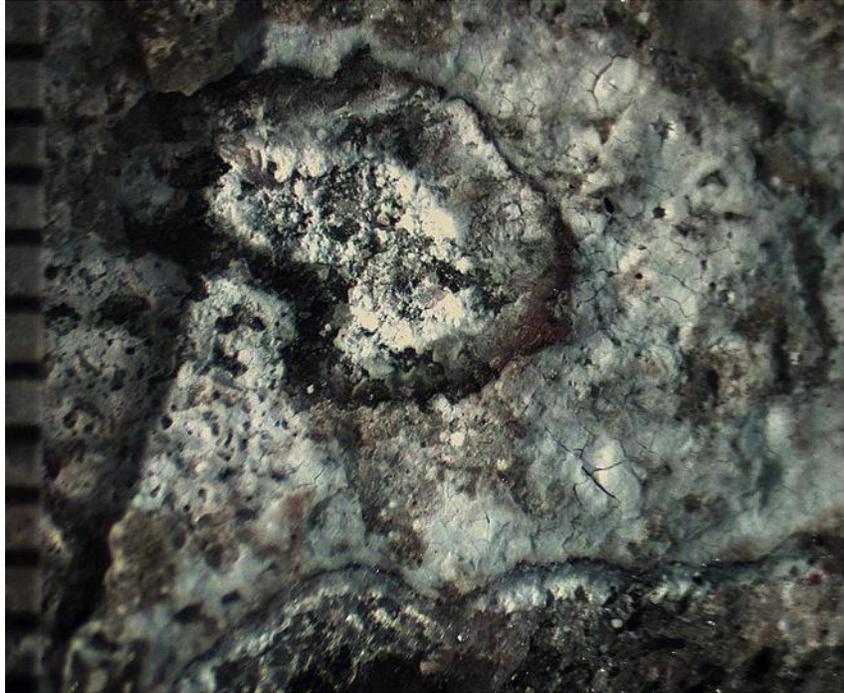
Figure 23. Photomicrograph of alkali-silica gel lining a crack in Core R-6. The reacting gneiss particles are delineated by red arrows. Scale is in millimeters.

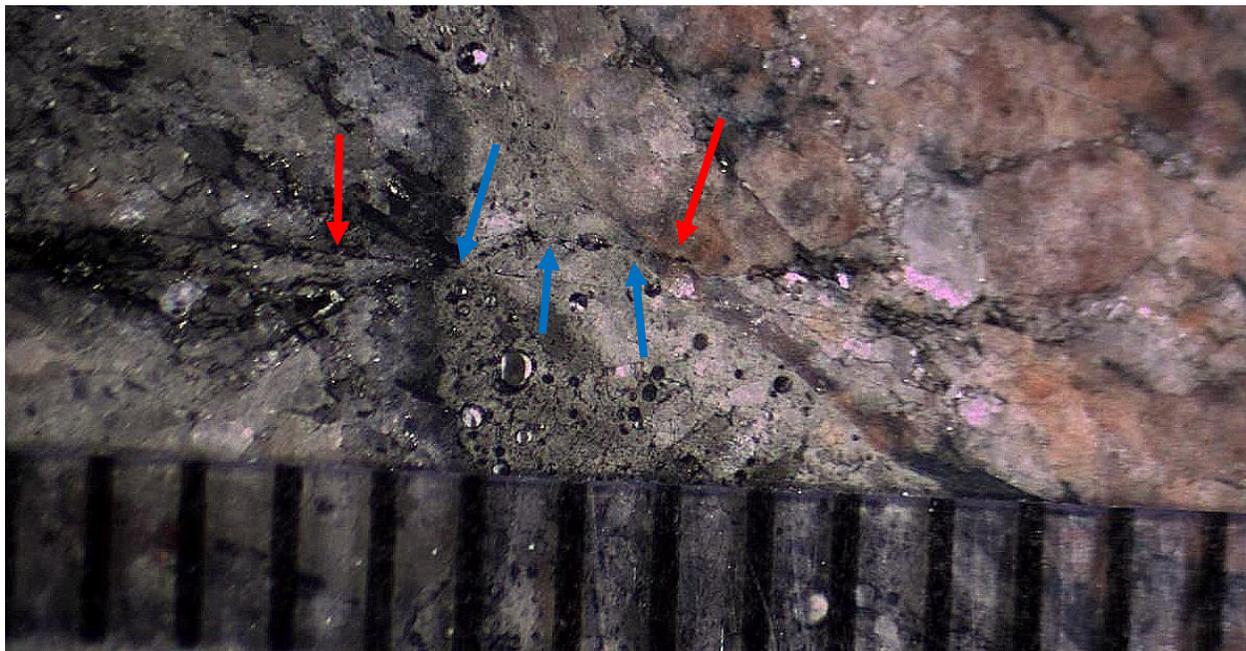
Figure 24. Photomicrograph of Core R-6 showing cracked and rimmed gneiss particles (red arrows) with an alkali-silica gel filled crack radiating from both particles (blue arrows). Scale is in millimeters.

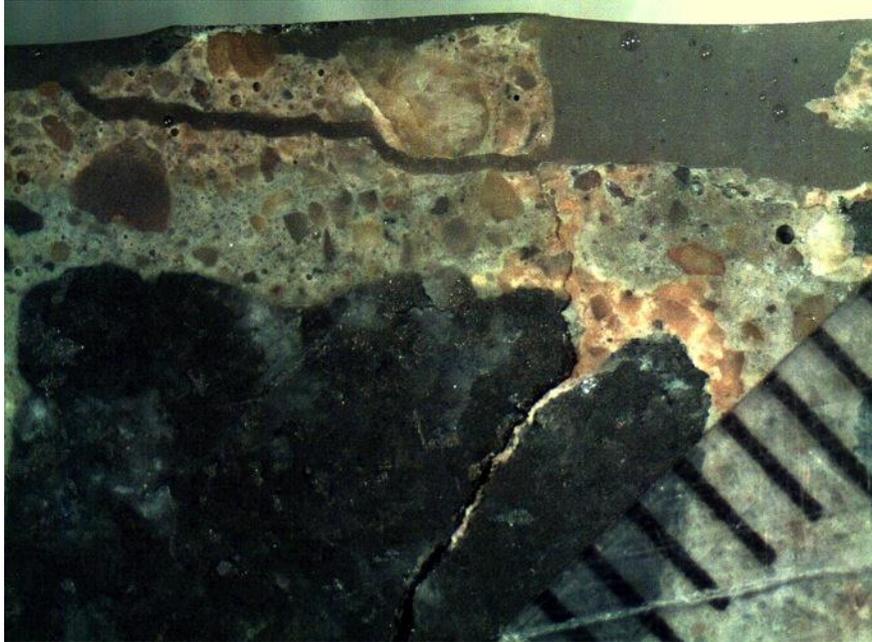
Figure 3. Photomicrograph of Core C1 showing a surface crack extending into the core well into a sound diabase coarse aggregate particle. In addition, the top 2 mm. (0.08 in.) of concrete nearest the wearing surface is an incipient popoff due to expansion. Scale is in millimeters.

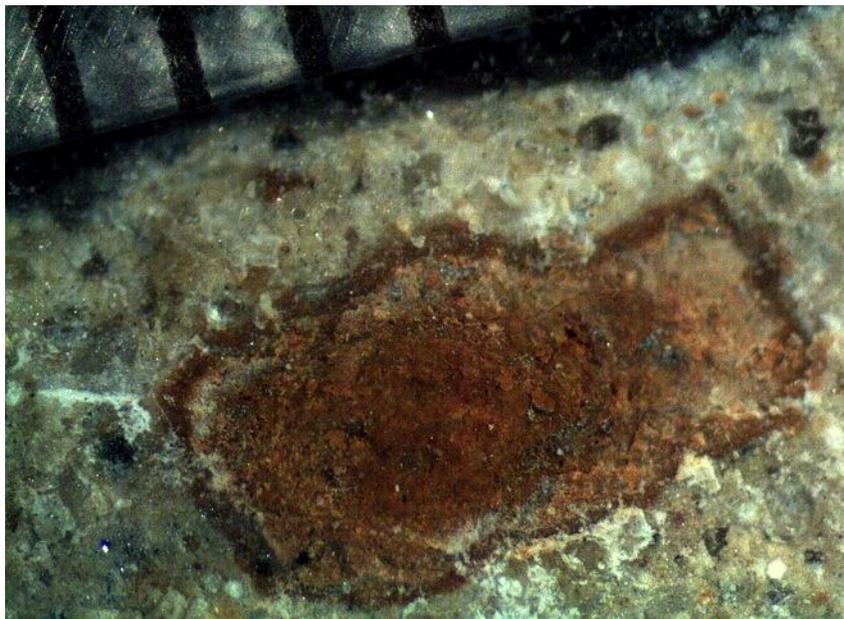
Figure 4. Photomicrograph of Core C1 illustrating a reacting chert particle. Scale is in millimeters.

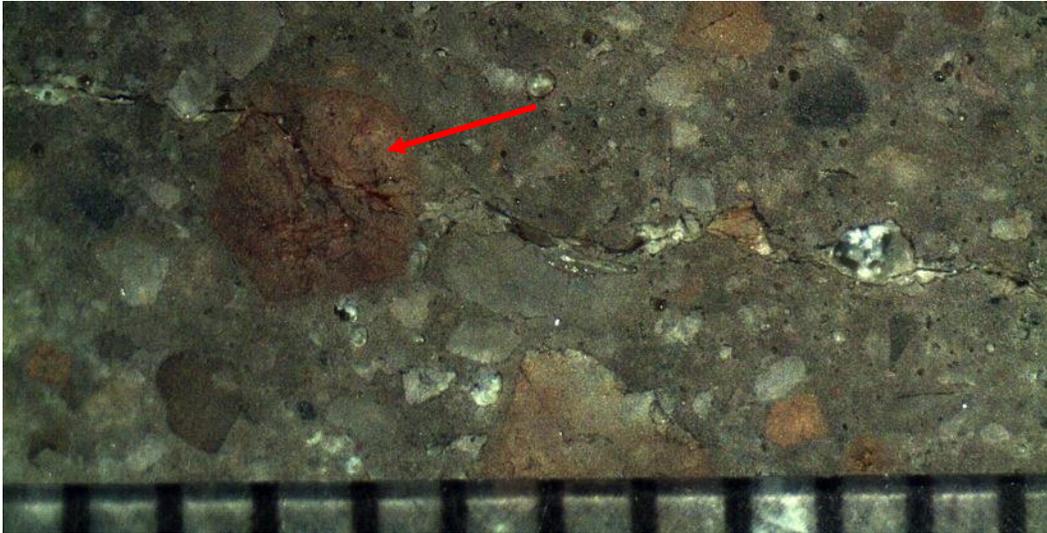
Figure 5. Lapped surface of Core C1 showing horizontal oriented cracking and microcracking extending outward from a metaquartzite fine aggregate particle (red arrow). Scale is in millimeters.

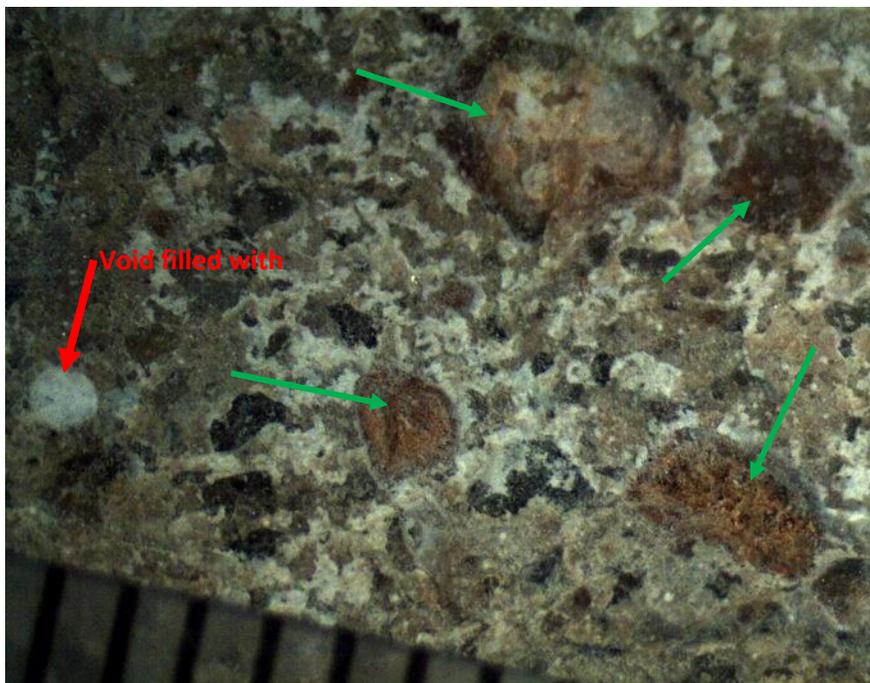
Figure 6. Magnified cracked surface in Core C1 where white alkali-silica gel lines the crack and voids adjacent to the crack. Several, cracked, rimmed and reacting chert and metaquartzite particles are present along the crack (green arrows). Scale is in millimeters.

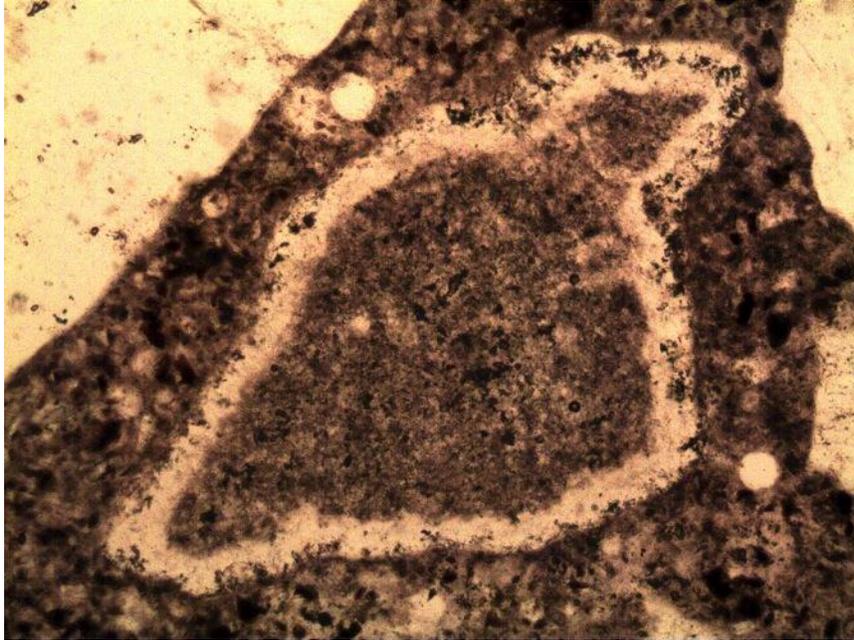
Figure 9. Thin section photomicrograph of a rimmed chert particle in Core C7. Vertical field of view is 1.1 mm. Plane polarized light.
