IPRF – Project 04-02

Final Report

Improved Overlay Design Parameters for Concrete Airfield Pavements (IPRF Project FAA-01-G-002-04-2)

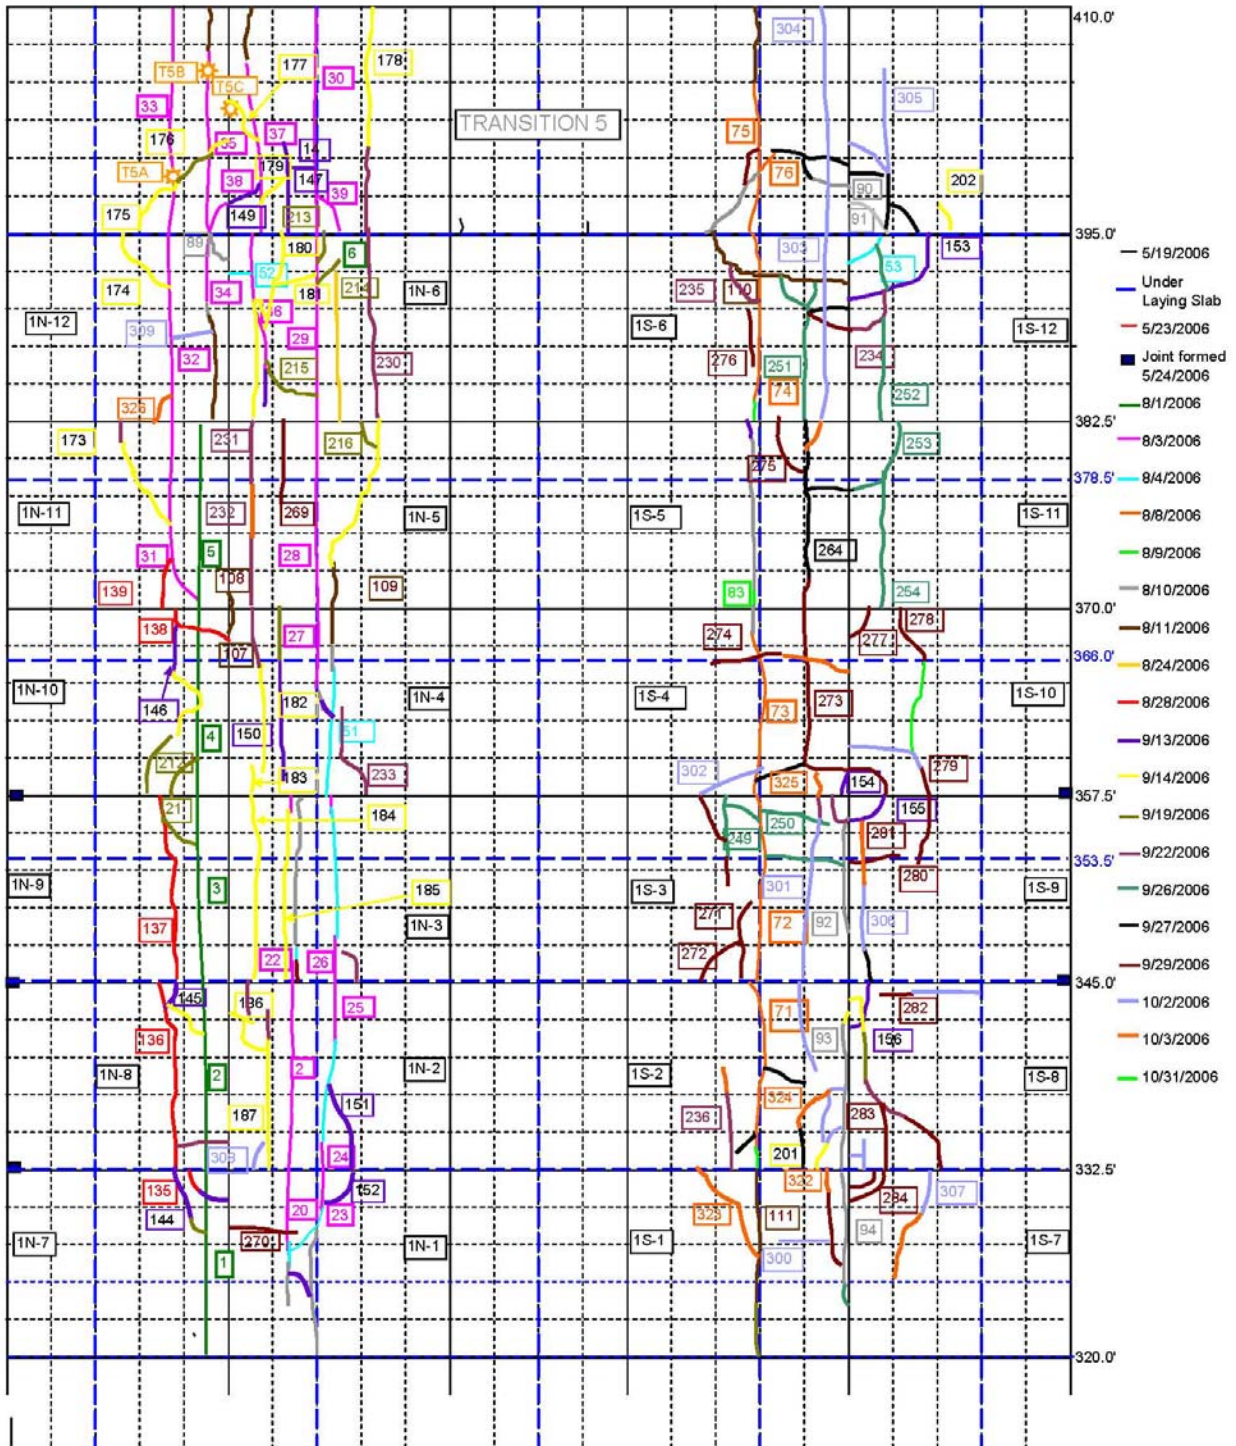
FIGURE 36. DISTRESS SURVEY ON OVERLAY AFTER FINAL LOADING FOR TEST ITEMS N1 AND S1

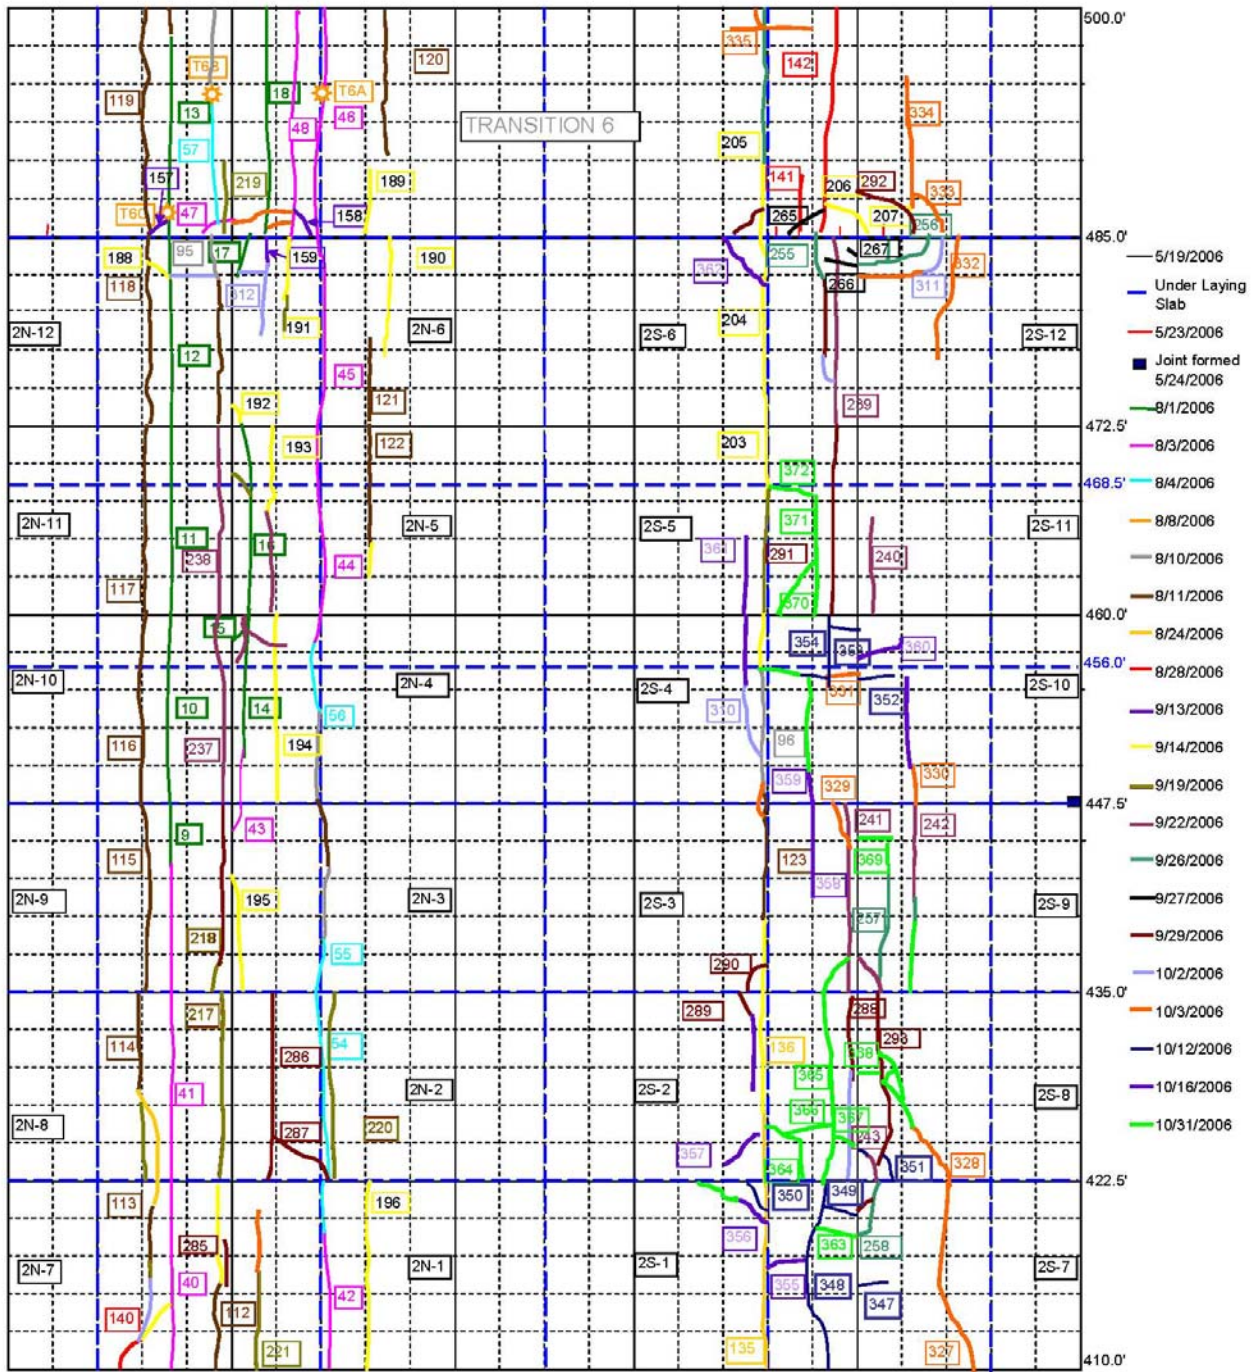
FIGURE 37. DISTRESS SURVEY ON OVERLAY AFTER FINAL LOADING FOR TEST ITEMS N2 AND S2

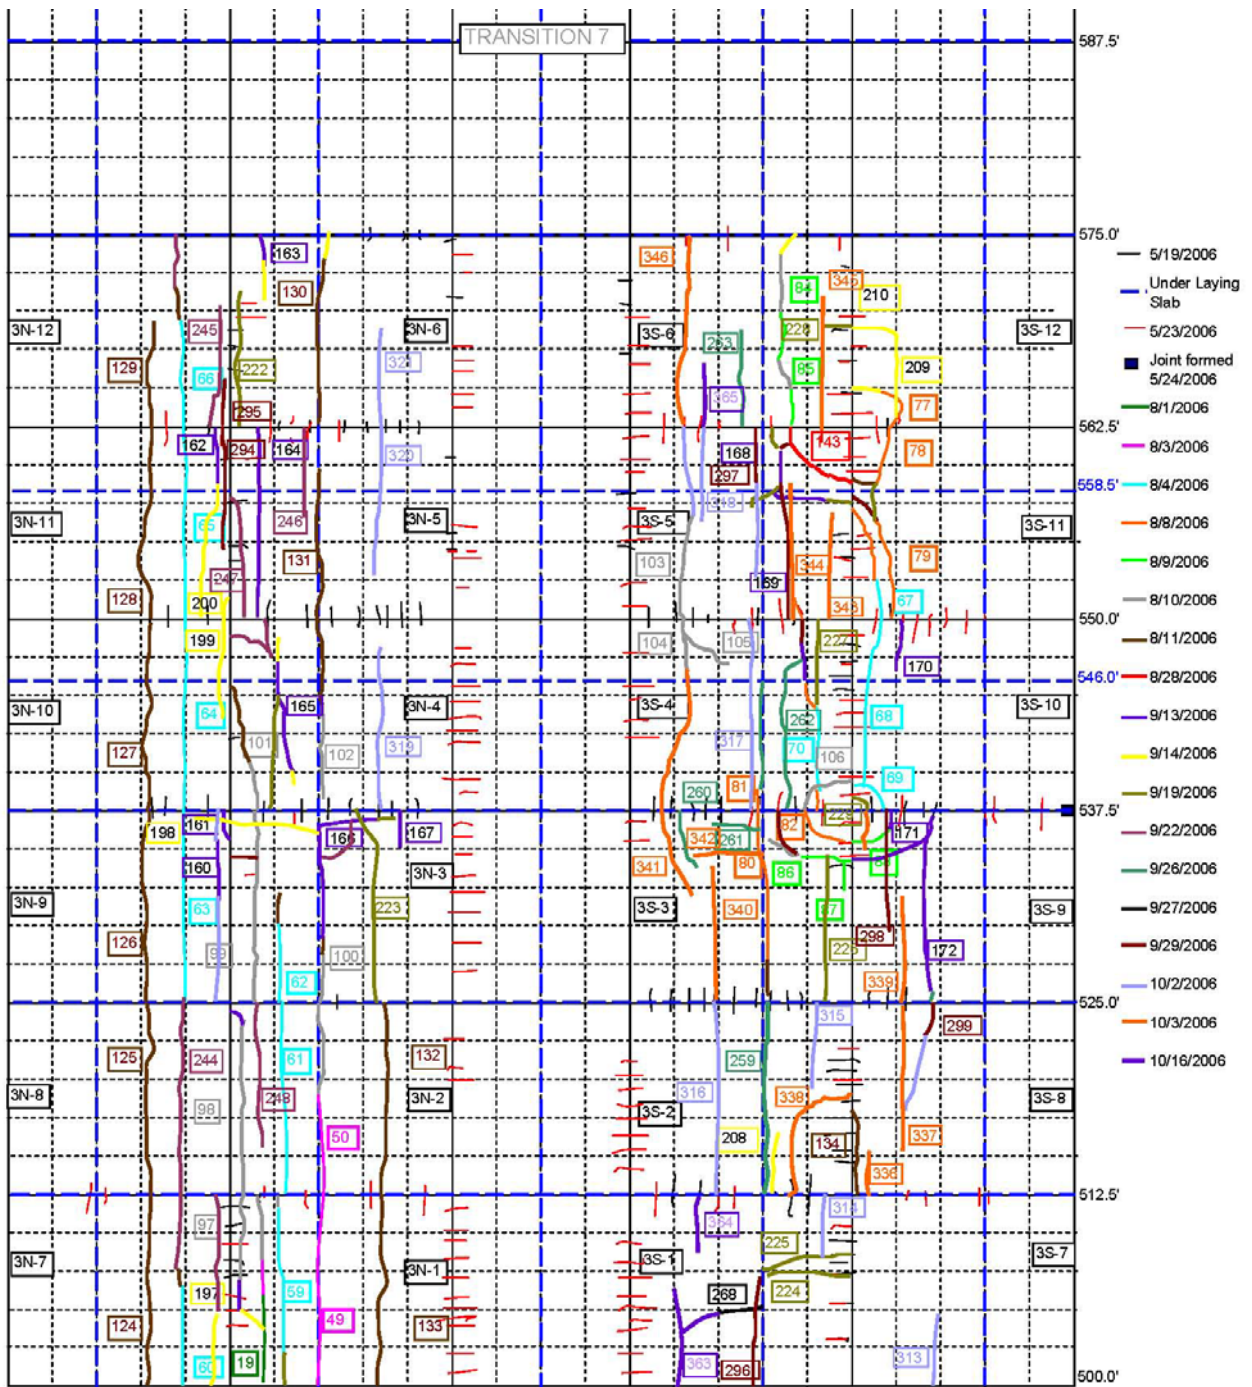
FIGURE 38. DISTRESS SURVEY ON OVERLAY AFTER FINAL LOADING FOR TEST ITEMS N3 AND S3

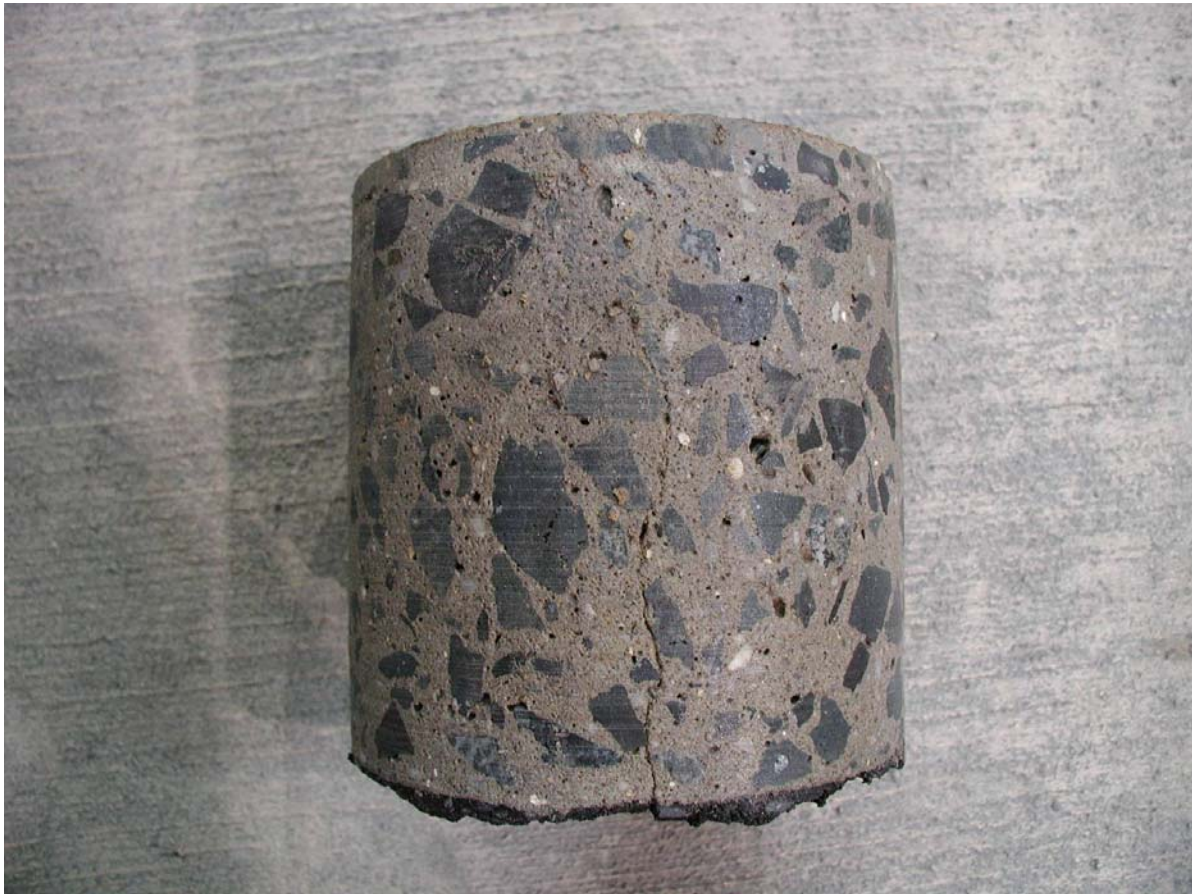
FIGURE 40. CORE FROM TRANSITION 5 SHOWING BOTTOM-UP CRACK THAT HAS NOT PROPAGATED TO THE SURFACE

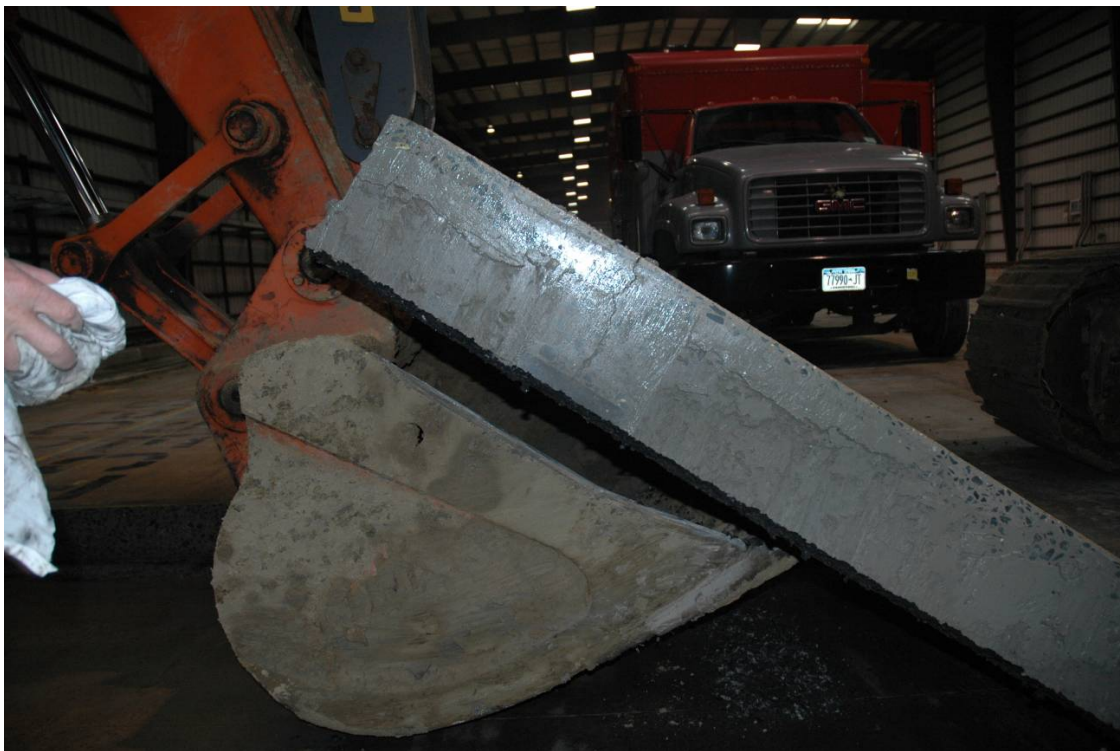
FIGURE 41. OVERLAY SLAB REMOVAL WITH ASPHALT INTERLAYER ADHERED AND VISIBLE TOP-DOWN CRACK

longitudinal cracking was the primary distress mode in this test item. The earliest longitudinal crack identified by the distress surveys coincided with the location of the lower support on the bottom of the chair supporting the dowels for the longitudinal joint. The other cracks observed in the top slab were determined to be formed from the top down. In many cases, the cracks were not formed through the full depth of the slab. Additionally, as the slabs were lifted, bending under their own weight clearly showed cracking only at the top of the slab, as seen, for example in the photographs in figure 41 and figure 42.

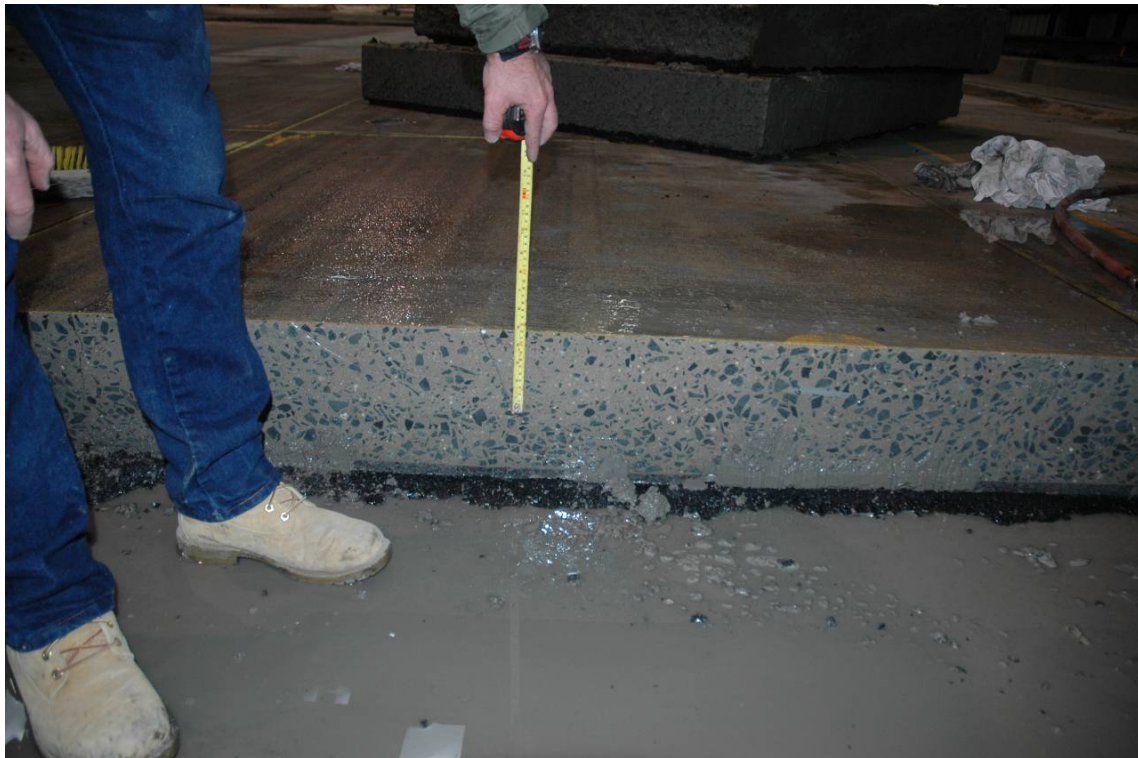
FIGURE 42. TOP-DOWN CRACK VISIBLE AS OVERLAY SLAB BENDS DURING REMOVAL

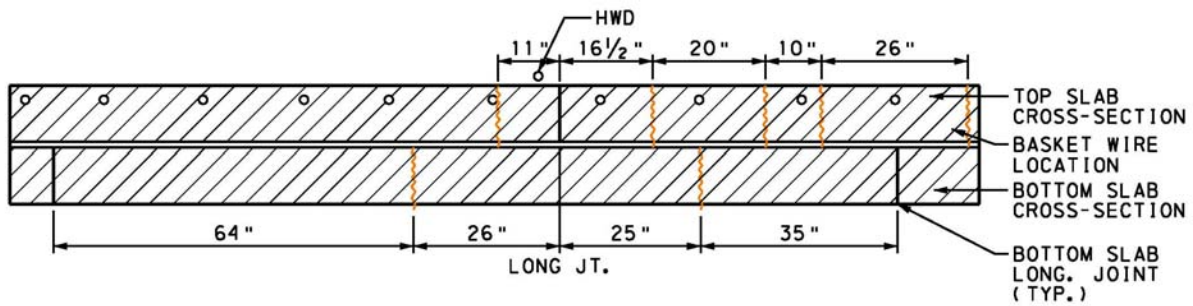
FIGURE 43. CRACK PATTERNS OBSERVED DURING OVERLAY REMOVAL, SLABS 3 AND 9 IN TEST ITEM N1

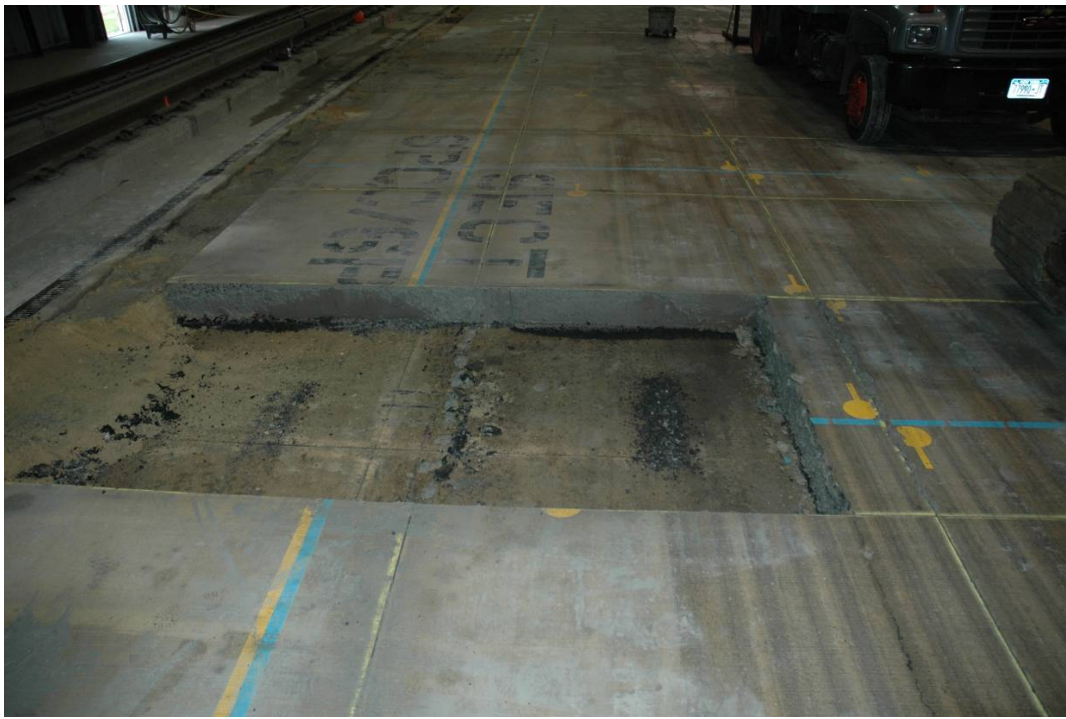
FIGURE 44. CRACKS OFFSET FROM LONGITUDINAL JOINT IN TEST ITEM N1

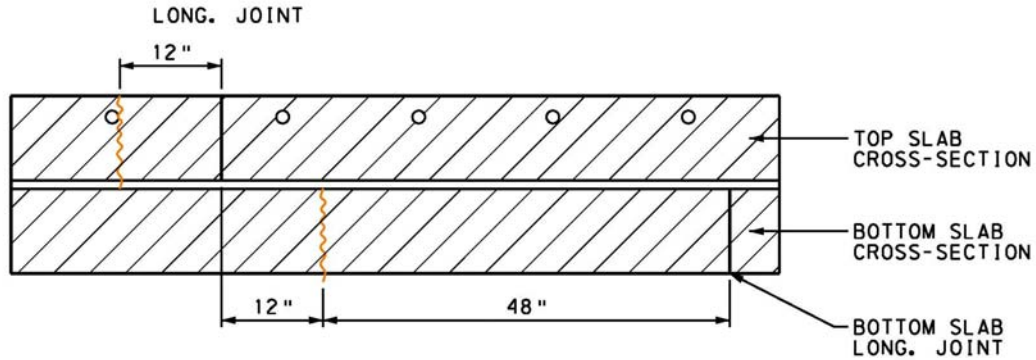
FIGURE 45. CRACK PATTERNS OBSERVED DURING OVERLAY REMOVAL, SLABS 3 AND 9 IN TEST ITEM N2

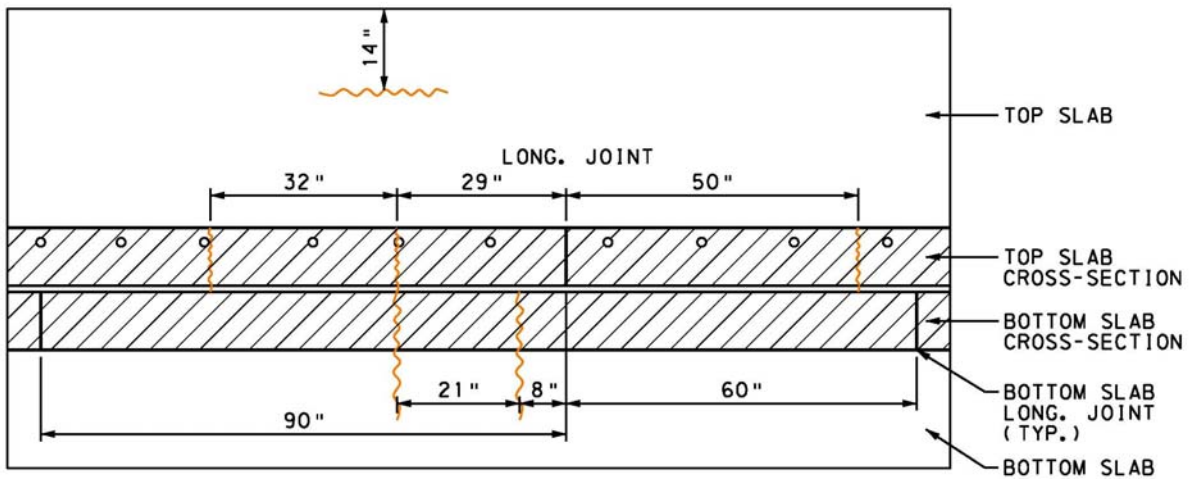
FIGURE 46. CRACK PATTERNS OBSERVED DURING OVERLAY REMOVAL, SLABS 9 AND 3 IN TEST ITEM S1

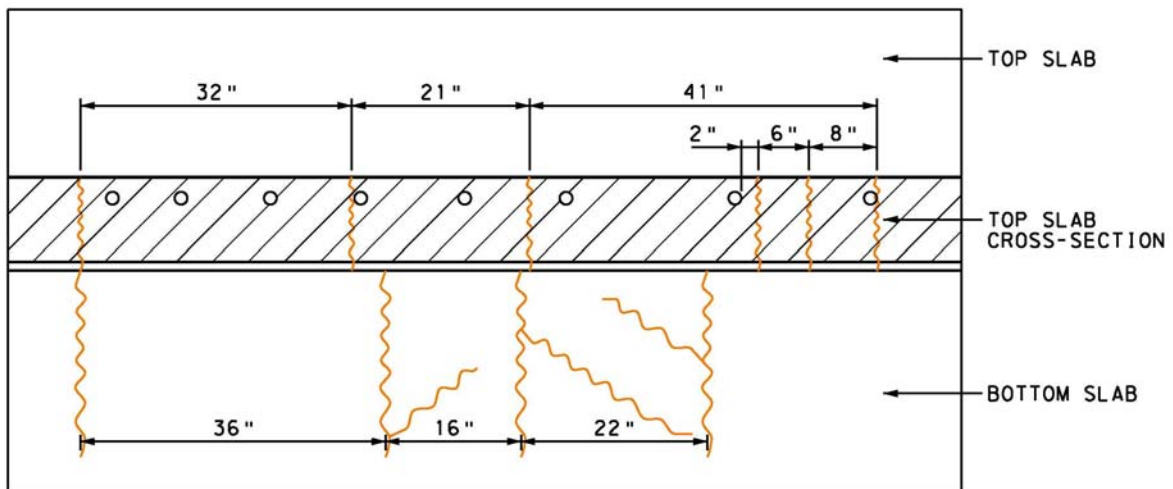
FIGURE 47. CRACK PATTERNS OBSERVED DURING OVERLAY REMOVAL, SLABS 9 AND 3 IN TEST ITEM S2

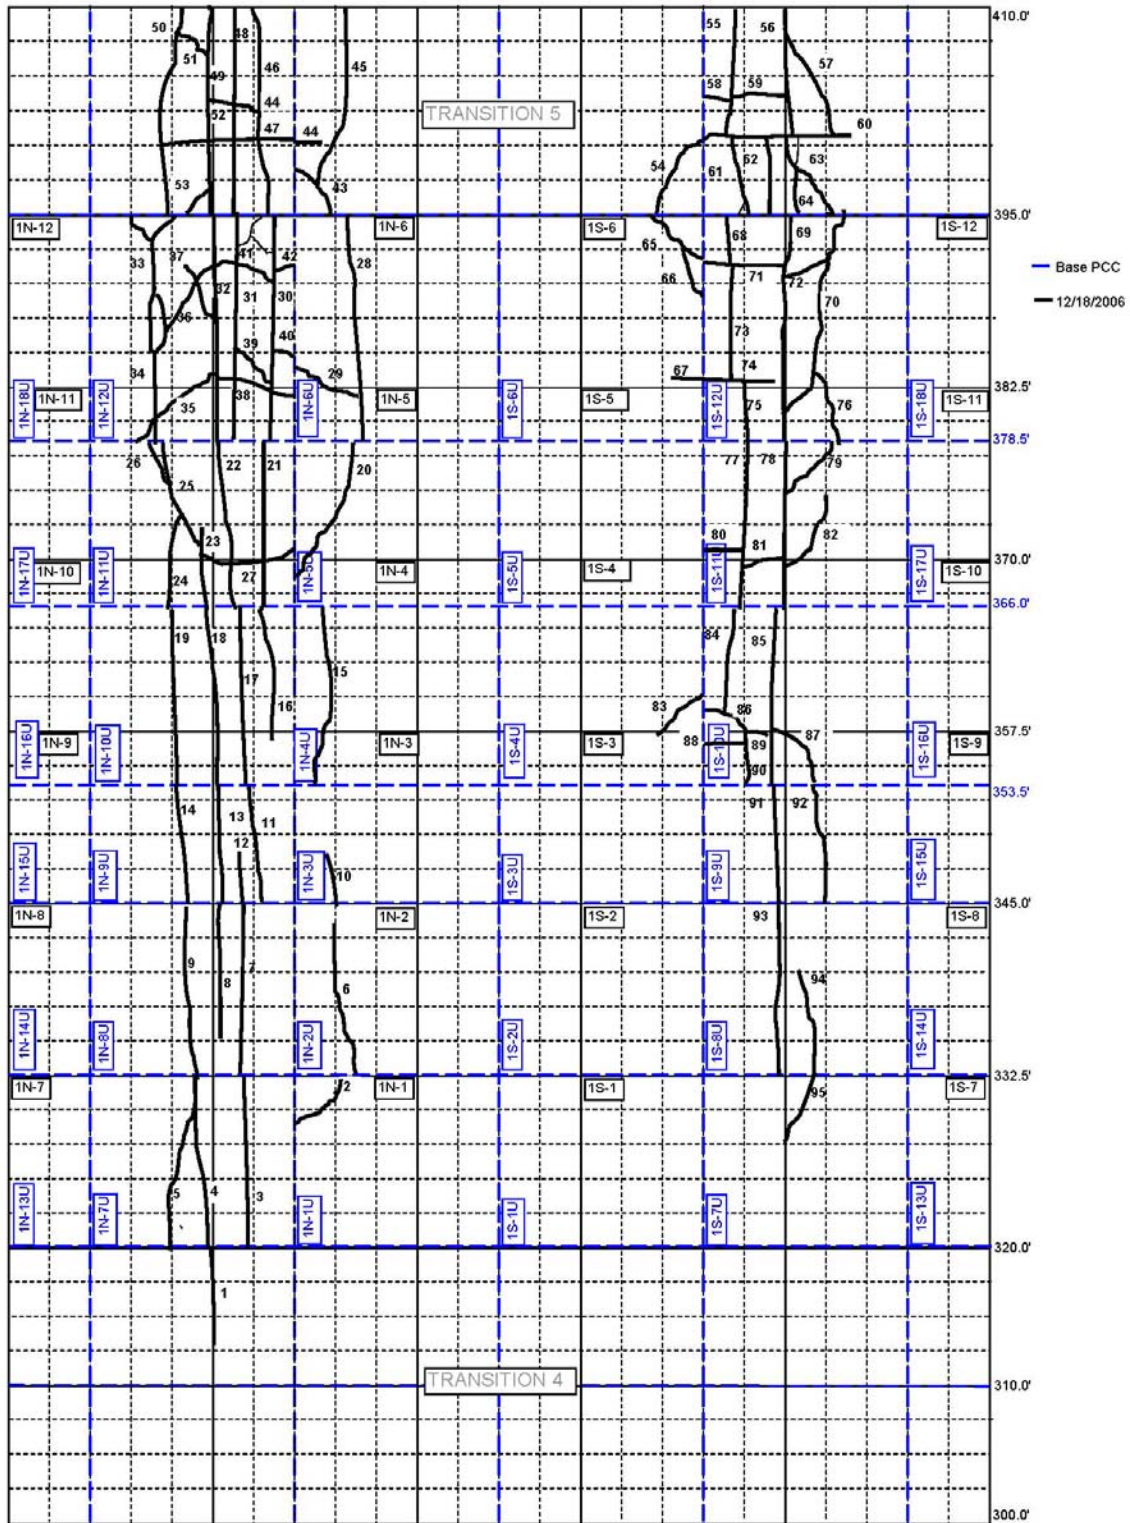
FIGURE 48. DISTRESS SURVEY ON BASE SLAB AFTER REMOVAL OF TOP SLAB FOR TEST ITEMS N1 AND S1

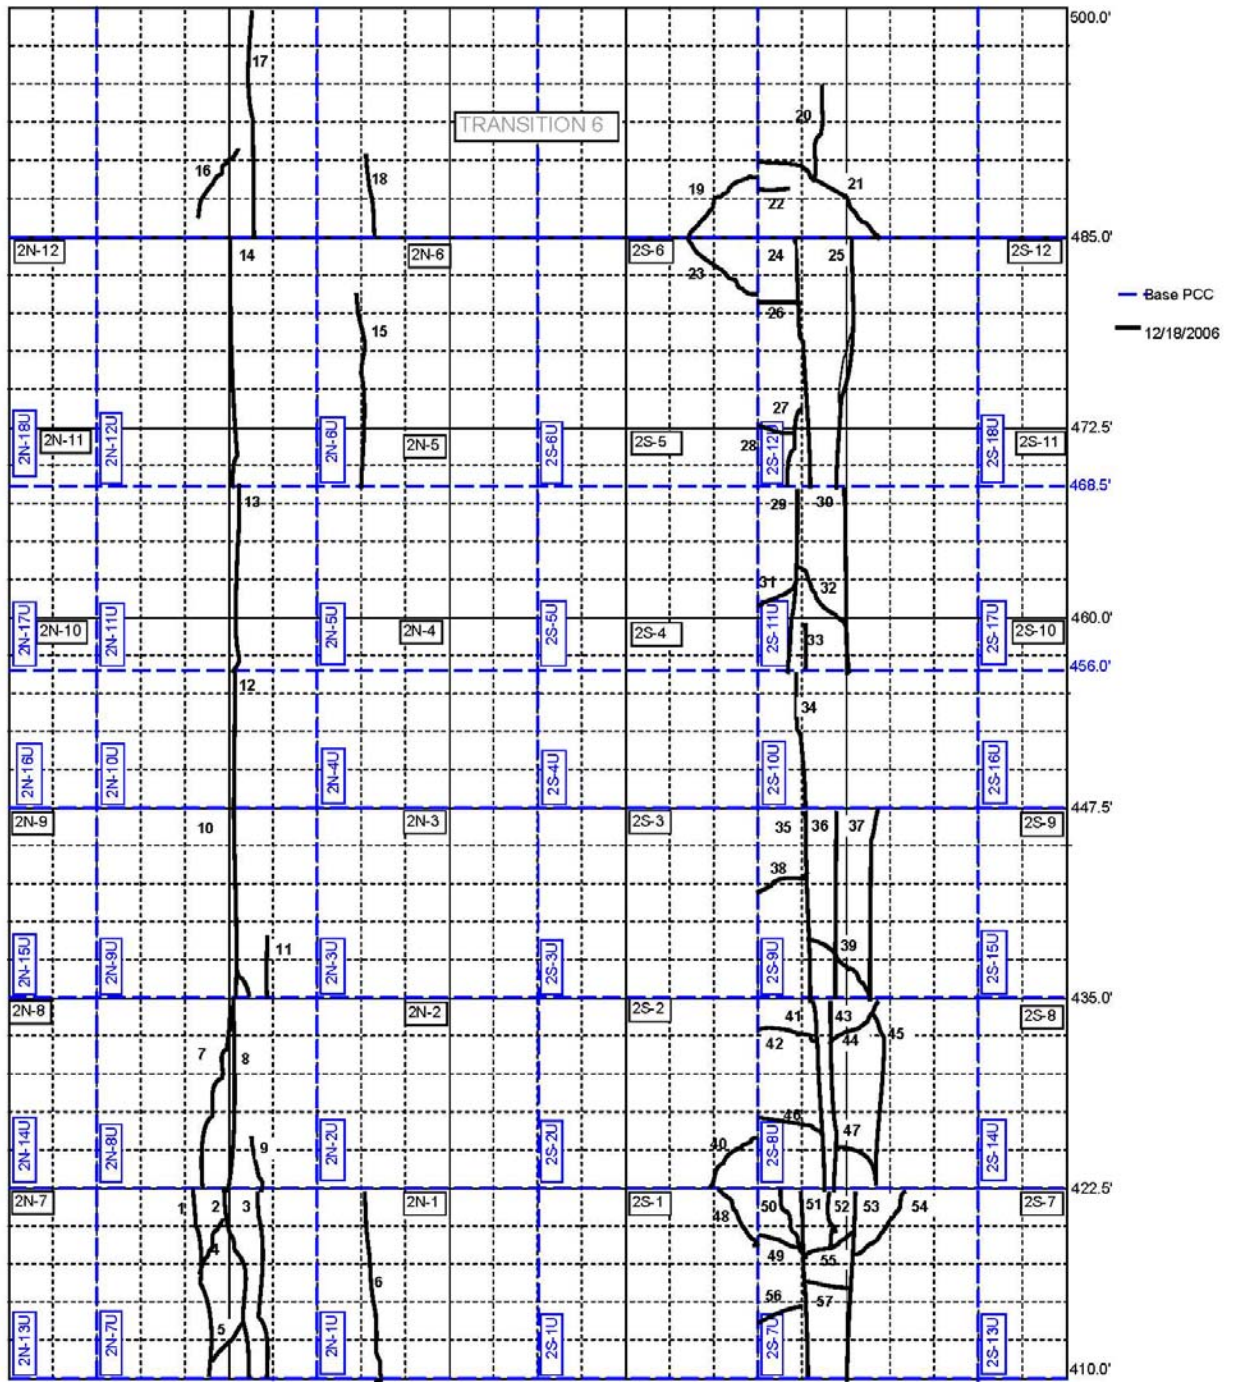
FIGURE 49. DISTRESS SURVEY ON UNDERLYING SLAB AFTER REMOVAL OF TOP SLAB FOR TEST ITEMS N2 AND S2

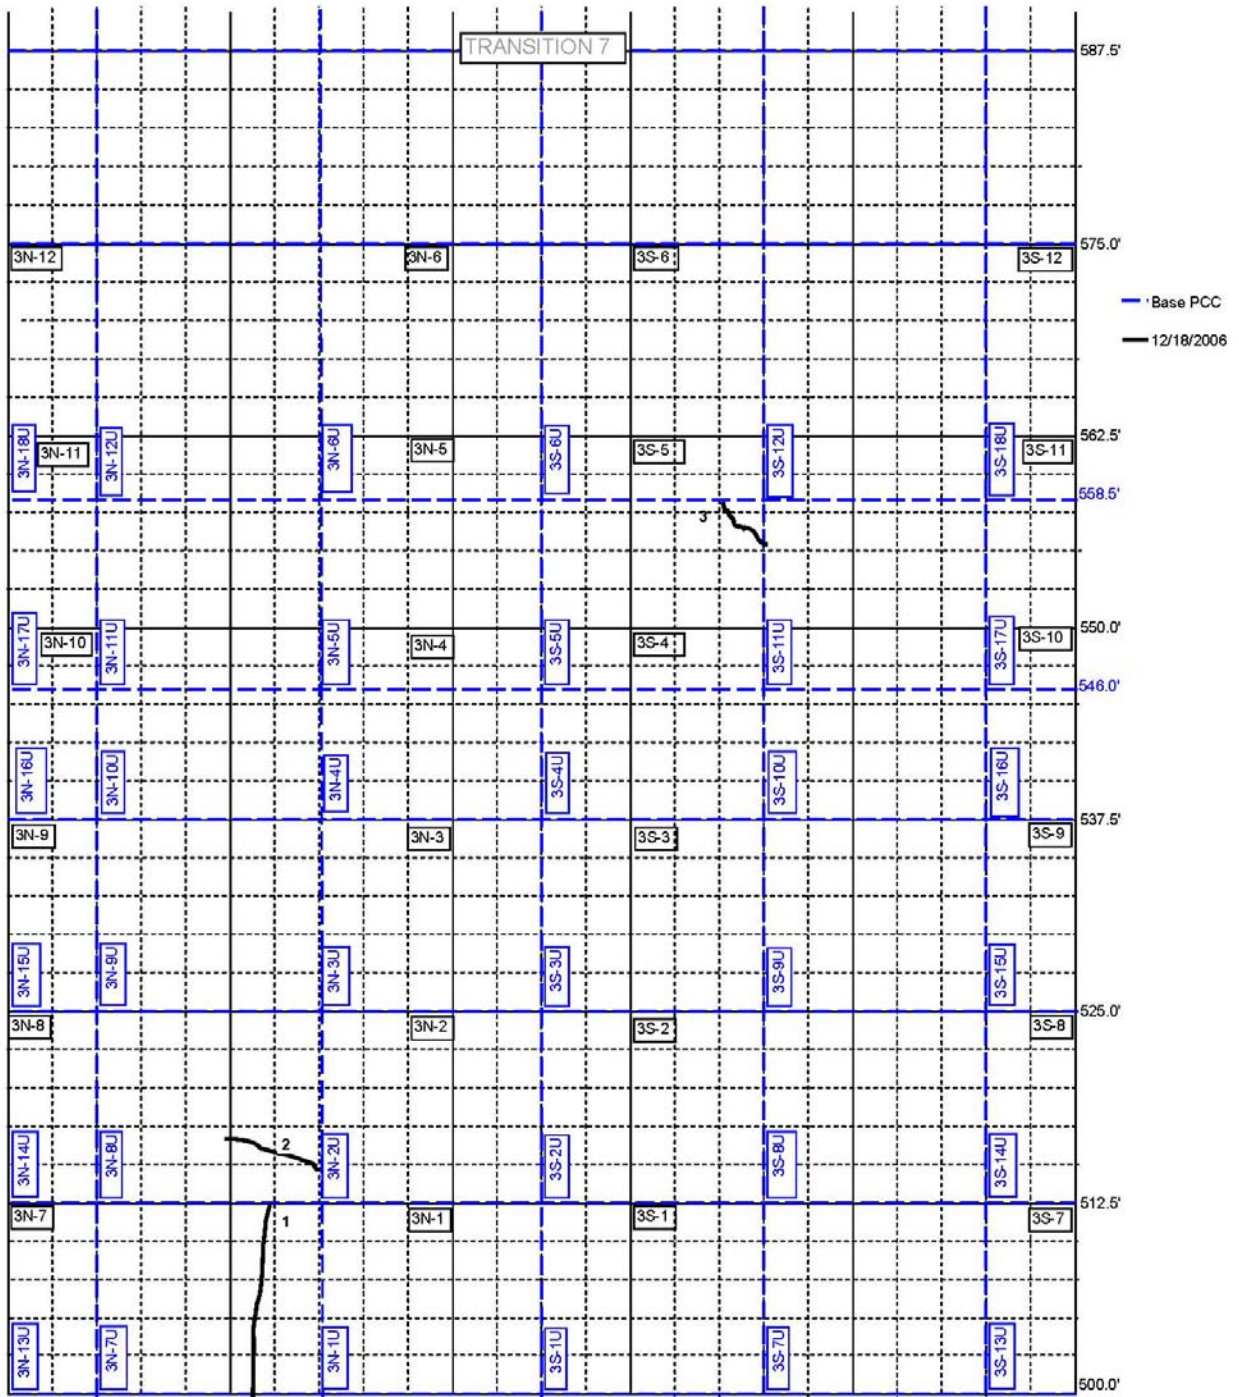
FIGURE 50. DISTRESS SURVEY ON UNDERLYING SLAB AFTER REMOVAL OF TOP SLAB FOR TEST ITEMS N3 AND S3
