An **IPRF** Research Report
Innovative Pavement Research Foundation
Airport Concrete Pavement Technology Program

SUMMARY REPORT

Report IPRF-01-G-002-05-7

**Performance of Concrete in the
Presence of Airfield Pavement
Deicers and Identification of
Induced Distress Mechanisms**

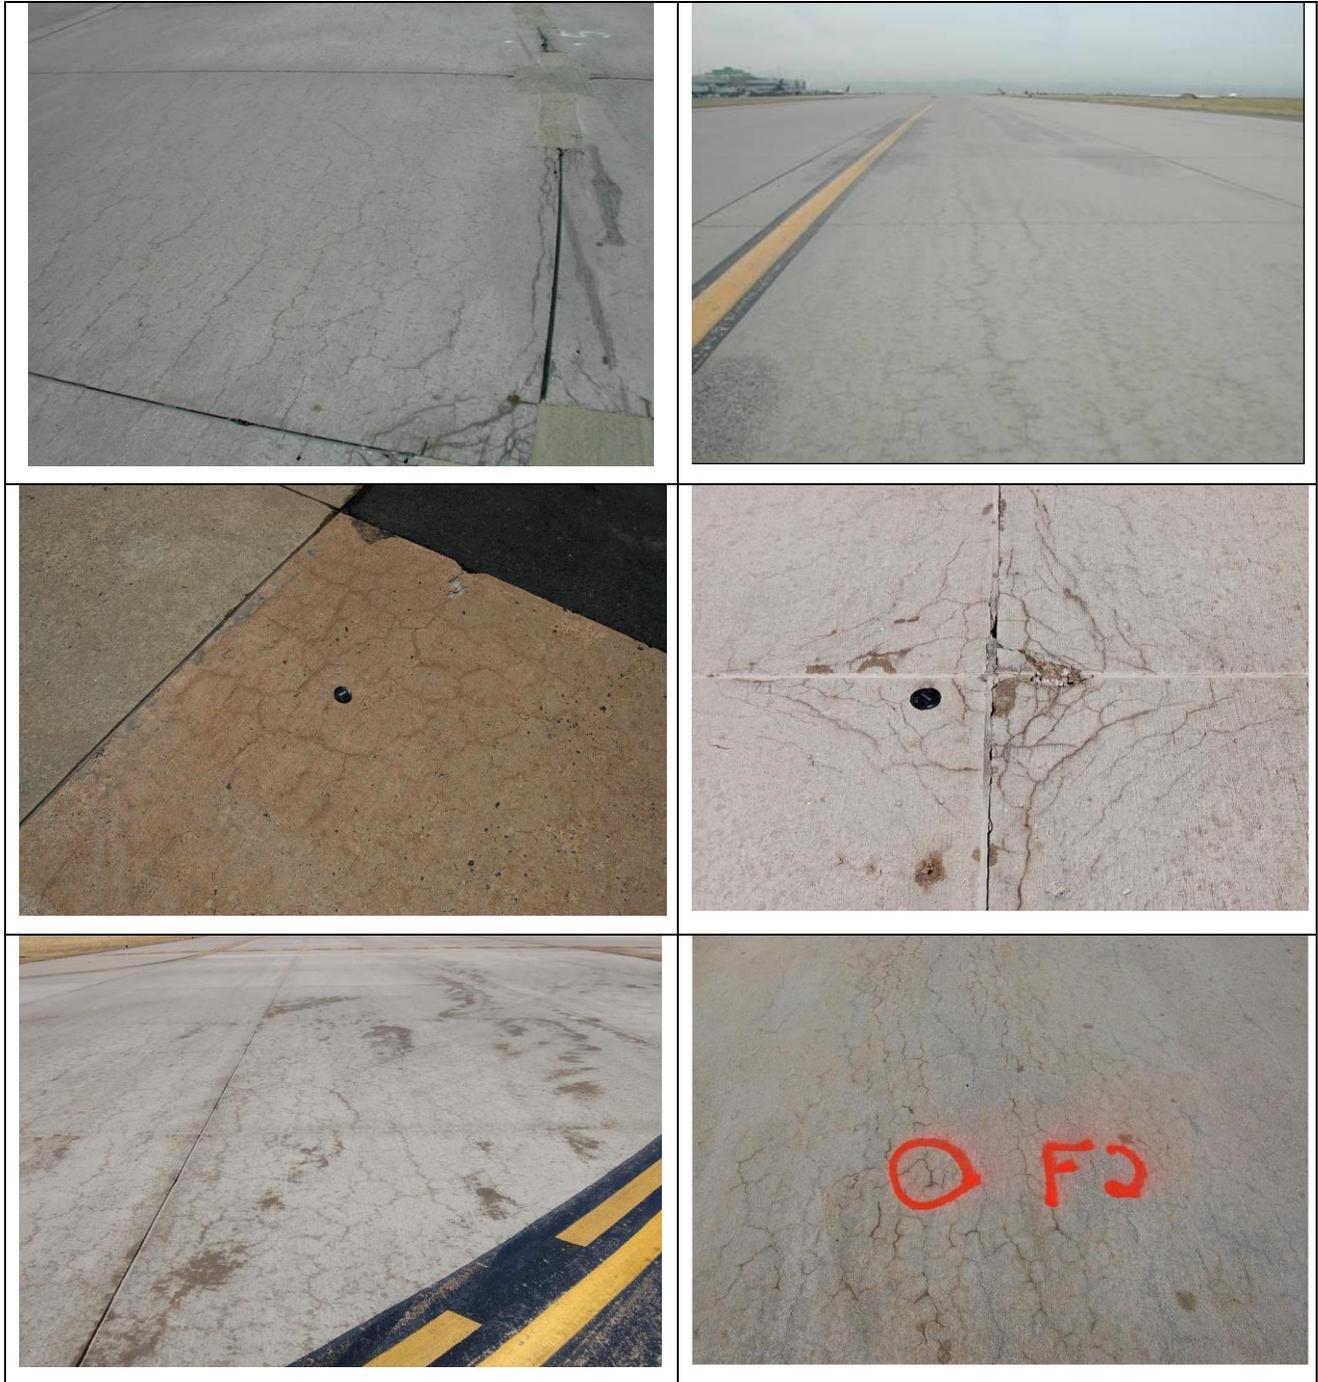
Figure 1 – Typical Patterns of Deterioration in Six Different Airfield Pavements Exposed to Deicing Chemicals

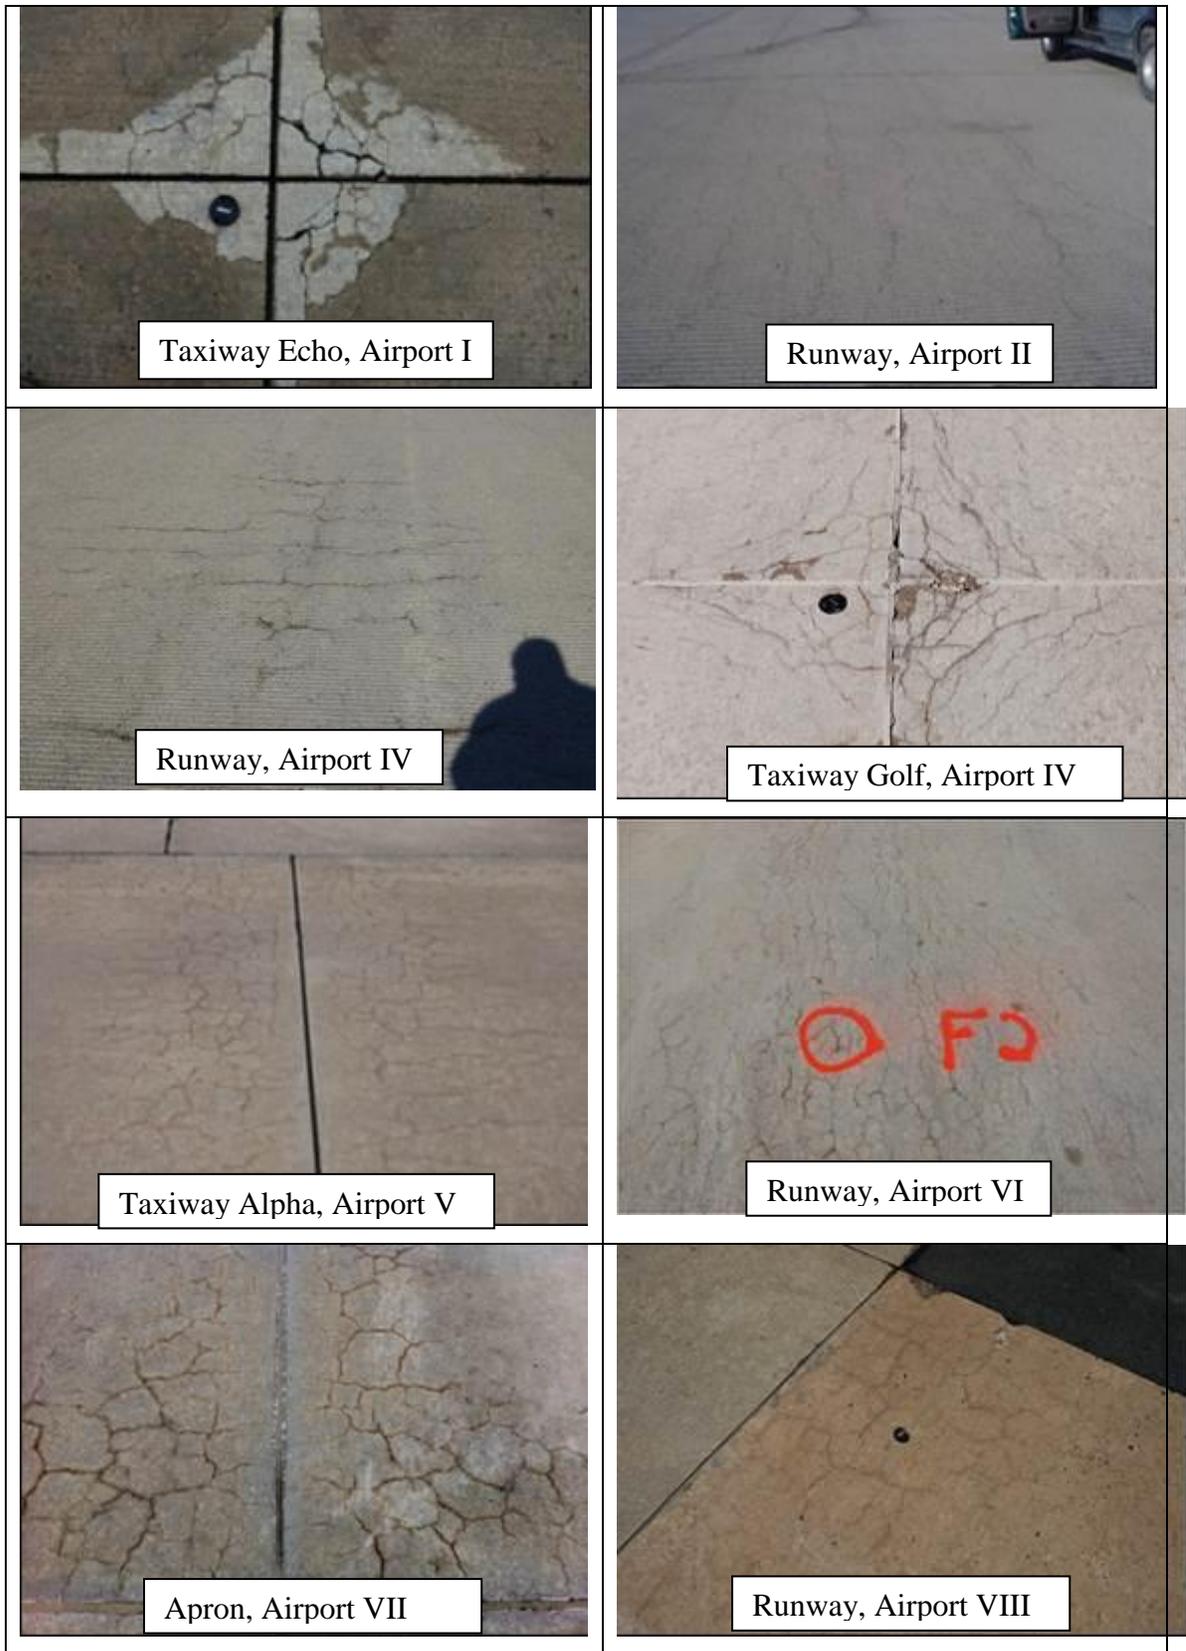
Figure 2A - Typical Deterioration in Different Airfield Pavements

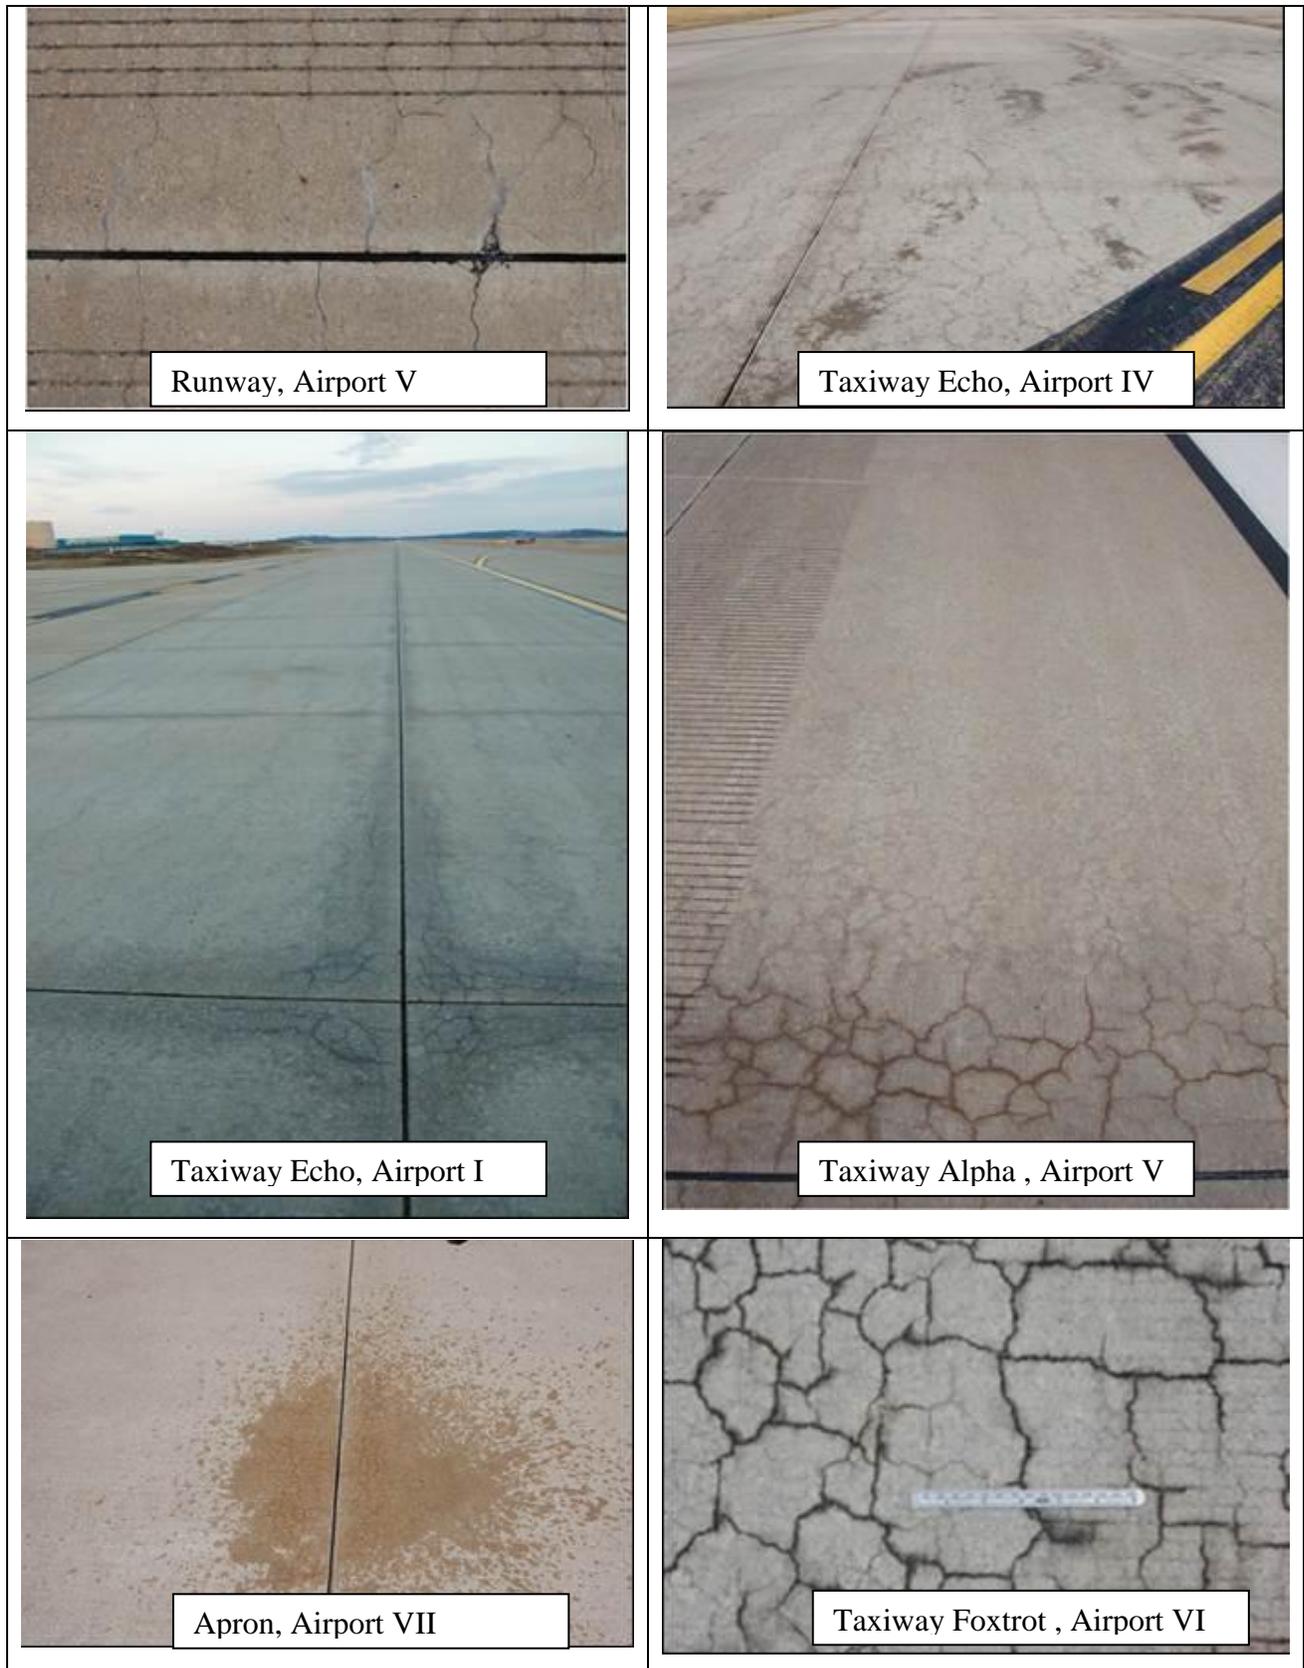
Figure 2B – Typical Deterioration in Airfield Pavements

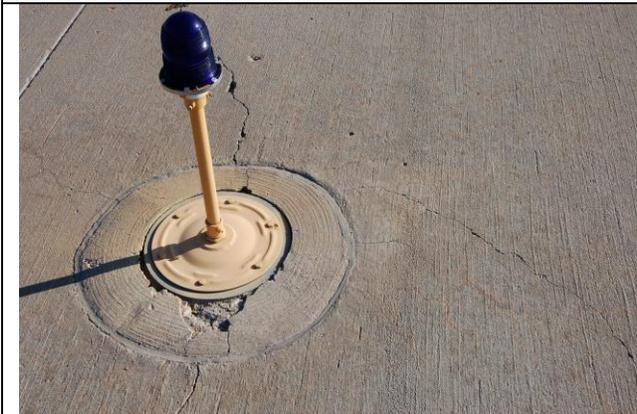
Misalignment and Damage to Light Canisters on Taxiway Echo at Airport IV

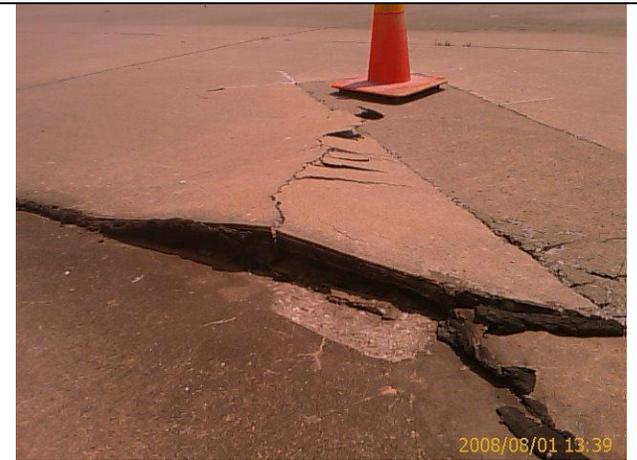
Blowout of Pavement in Airport VII

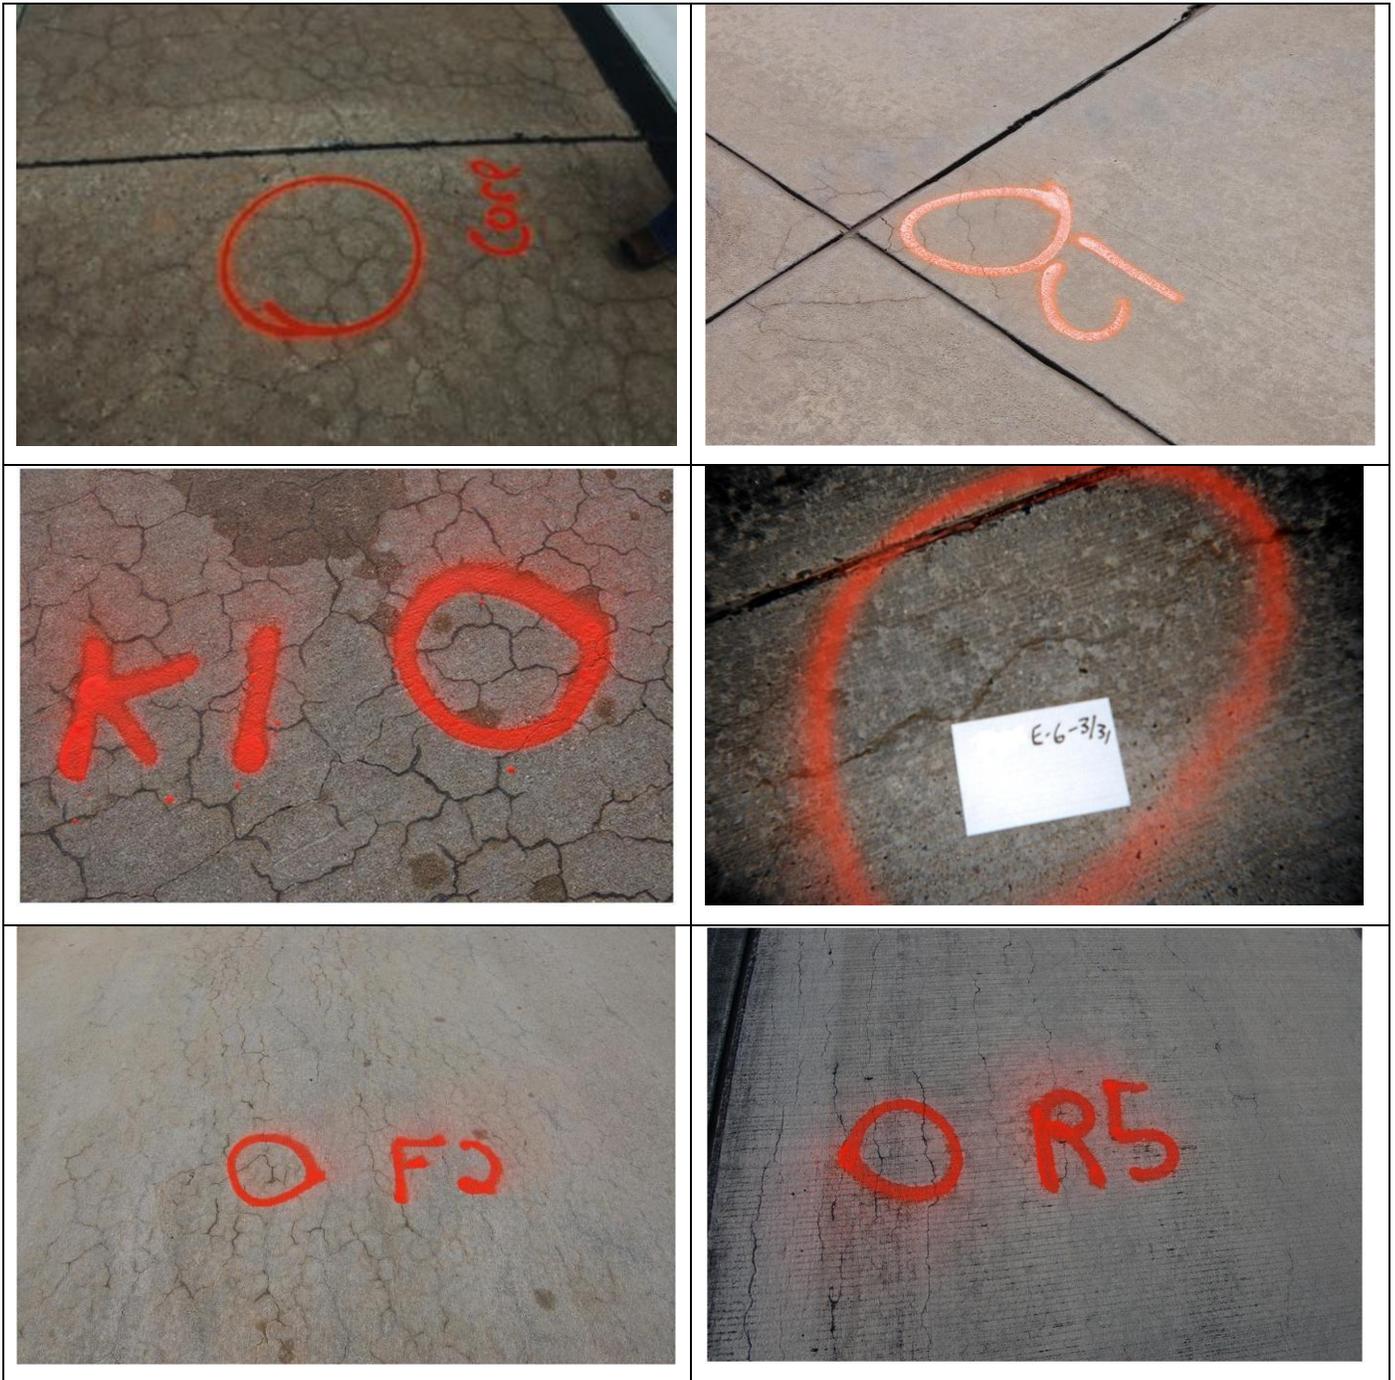
Figure 3 shows a typical layout of pavements at an airfield and coring locations in those pavements. Figure 4 shows photographs of typical locations in pavements from where cores were obtained. Where possible, multiple cores representing concrete from the same pavement with varying degree of distress were obtained. The typical core size used in this investigation was 4 inch in diameter and full depth of the pavement, although in a few pavements the core diameter ranged from 3.75 inches to 5.75 inches.

Figure 4 – Typical coring locations in airfield pavements to capture distress of different intensity

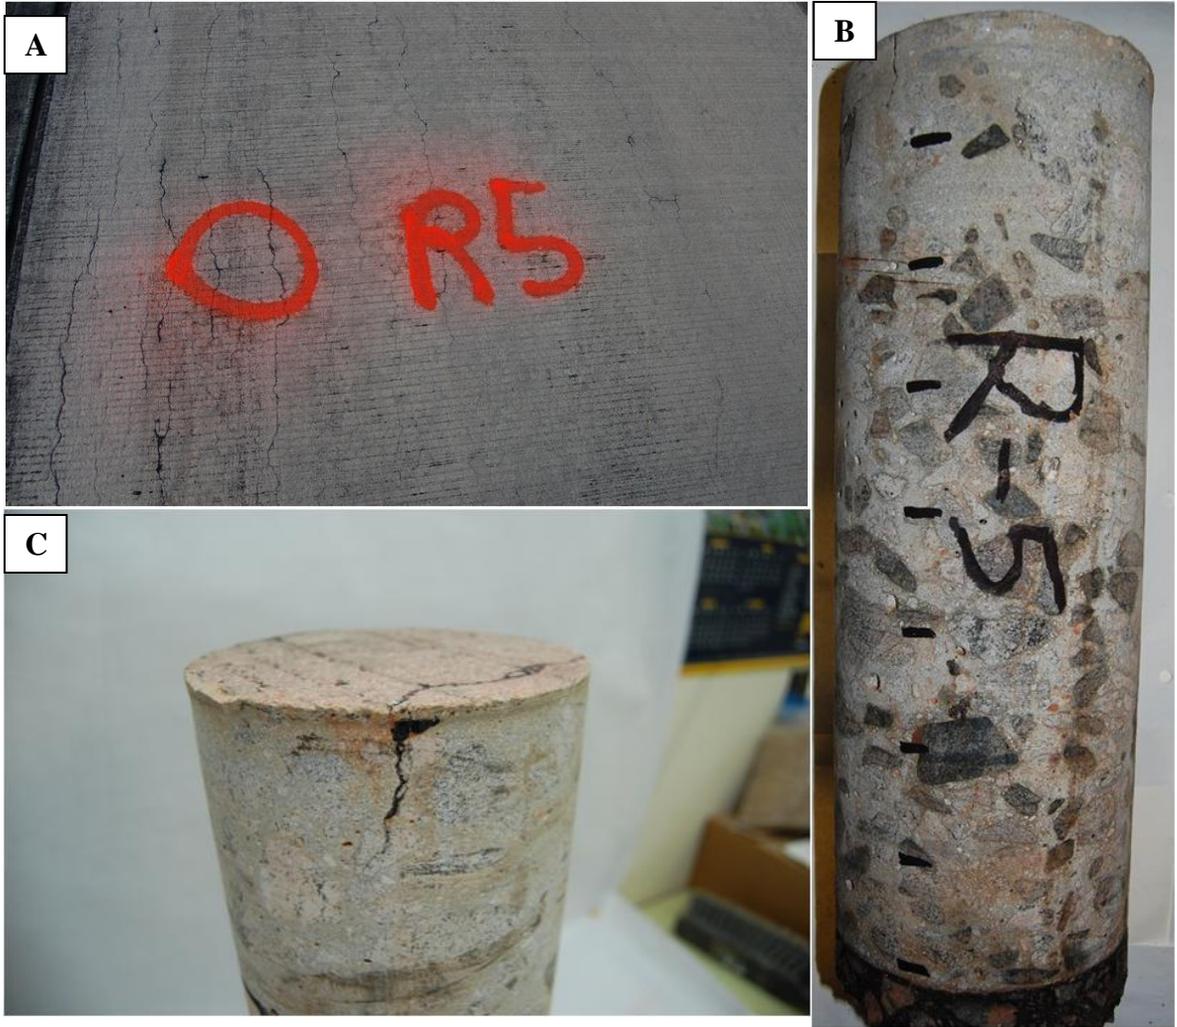
Figure 5B – (A) Typical location for coring in a distressed pavement (Runway at Airport VI) (B) – Physical condition of the core (C) The 5.75 in. diameter core was 16.38 inches long with a single crack running down from the pavement surface to about a depth of 2.5 inches.

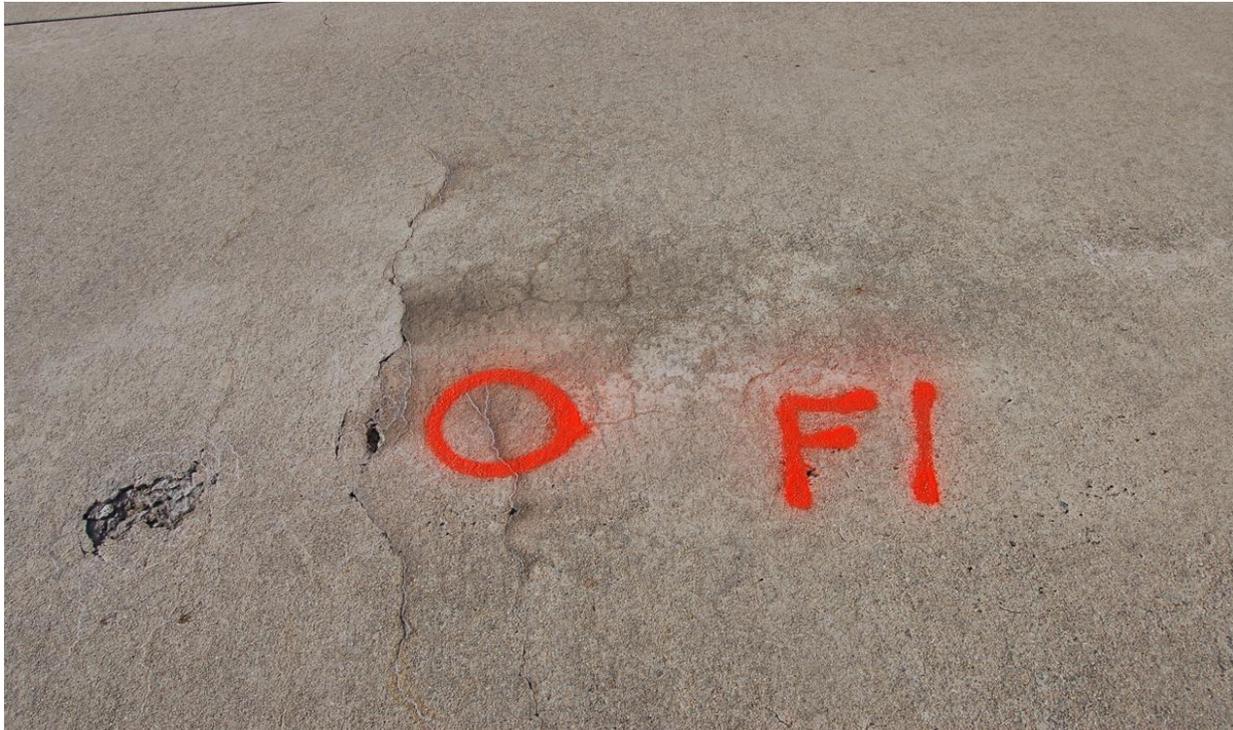
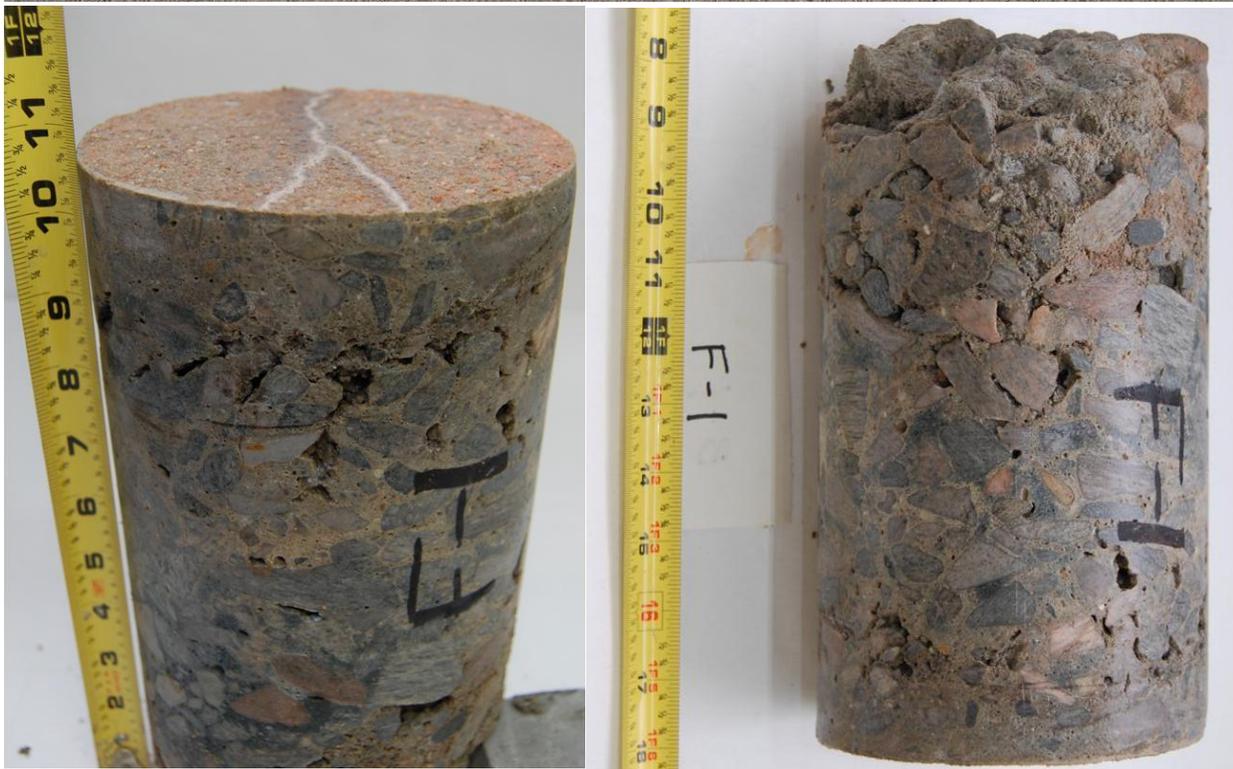
Figure 5C – (A) Typical location for coring in a distressed pavement (Taxiway Foxtrot at Airport VI) (B) – Physical condition of the core with significant honeycombing in the top 4 inches and from 7 - 12 inches below the pavement surface. The core was retrieved in two pieces, with 5.75 in. in diameter and a total length of 16.13 inches.

- v. Drying shrinkage was found to be a significant cause for distress in runway at Airport II, while poor construction practices such as inadequate mixing and consolidation of concrete have led to failure in Taxiway Foxtrot at Airport VI. (see Figure 5C).

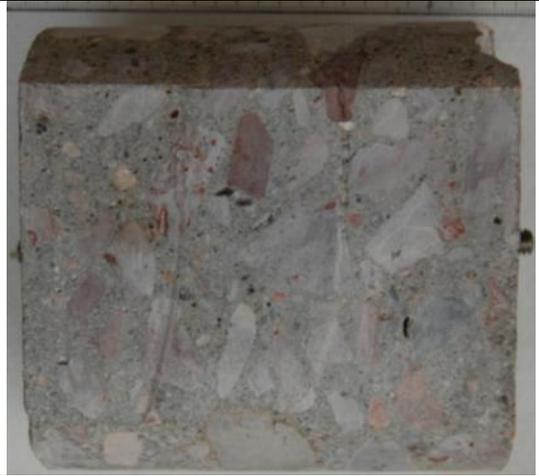
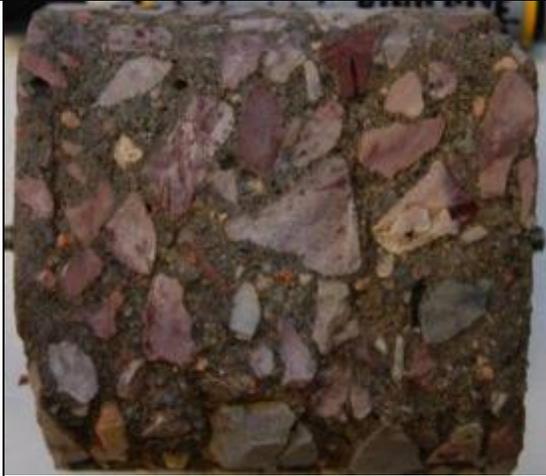
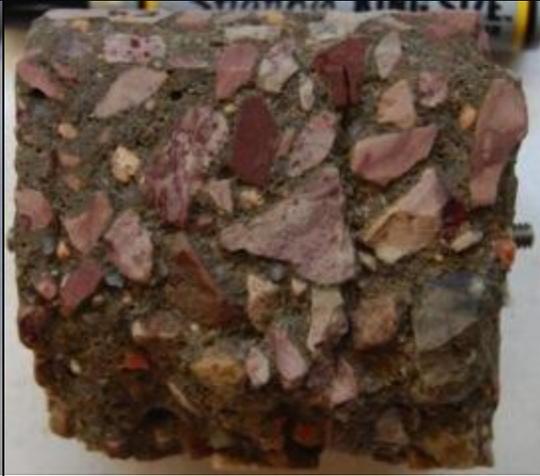
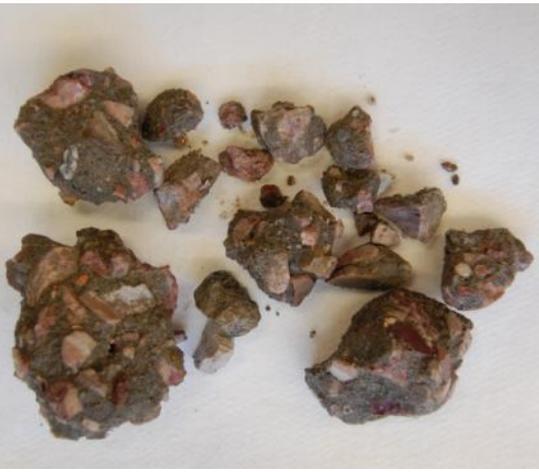
0 Freeze-Thaw Cycles	60 Freeze-Thaw Cycles	120 Freeze-Thaw Cycles

Sample Failed	Sample Failed
180 Freeze-Thaw Cycles	240 Freeze-Thaw Cycles	300 Freeze-Thaw Cycles

Figure 20 – Visual Condition of Airport IV Taxiway Echo 4 Core 2 (exposed to 6.4 M KAc deicer) During the Freeze Thaw Testing
