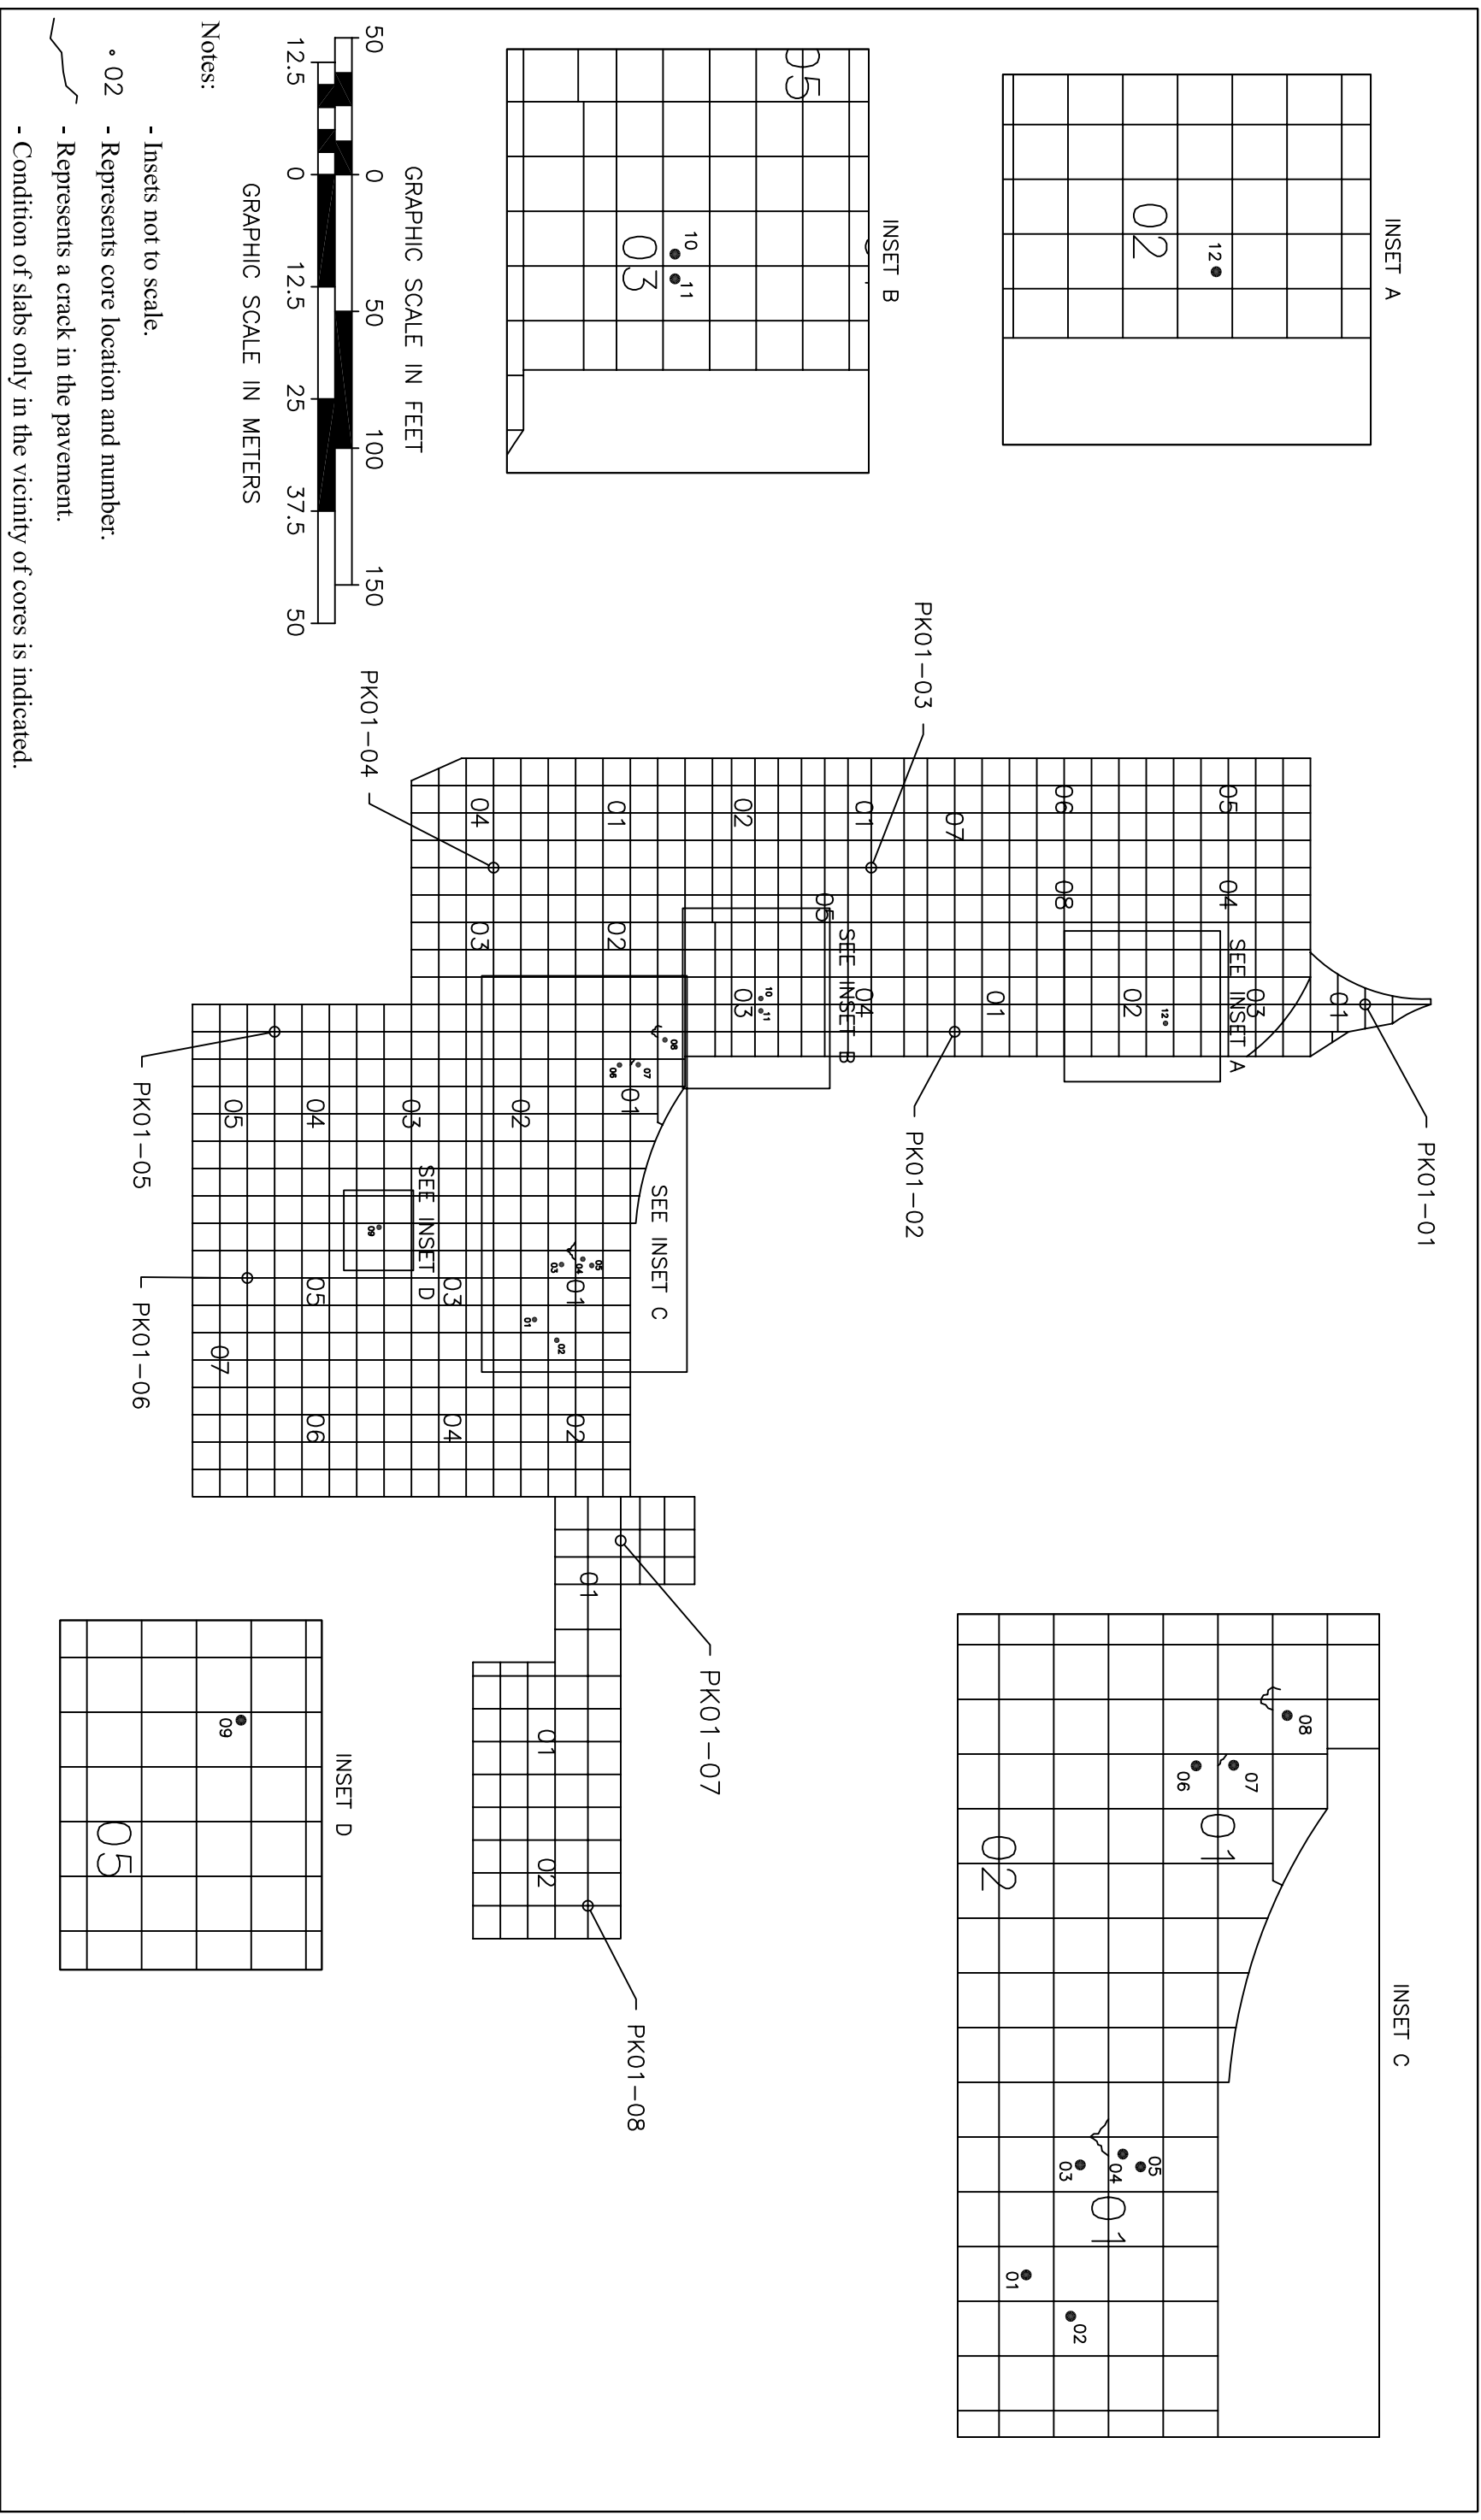
- Cores 5 and 12 were not taken.
- Insets are not to scale.
- Represents area with steel reinforcement.
- Represents core location and number.
- Represents a crack in the pavement.
- Condition of slabs only in the vicinity of cores is indicated.

Figure 2.46. Location of cores removed at Life Bridge Christian Church.
