APPENDIX C
Petrographic Analysis Reports

Appendix D: Petrographic Analysis

Introduction for Airports I – III

Airport I

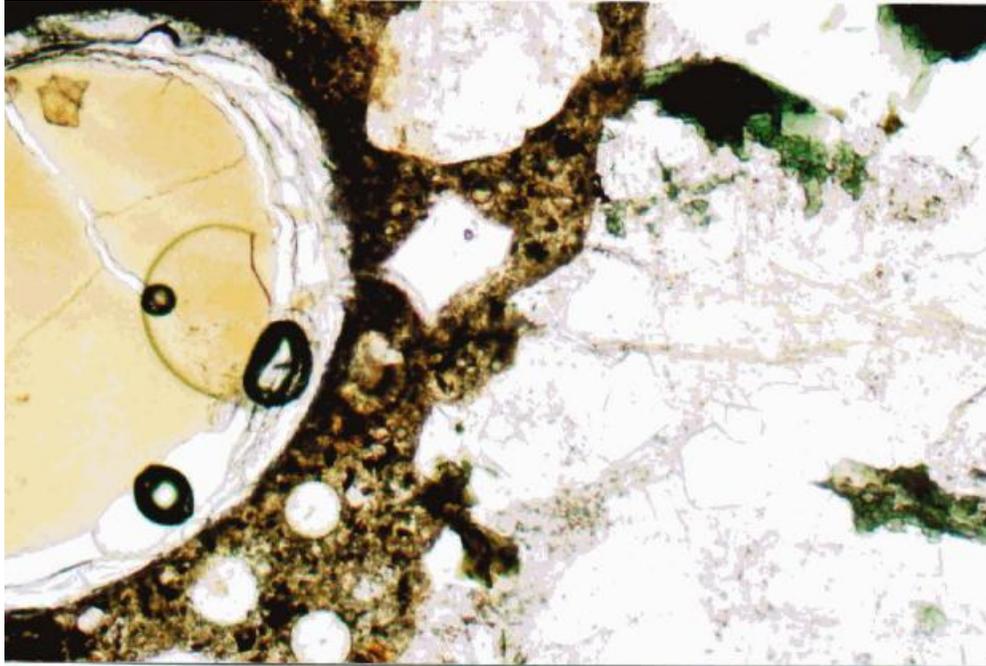
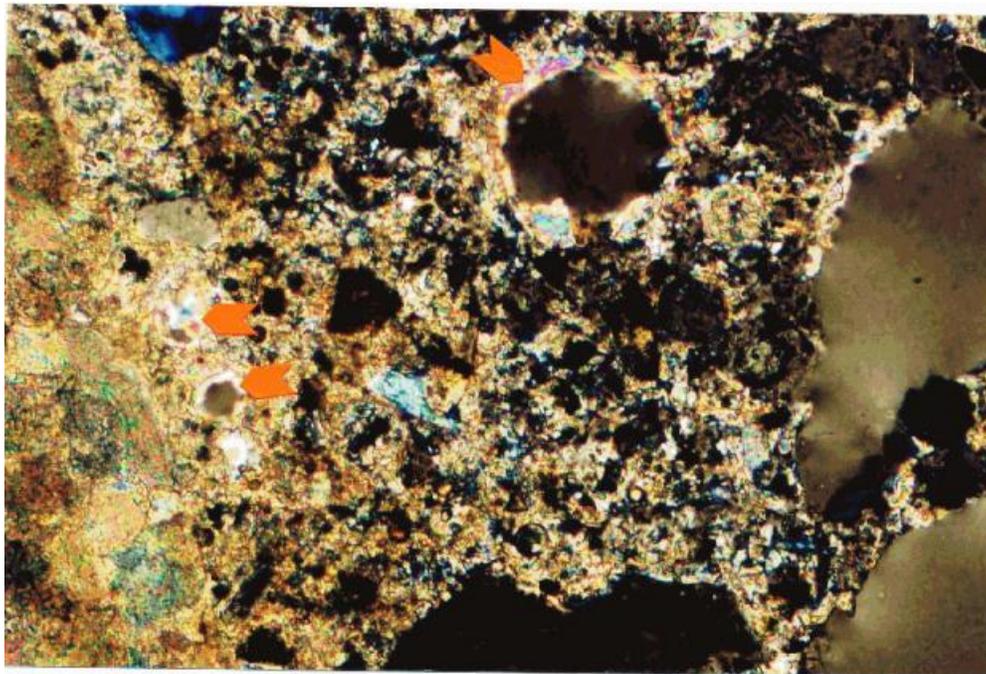
Figure 1: (Upper) Thin section of Core #1 at 100X, showing ASR gel in void connected to “microgranite” coarse aggregate (right). Gel in the interior of the void is light tan and finely microcrystalline, but in the void lining it is clear and amorphous. Dark bubbles in epoxy. Depth in core is 100 mm. LP = 10 mm. (Lower) ACR carbonation of paste adjacent to reacting dolostone (left). Some of the resulting calcite occurs as void fillings (arrows). Partially cross-polarized light. 200X. LP = 0.5 mm.

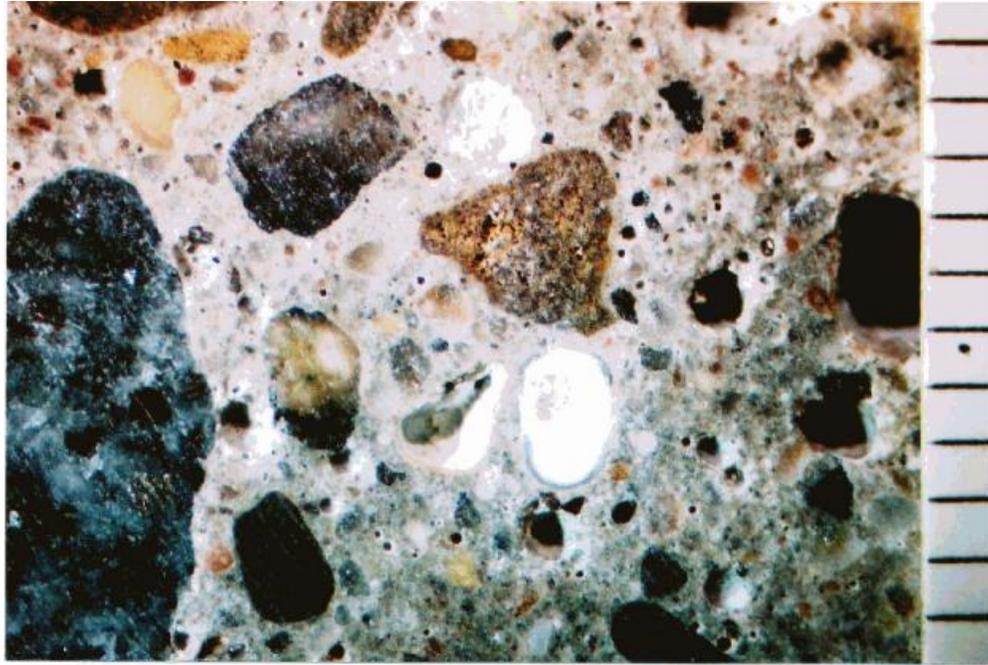
Figure 2: Lapped surface of Core # 1 under the stereomicroscope, showing three voids containing ASR gel around a microcracked fine-aggregate particle of brown siltstone. Millimeter scale divisions.

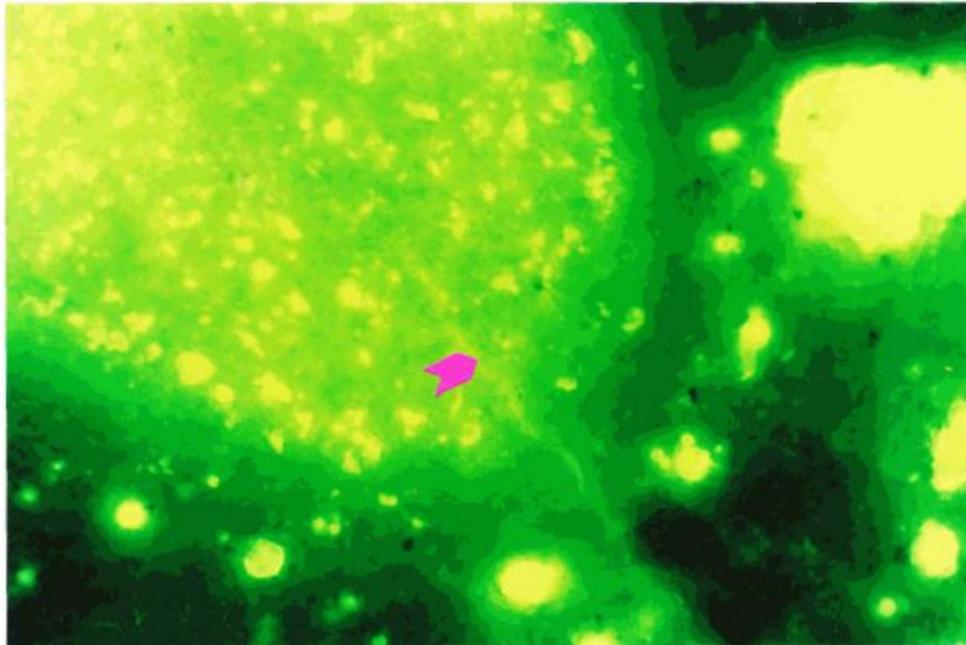
- Core 106: Counting 67 coarse aggregates exposed on a lapped fluorescent-epoxy-impregnated surface revealed nine (9) microcracks, in 6 particles, apparently originating mostly within chert-cemented sandstone (thin section for better photo) and passing into the adjacent paste; crack widths are approximately two (2) microns wide within the rock. The reaction rims, possibly combined with weathering rims, do not contain the fluorescent epoxy.

Figure 1: Lapped section of Core 106 at 40X magnification under reflected UV light, showing an open microcrack (magenta arrow), beginning within a porous sandstone coarse aggregate, passing into the adjacent paste where the crack terminated. Crack width approximately 4 to 10 microns, depth in core is 55mm below top surface. Incipient ASR. Length of photo (LP), left to right = 2.6 mm.

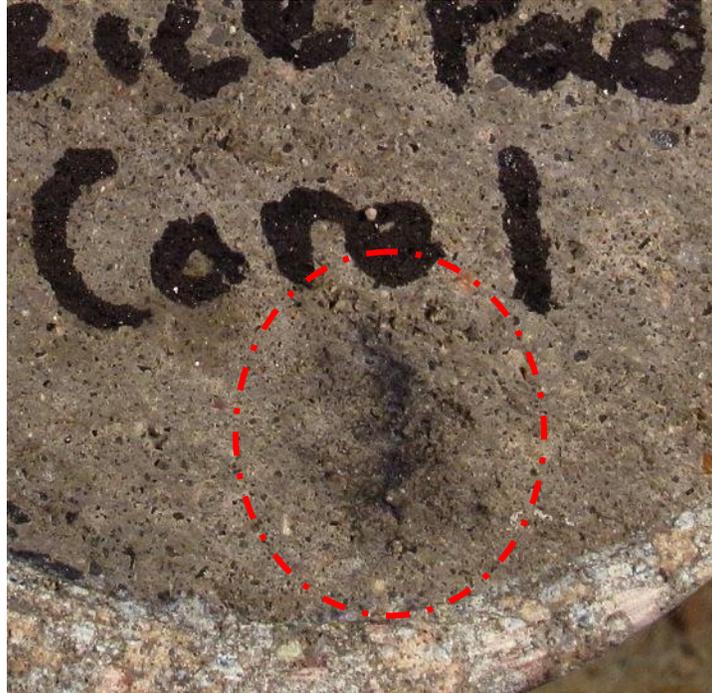
Figure 5. Close-up of the wearing surface in Core 1 (De-Ice Pad). Within the red dashed circle is an area of minor surface pitting.

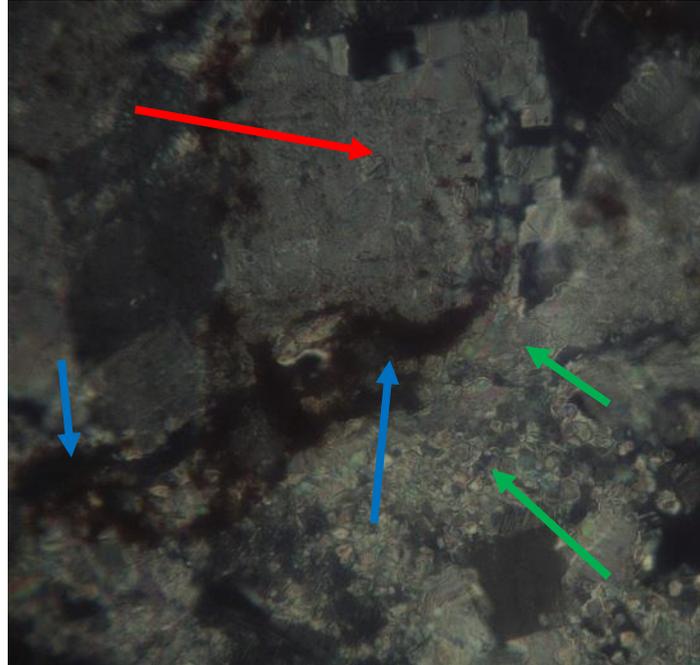
Some of the clay occurs as fine seams or stringers. Some of the dolomite rhombs have cores containing fine argillaceous material surrounded by an outer argillaceous-free rim of dolomite that is slowly de-dolomitizing into calcite (Figures 9 and 10). Conversion of dolomite to calcite is also evident adjacent to cracks that radiate out of coarse aggregate particles (Figure 12).

Figure 9. Thin section photomicrograph of Echo 5 – Core 4 illustrating microstructure of a dolomite coarse aggregate particle. Red arrow points to a dolomite rhomb in the process of de-dolomitization. Green arrows point to calcite converted from dolomite. Blue arrows point to brown, argillaceous material (clay) within the dolomite. Crossed-polarized light. Vertical field of view is 0.25 mm.

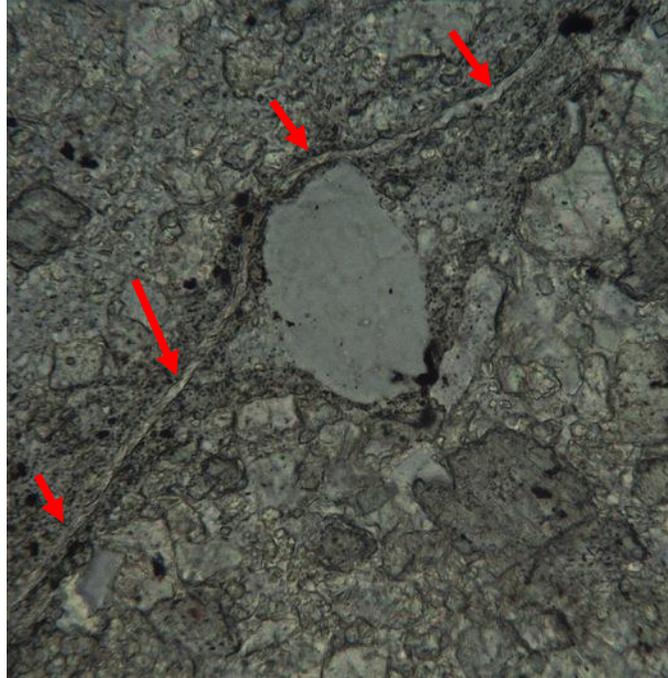
Figure 12. Thin section photomicrograph of Echo 5 – Core 4 illustrating a crack within a dolomite coarse aggregate particle (red arrows). The crack is lined with brucite and rock adjacent to the crack has been converted to a fine-grained calcite as compared to the coarser-grained dolomite further away from the crack. Vertical field of view is 0.60 mm. Plane-polarized light.

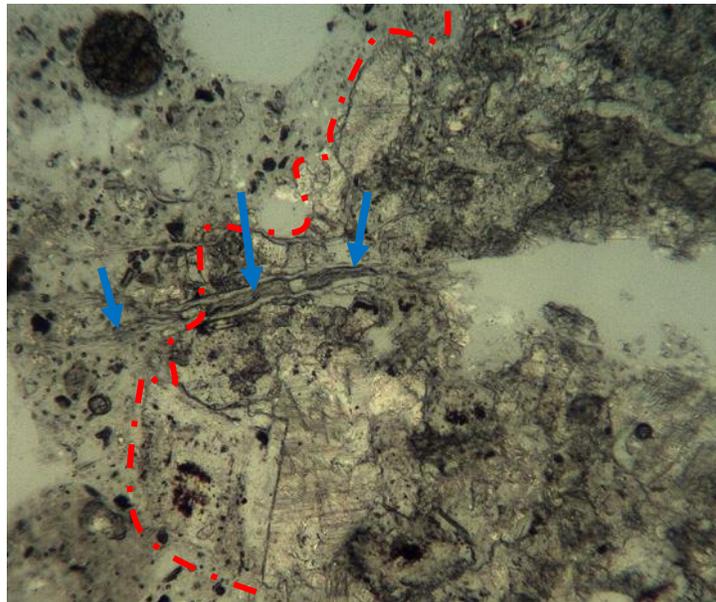
Figure 13. Thin section photomicrograph of Echo 5 – Core 4 illustrating a crack radiating out from a dolomite coarse aggregate particle (right of red dashed line) into the cementitious materials paste (blue arrows). The crack is lined with brucite. Vertical field of view is 0.60 mm. Plane-polarized light.

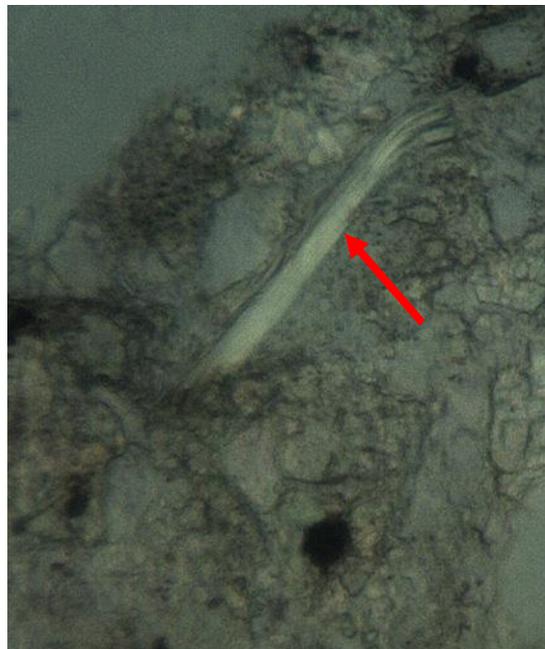
Figure 15. Thin section photomicrograph of Echo 5 – Core 4 showing coarse, fibrous brucite (red arrow) within a dolomite coarse aggregate particle. Vertical field of view is 0.25 mm. Plane-polarized light.

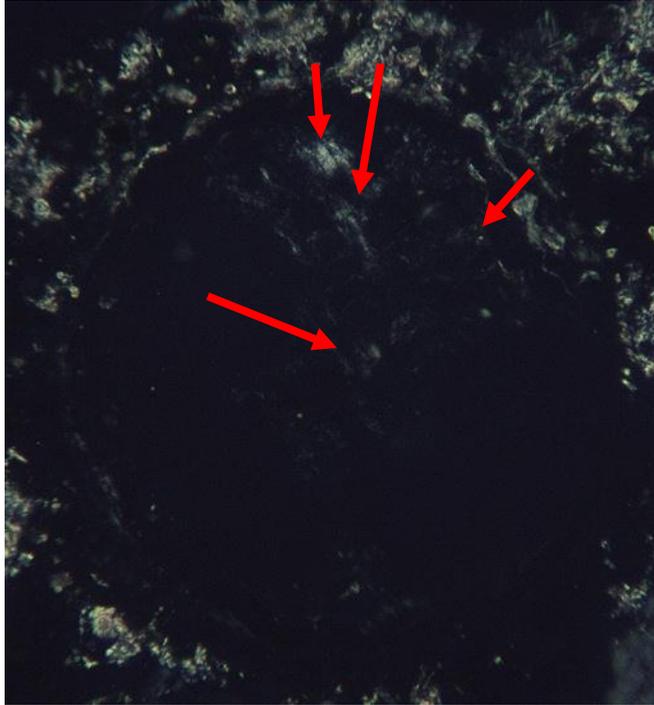
Figure 16. Thin section photomicrograph of Echo 5 – Core 4 illustrating fibrous brucite (red arrows) partially filling an air void. Vertical field of view is 0.25 mm. Crossed-polarized light.

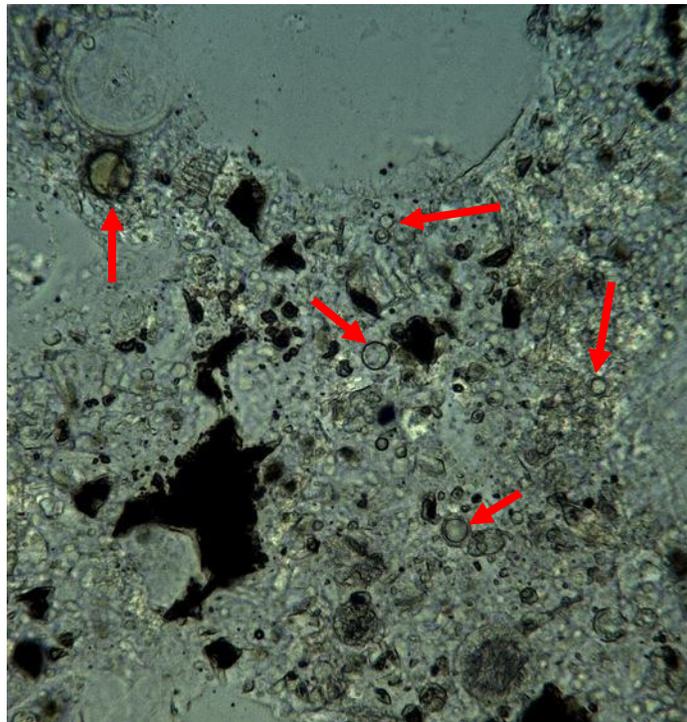
Residual fly ash is present, representing the use of supplementary cementitious materials in the mix (Figures 11 and 17). Residual fly ash is estimated to be 12-to-17%, by volume of paste.

Figure 17. Thin section photomicrograph of Echo 5 – Core 4 showing the presence of residual fly ash particles (red arrows). Vertical field of view is 0.60 mm. Plane-polarized light.

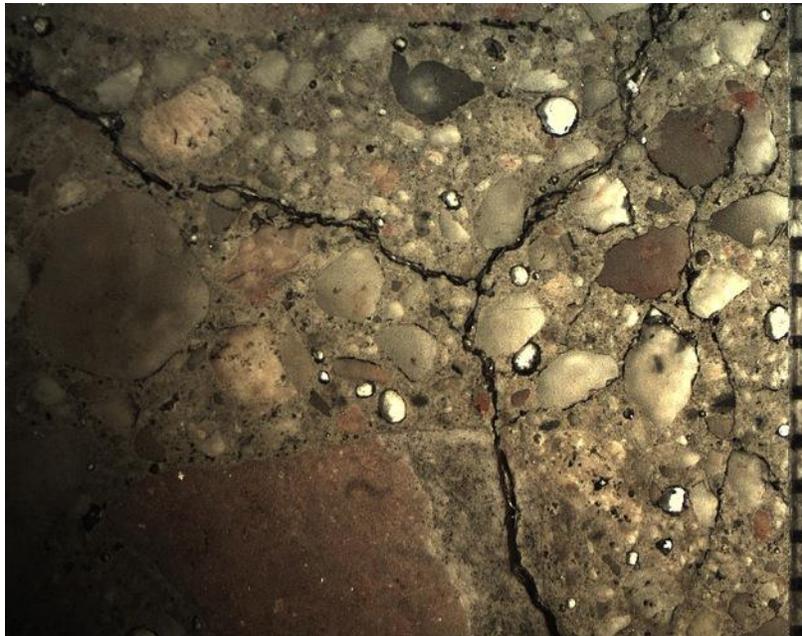
Figure 21. Magnified lapped slice of Core C1C7 showing numerous, random cracks in the cement paste. White, brucite (and other related) deposits line the cracks and voids in the field of view. This damage is due to alkali-carbonate reaction. Scale is in millimeters.

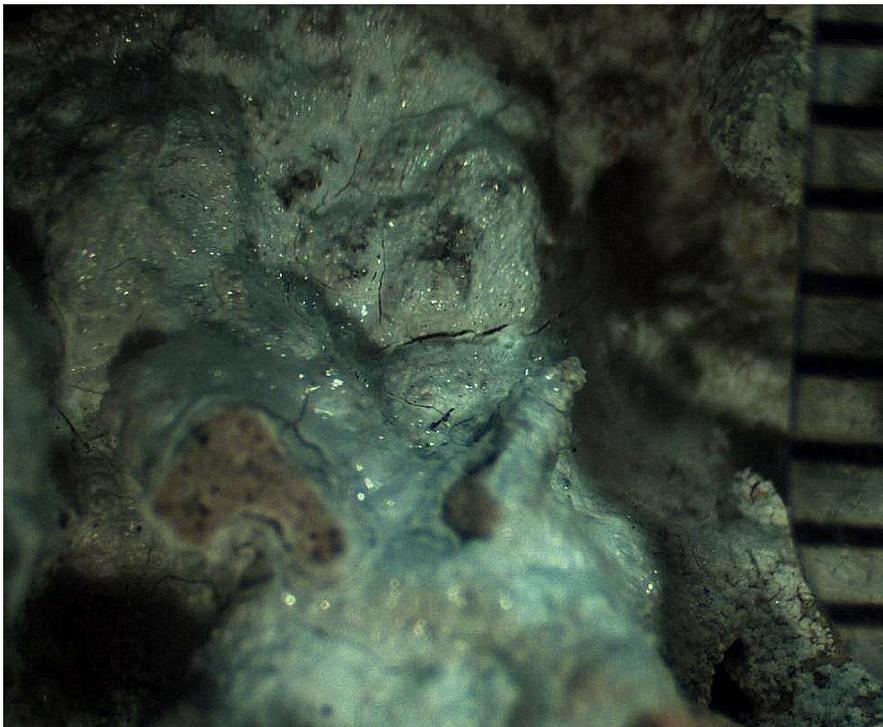
A relatively small number of random, fine (less 0.08 mm dia.) microcracks occur throughout the core (Figures 7 and 8). The microcracks appear to originate within granite gneiss coarse aggregate particles (Figure 9) and some of the chert fine aggregate particles and radiate out into adjacent paste for a few centimeters. The microcracks and voids intersected by the microcracks are lined with alkali-silica gel (Figure 10). Thus, the microcracks appear to be due to alkali-silica reaction.

Figure 10. Alkali-silica gel lining an entrapped air void of Core B-1. Scale is in millimeters.

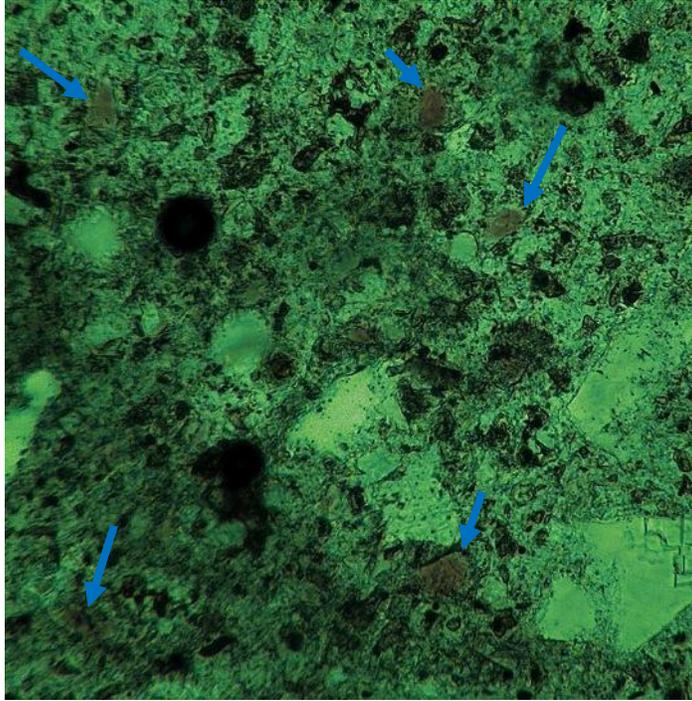
Ground granulated blast furnace slag is present as a supplementary cementitious material. Some of the slag has hydrated into yellowish amorphous relicts in the paste (Figure 11). Residual slag content is estimated to be 20 to 25%, by volume of paste.

Figure 11. Thin section photomicrograph of a portion Core B-1 illustrating brown slag relicts (blue arrows). Vertical field of view is 0.60 mm. Plane-polarized light.

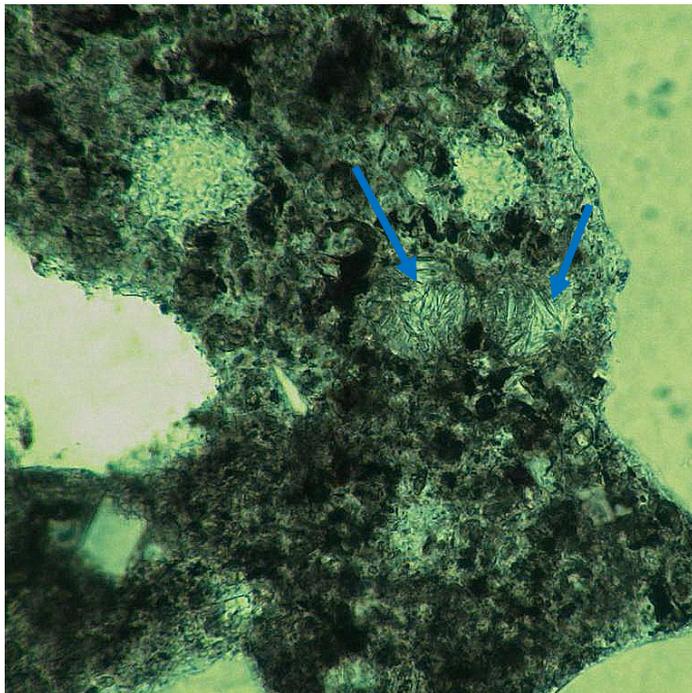
Ettringite lines many of the voids (Figure 12).

Figure 12. Thin section photomicrograph of a portion Core B-1 showing voids filled with ettringite (blue arrows). Vertical field of view is 0.60 mm. Plane-polarized light.

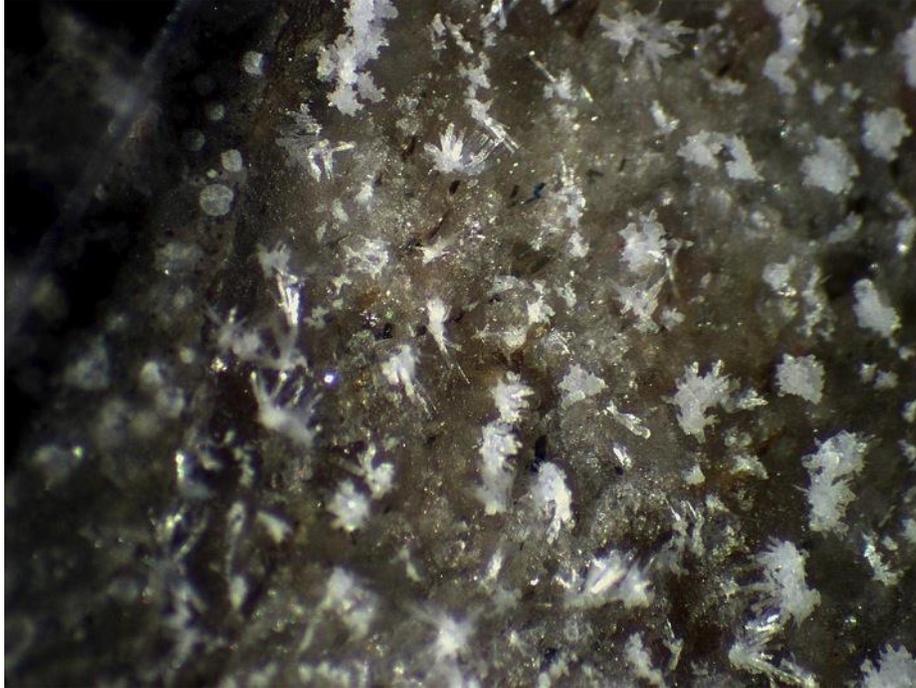
Along the “as-received” saw cut surface white deposits are observed growing out of the coarse aggregate particles (Figure 13). These deposits have been optically identified as aragonite.

Figure 13. Photomicrograph of Core F-2 illustrating aragonite crystals growing out of a granite gneiss particle along a sawn surface. Scale is in millimeters.

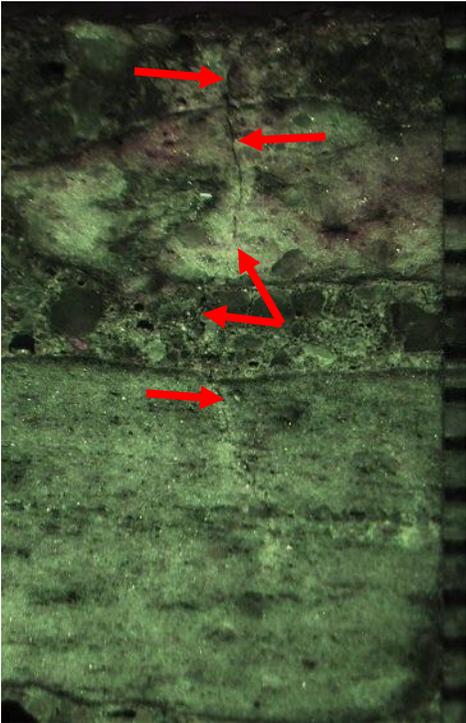
Cracks at the wearing surface are 0.08 to 0.1 mm (0.003 to 0.004 in.) wide and extend 45 to 70 mm (1.8 to 2.8 in.) depth where they terminate in granite gneiss coarse aggregate particles (Figure 14). The cracks pass both around and through aggregate particles. These cracks are lined only with dirt, debris and a small amount of calcium carbonate.

Figure 14. Photomicrograph of Core F-2 illustrating a surface crack extending through two rimmed gneiss particles (red arrows). Scale is in millimeters.

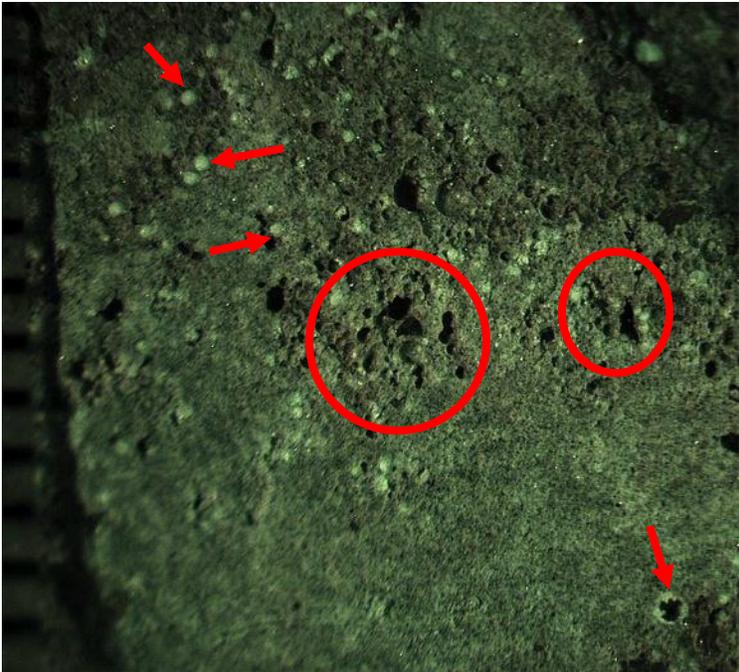
Some areas contain few to no voids and in other areas are clusters where the void content appears to be as high as 7% (Figures 16 and 17). The air-voids are very non-uniformly dispersed throughout the concrete. Air content is estimated to be 2.5 to 7.0%.

Figure 16. Photomicrograph of Core F-2 illustrating air-void clusters (within red circles) and ettringite filled voids (red arrows). Scale is in millimeters.

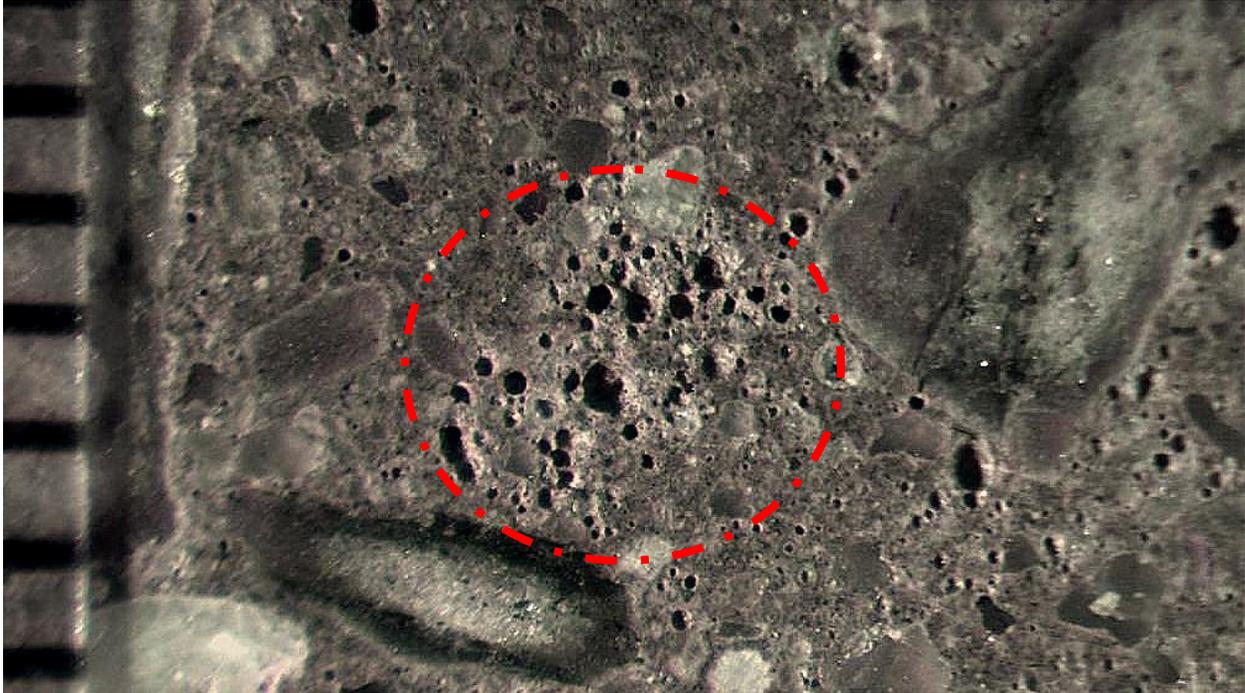
Ettringite lines most of the voids (Figure 17).

Figure 17. Photomicrograph of Core F-2 illustrating air-void clusters (within red dashed circle). Scale is in millimeters.

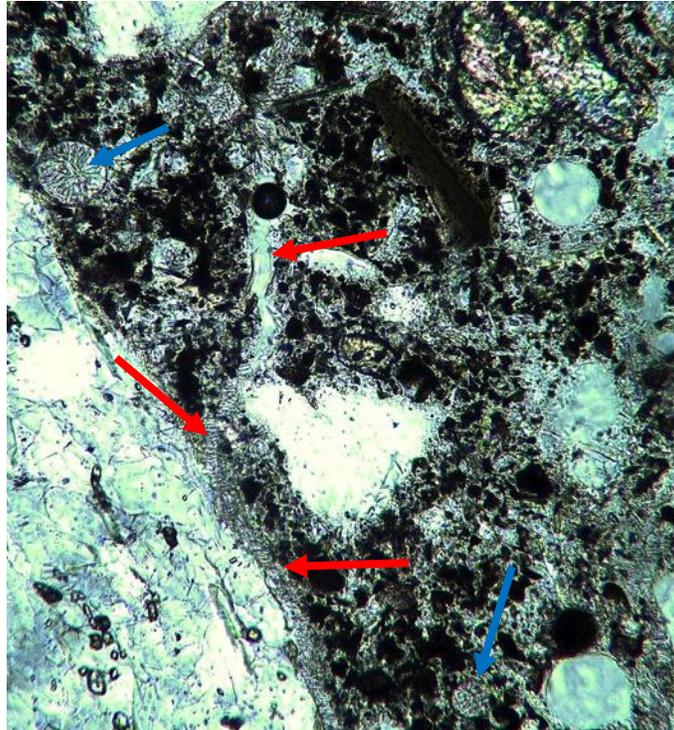
Ettringite lines many of the voids (Figures 19 and 20).

Figure 19. Thin section photomicrograph of Core K-1 showing a microcrack (red arrows) and voids lined to filled with ettringite (blue arrows). Vertical field of view is 0.60 mm. Plane-polarized light.

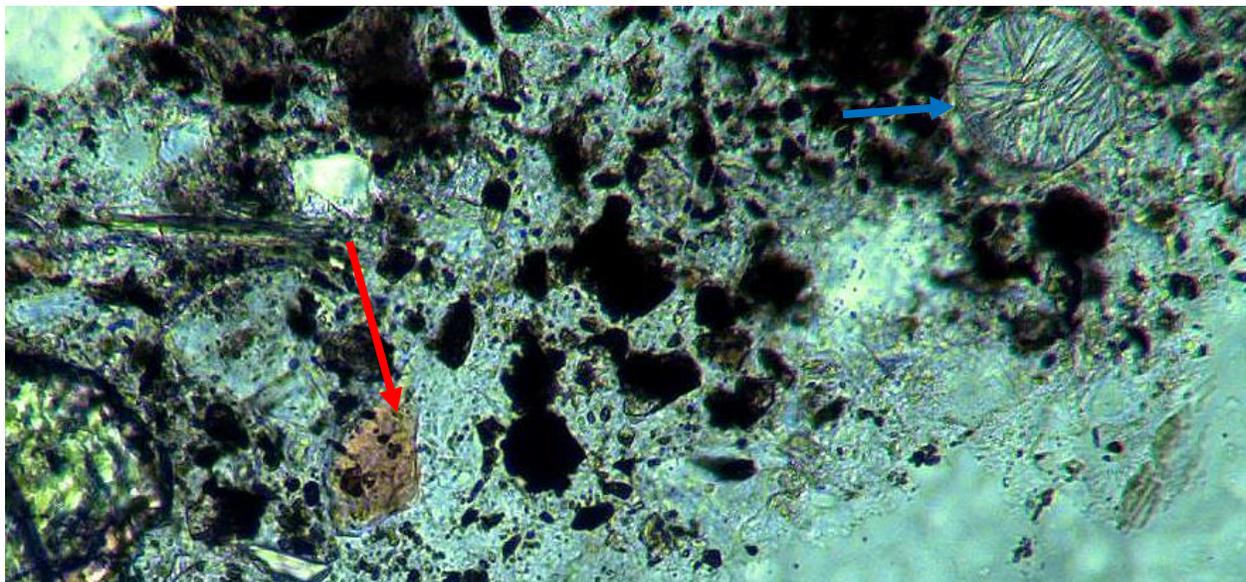
Ground granulated blast furnace slag is present as a supplementary cementitious material. Some of the slag has hydrated into yellowish amorphous relicts in the paste (Figure 19). Residual slag content is estimated to be 5 to 10%, by volume of paste.

Figure 20. Thin section photomicrograph of Core K-1 illustrating a slag relict (red arrow) and a void filled with ettringite (blue arrow). Vertical field of view is 0.60 mm. Plane-polarized light.

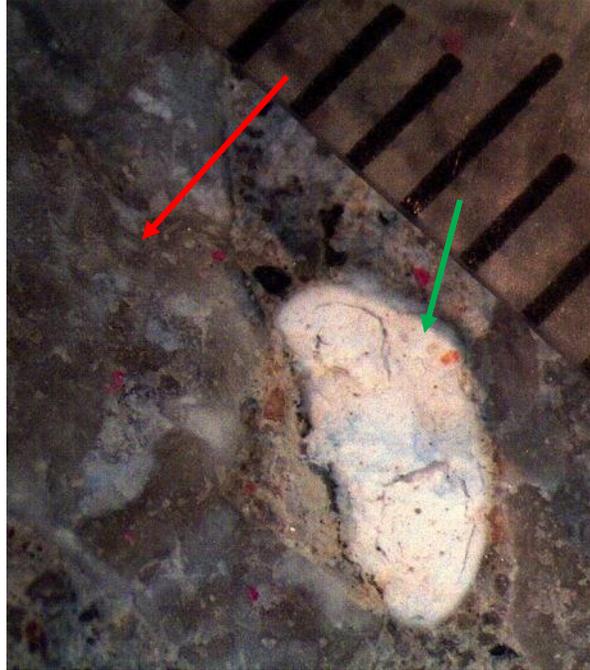
Figure 3. Photomicrograph along a freshly fractured surface of Core D8. Red arrow points to a reacting chert coarse aggregate particle with an alkali-silica gel filled void (green arrow) adjacent to the reacting particle. Scale is in millimeters.

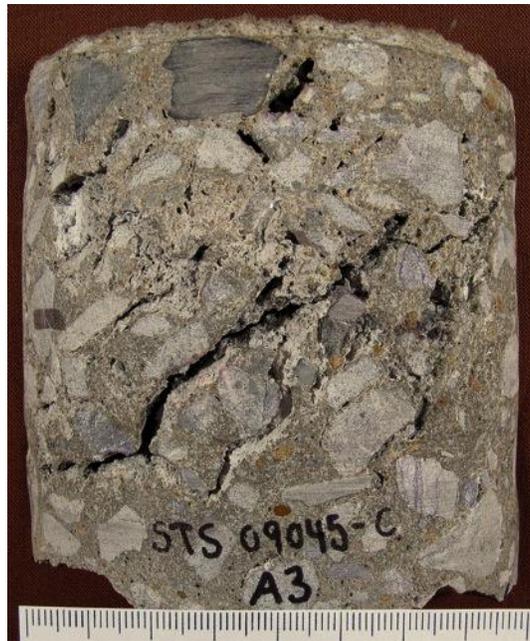
Figure 4. Honeycomb or poor consolidation in the upper 2-to-3 inches of Core A3. Scale is in millimeters.

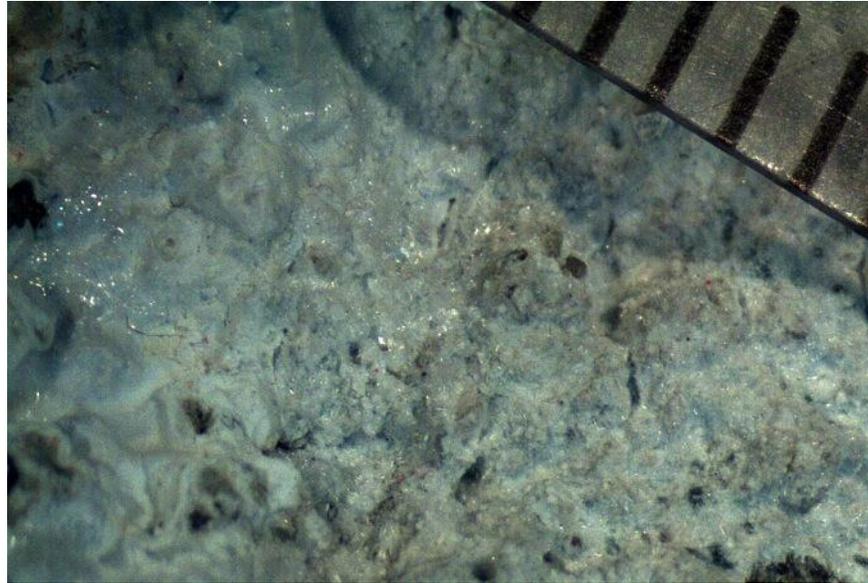
Figure 5. Photomicrograph along a large, poorly consolidated void (honeycomb) in Core A3. The void is lined with calcium carbonate, ettringite and wet appearing alkali-silica gel. Scale is in millimeters.

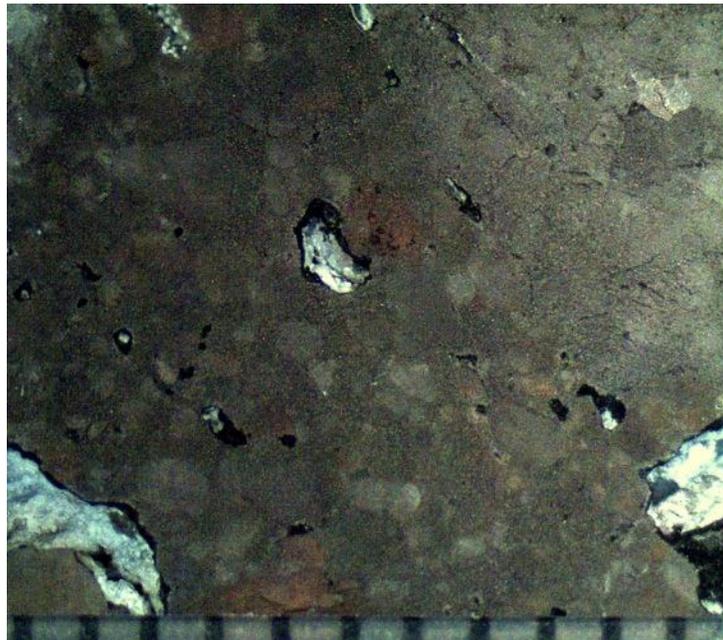
Figure 6. Photomicrograph along the lapped surface within the upper area of poor consolidation in Core A3. Air content is low, estimated to be 2.5-to-4.5% in the top 2-to-3 inches. Scale is in millimeters.

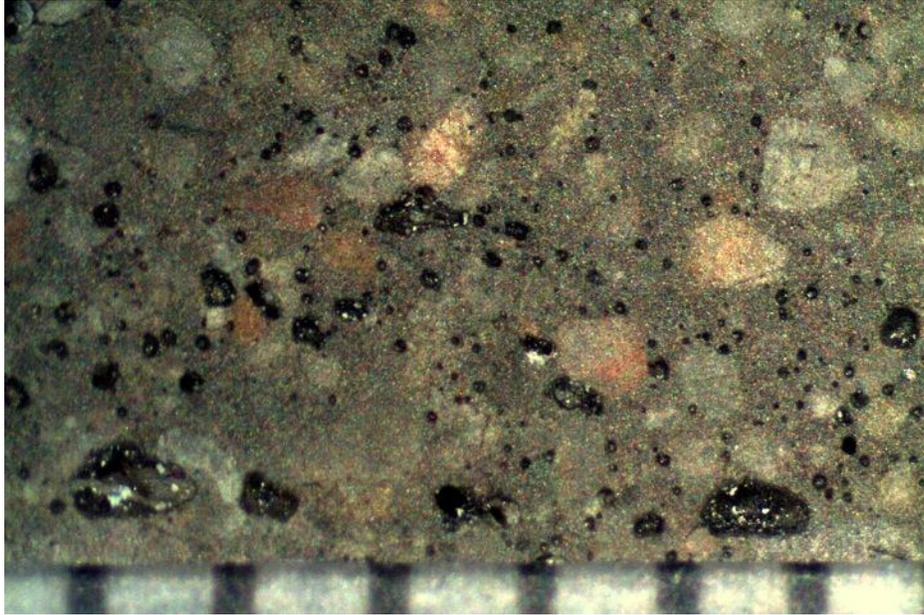
Figure 7. Photomicrograph along the lapped surface in the bottom half of Core A3. Air content is estimated to be 4.5-to-6.0% in this view. Scale is in millimeters.

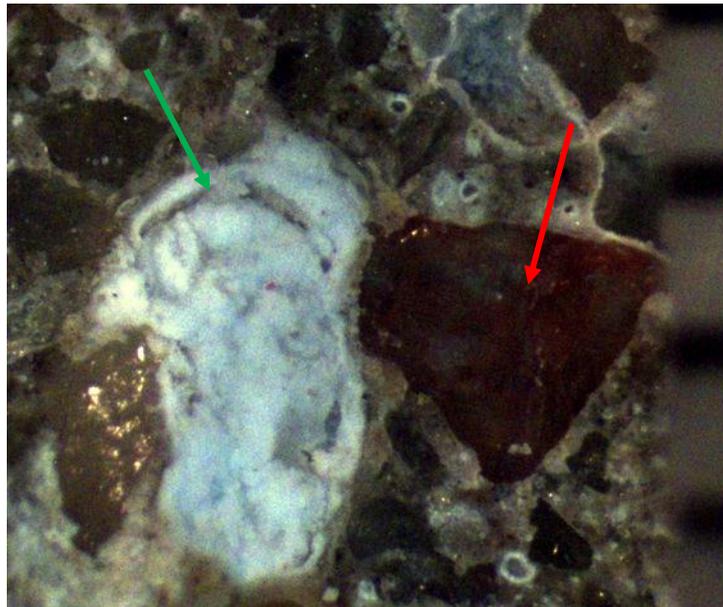
5. The fine aggregate in both cores is natural sand containing discrete chert particles among other lithologies. Again, there is minor evidence of alkali-silica reaction associated with chert in the fine aggregate, in the form of alkali-silica gel in voids adjacent to a few of the chert particles (Figure 8), but no cracking damage associated with the fine aggregate particles or in paste around the gel in either core.

Some of the chert and meta-argillite particles contain reaction rims along their outer periphery. As in the coarse aggregate, there is minor evidence of alkali-silica reaction associated with chert and meta-argillite in a few of the fine aggregate particles. Minor evidence includes alkali-silica gel in voids adjacent to the chert (Figure 8) and meta-argillite, but no cracking damage associated with the particle or in paste around the gel.

Figure 8. Photomicrograph along a freshly fractured surface of Core A3. Red arrow points to a reacting chert fine aggregate particle with an alkali-silica gel filled void (green arrow) adjacent to the reacting particle. Scale is in millimeters.

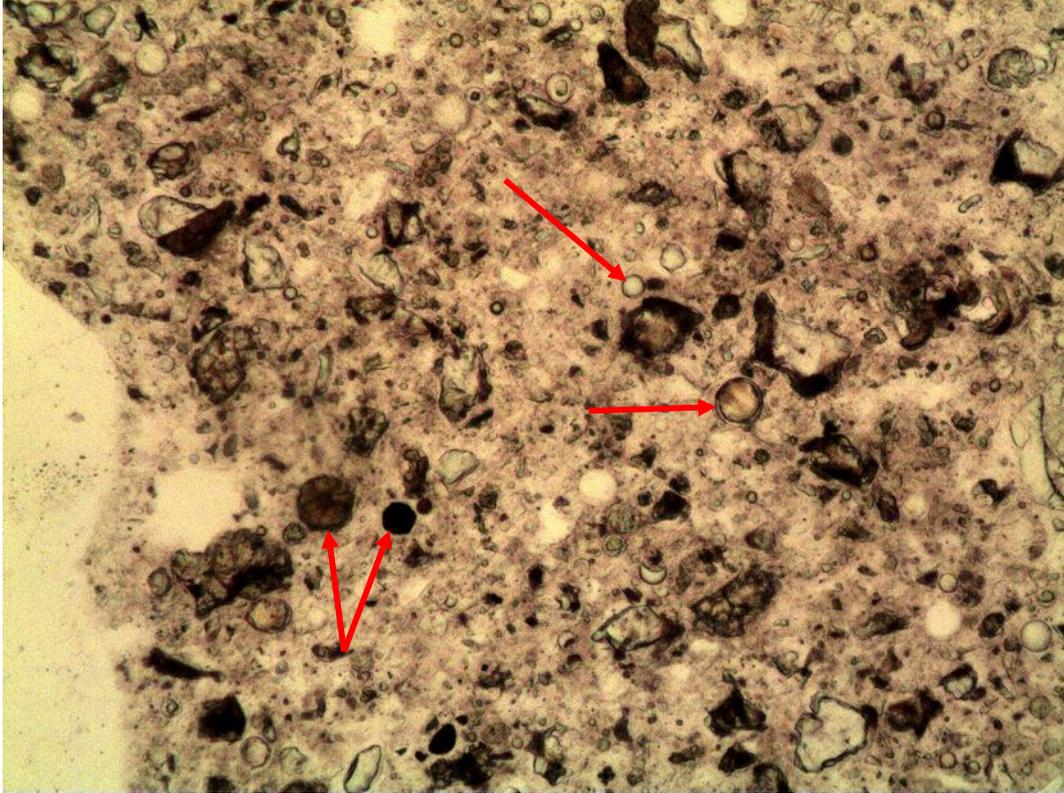
Figure 9. Thin section photomicrograph of Core D8. Red arrow points to fly ash particles that are present as supplementary cementitious materials in both cores. Plane polarized light. Vertical field of view is 0.6 mm.

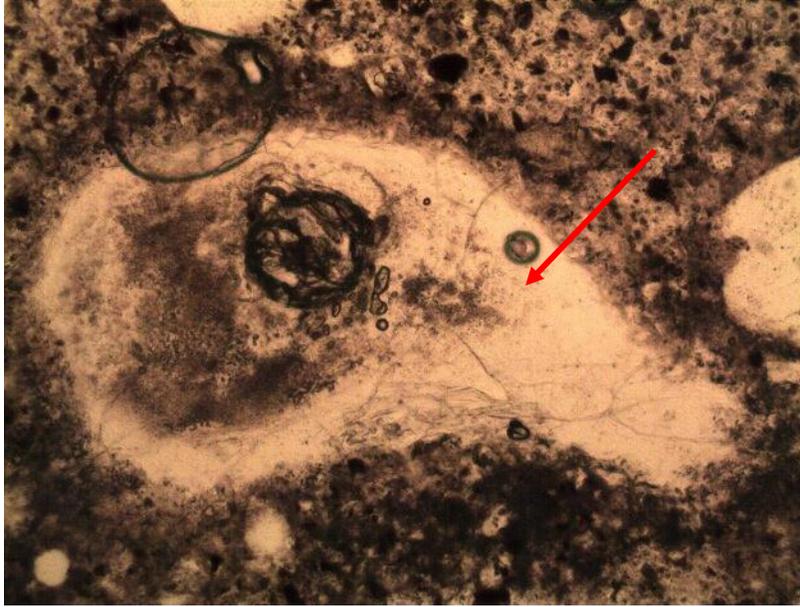
Figure 7. Thin section photomicrograph of a reacting chert particle in Core C7. Cracks radiate from a rimmed, beige chert particle (red arrow) into adjacent paste. The cracks are filled with alkali-silica gel and paste is soaked by gel. Vertical field of view is 1.1 mm. Plane polarized light.

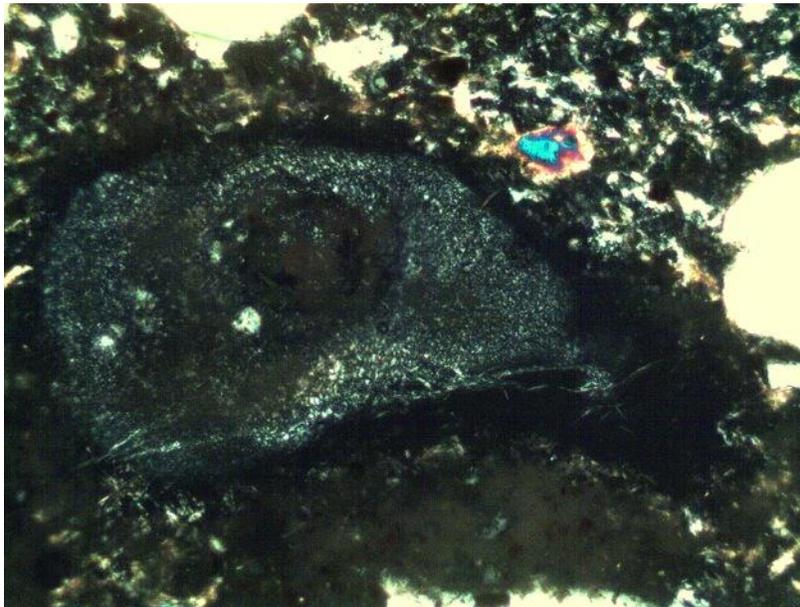
Figure 8. Thin section photomicrograph of the same reacting chert particle as in Figure 7. Gel filled cracks are slightly more apparent. Vertical field of view is 1.1 mm. Cross-polarized light.

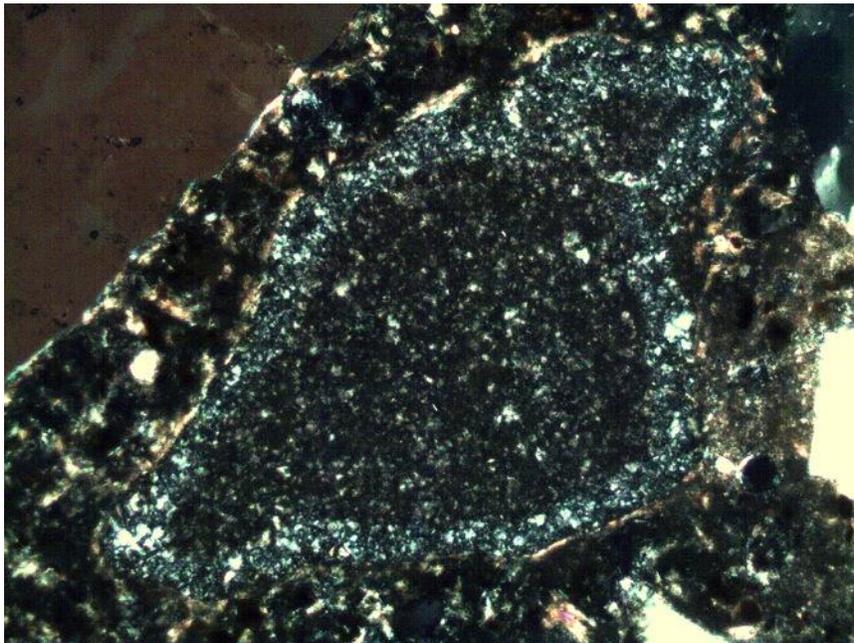
Figure 10. Thin section photomicrograph of the same rimmed chert particle as in Figure 9. Vertical field of view is 1.1 mm. Cross-polarized light.
