IPRF – Project 04-02

Final Report

Improved Overlay Design Parameters for Concrete Airfield Pavements (IPRF Project FAA-01-G-002-04-2)

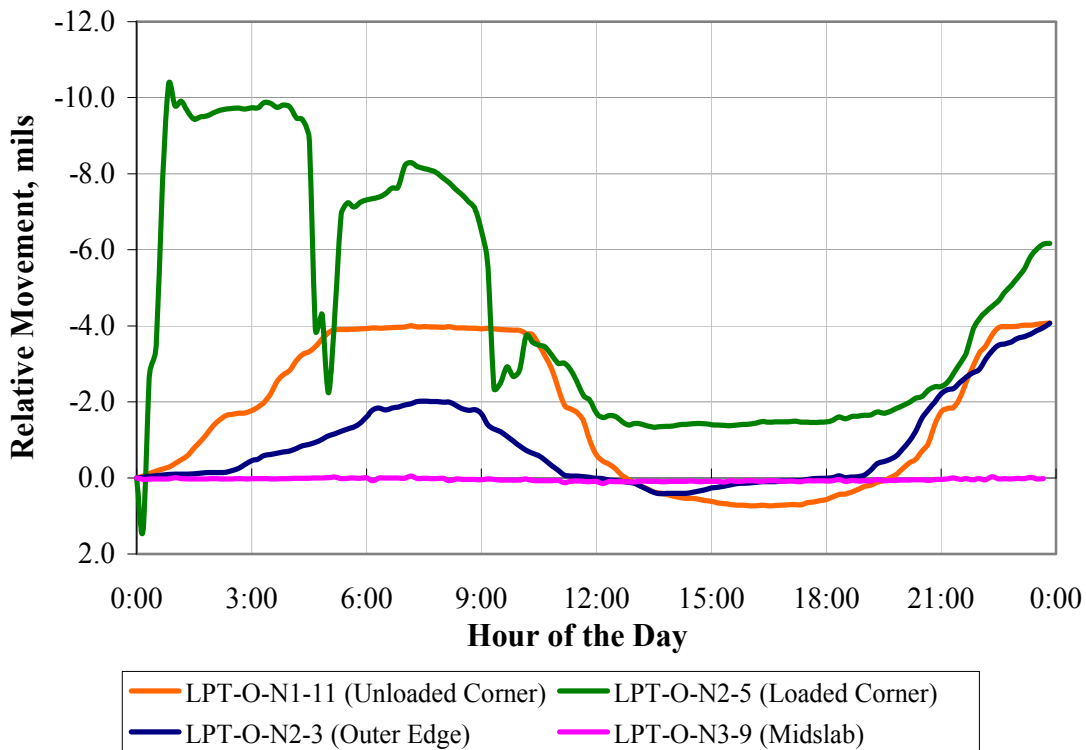
FIGURE 25. DIURNAL VARIATIONS OF LPTS ON AUGUST 5, 2006 (INITIAL LOADING PHASE)

The diurnal movements of LPTs on August 5 and September 30, 2006, are shown in figure 25 and figure 26, respectively, after loading had begun. The variations on August 5 indicate the early distress condition of the overlay, with a few longitudinal cracks. On August 5, the LPT in the loaded corner (LPT-O-N2-5) exhibited significant increase in upward curl between 1:00 a.m. and 4:30 a.m., followed by a significant decline for an hour, and another steep increase in upward curl between 5:30 a.m. and 9:00 a.m. This steep rise and fall of the LPT can be attributed to crack development and aggregate interlock. The other two LPTs on the unloaded corner and edge exhibited typical behavior. The midslab LPT exhibited a typical inverse trend with much smaller variations not exceeding 0.1 mils.

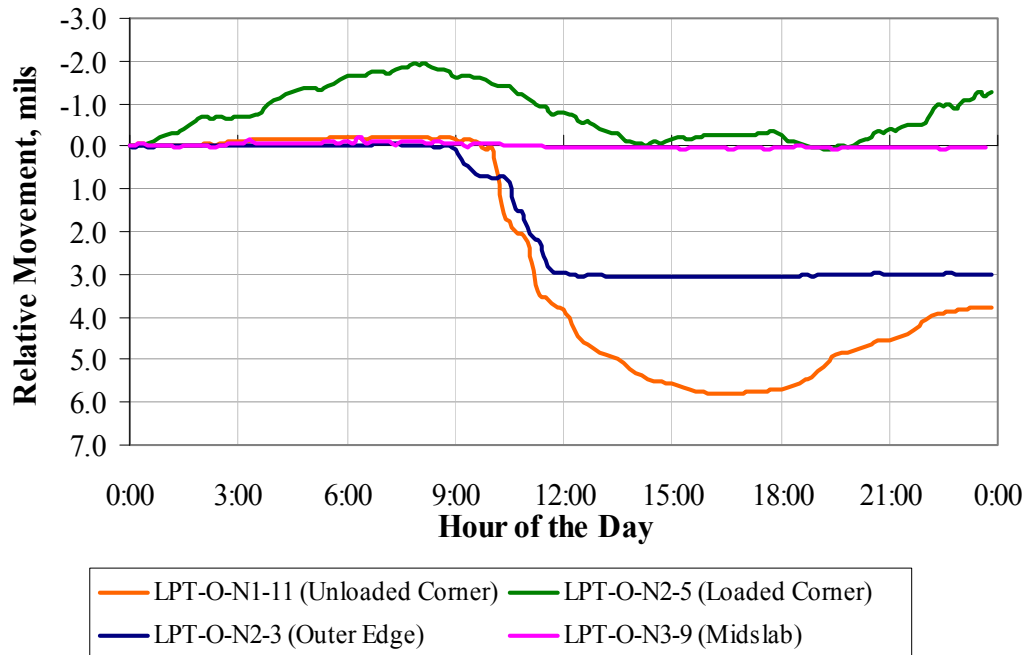
FIGURE 26. DIURNAL VARIATIONS OF LPTS ON SEPTEMBER 30, 2006 (FINAL LOADING PHASE)

On September 30, the north test items had reached their final distressed condition. The LPTs in the loaded corner exhibited significant upward curl in the early morning and insignificant downward curl in the late afternoon. The LPTs in the unloaded corner and the edge exhibited little or no upward curl in the morning and significant downward curl in the afternoon. The midslab LPT-O-N3-9 exhibited similar behavior to LPT-O-N2-5, opposite to its usual trends, but with much smaller magnitudes. Cracks had developed all around the vicinity of LPT-O-N3-9.

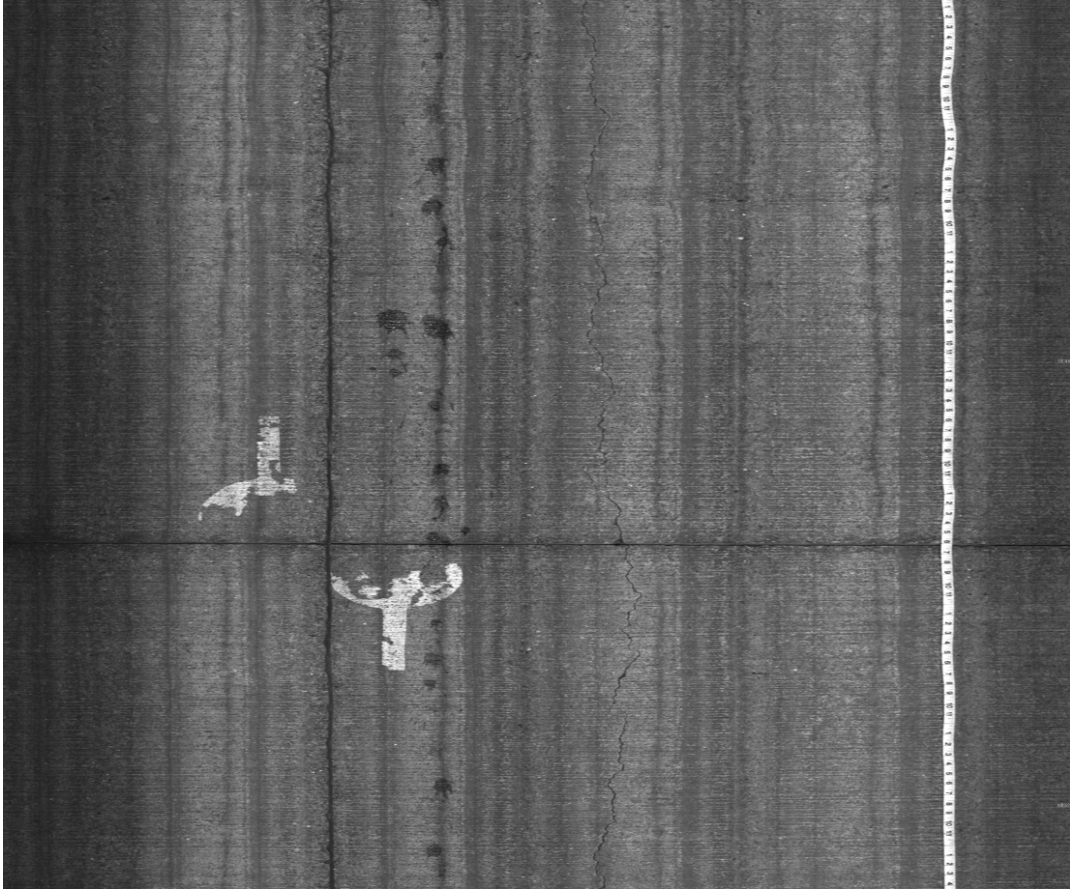
FIGURE 39. DIGITAL IMAGE OF SURFACE AND DISTRESS

Figure 39 is an example of several digital images “stitched” together. This image represents imaging with the equipment set up such that a 0.5-mm dimension is the size of a single pixel. Images were also recorded of the pavement with a camera height such that a 0.3-mm dimension is one pixel size.

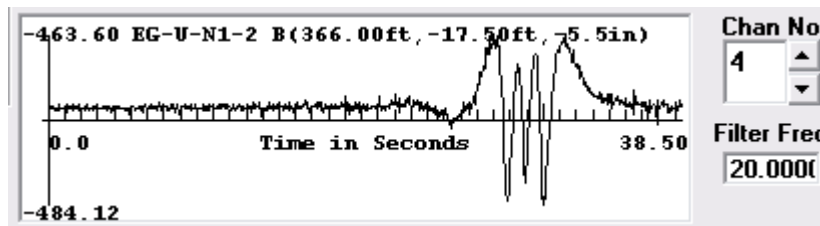
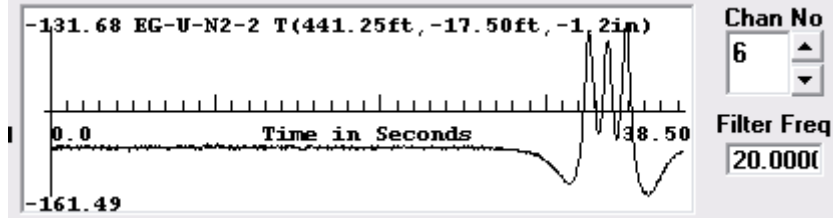
Figure 59 and figure 60 illustrate the responses from underlay gages in test item N2 from August 3, 2006. On that date, these gages did not follow the pattern of steadily increasing strain with the passage of each axle. While the third axle typically produced the greatest strain, the second peak was less than the first. In figure 60, for the gage at the bottom of the underlay, strain reversal occurred between the peaks from each axle.

FIGURE 59. TEST ITEM N2, EMBEDDED STRAIN GAGE RESPONSE AT BOTTOM OF UNDERLAY, TRACK 0 (NOTE: GAGE IS MISIDENTIFIED IN TENVIEW; GAGE IS EG-U-N2-2 B)

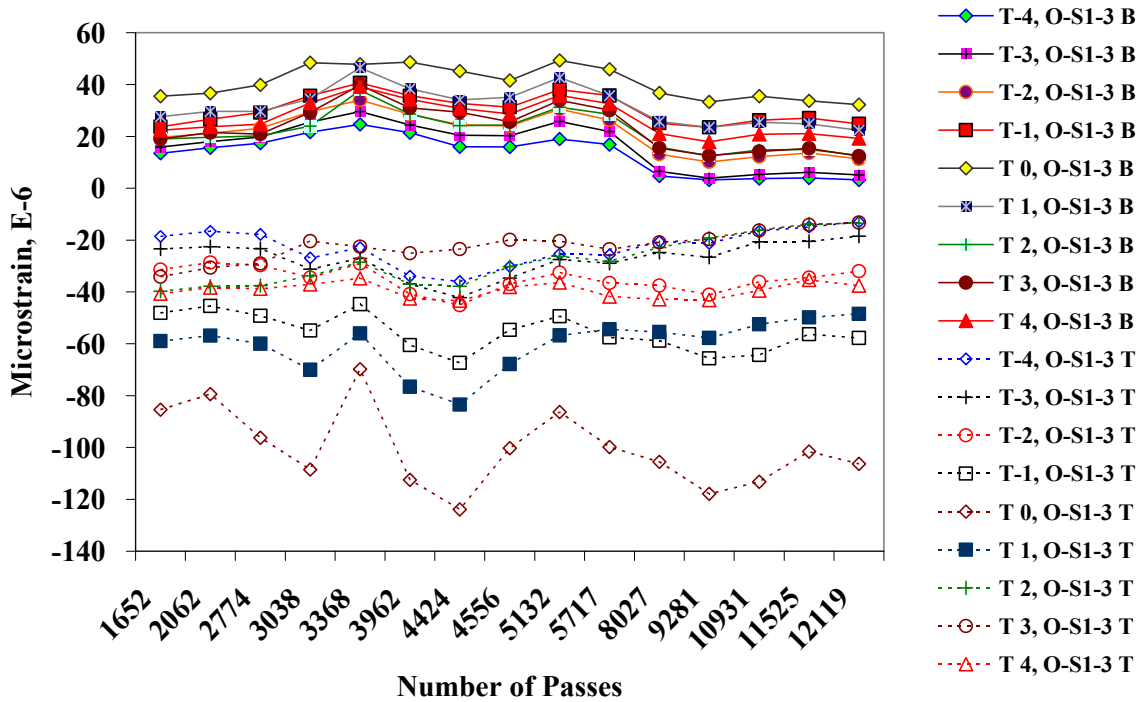
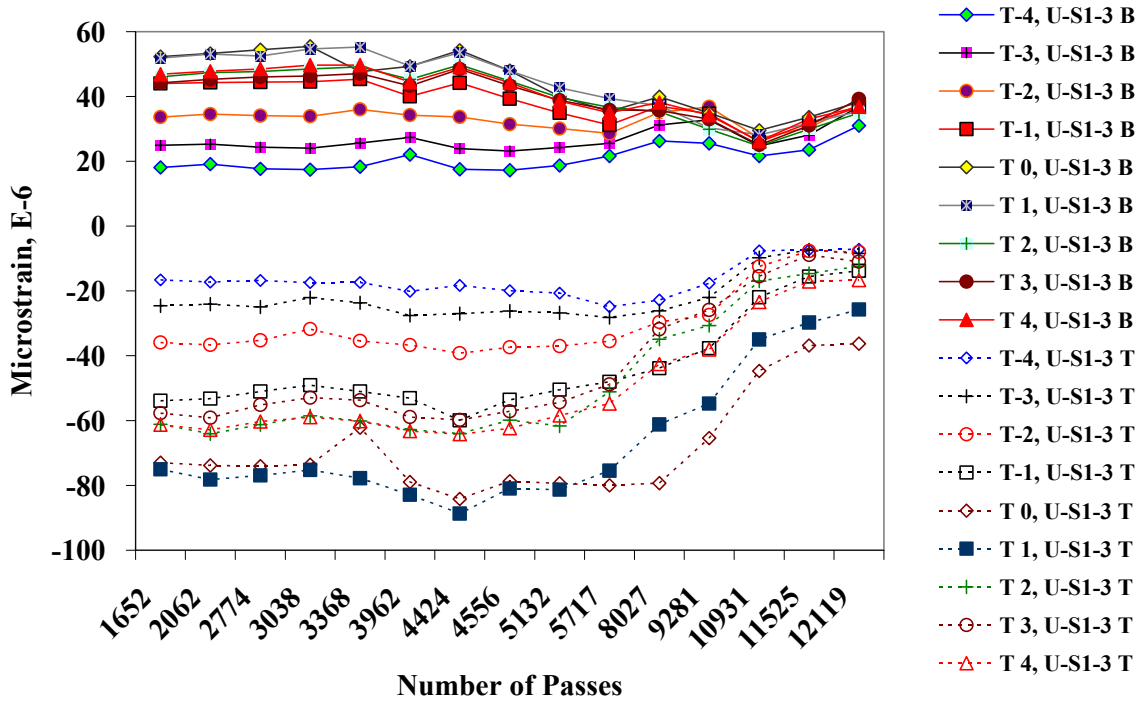
Figure 63 and 64 contain example summary plots of peak strain. These examples are for test item S1, for the overlay and underlay gages, respectively, at gage location 3. These values were plotted for various numbers of prior cumulative passes of the test vehicle, corresponding approximately to the intervals of the visual distress surveys. Each plot contains lines for the gages near the top and the bottom of the slab, and for each loading track. The responses were determined by averaging selected passes in that track in a single wander. Appendix H contains the peak strain responses for all embedded strain gages. Both the magnitude and pattern of variation of response over time was different for gages at different locations within a single test item. The changes over time often corresponded to differences in distress patterns. For example, a decrease in strain response for a given track sometimes corresponded to the occurrence of a crack between that track and the gage location.
